the **play inspection** company

Annual Inspection

Welton Parish Council

Welton Recreation Ground

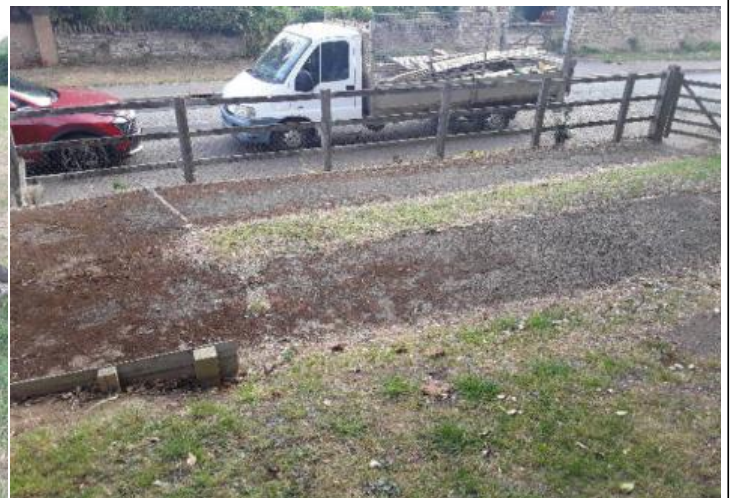
Finding: There is algae, silt or moss growth on the surface resulting in slippery conditions

Action: Clean and treat appropriately

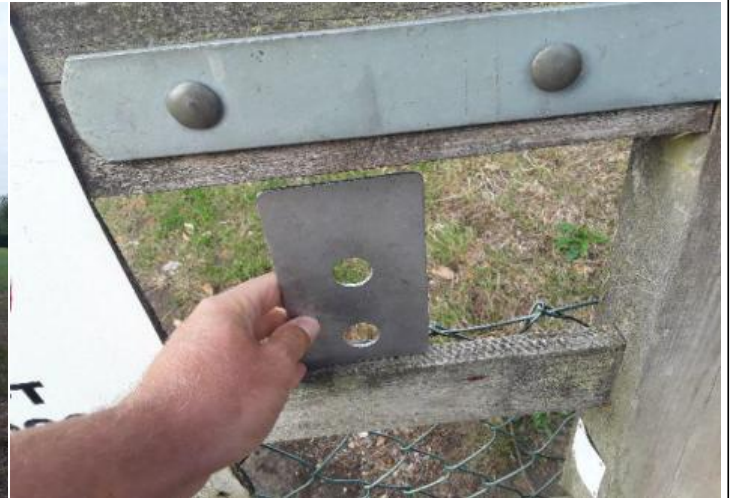
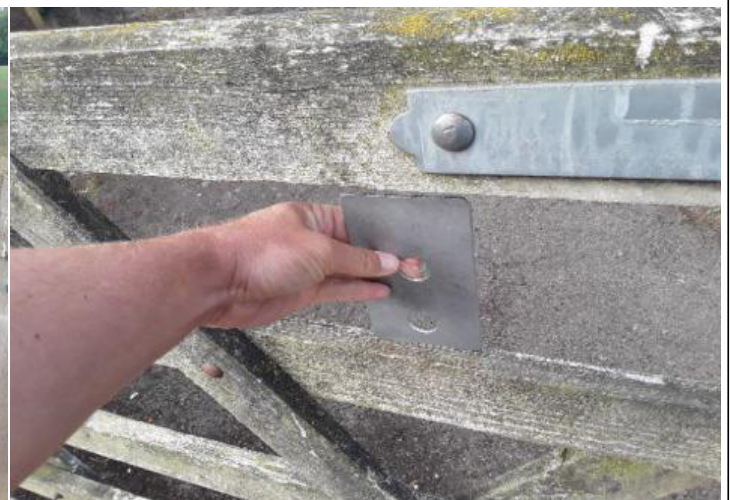
Finding: There is a risk of head and neck entrapment in the gates **Action:** Monitor - no remedial work recommended

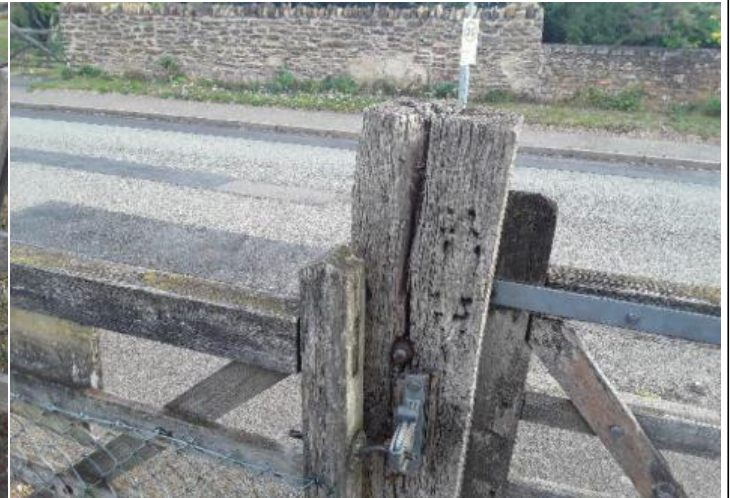
Finding: The timber has a number of splits/shakes or air cracks and this may affect the stability or allow water ingress which will accelerate the rotting process. Timber splits may also create rough / splintering edges.

Action: Monitor, sand down any rough edges and ensure the splits do not cross through fixing points of the structure and/or cause any instability

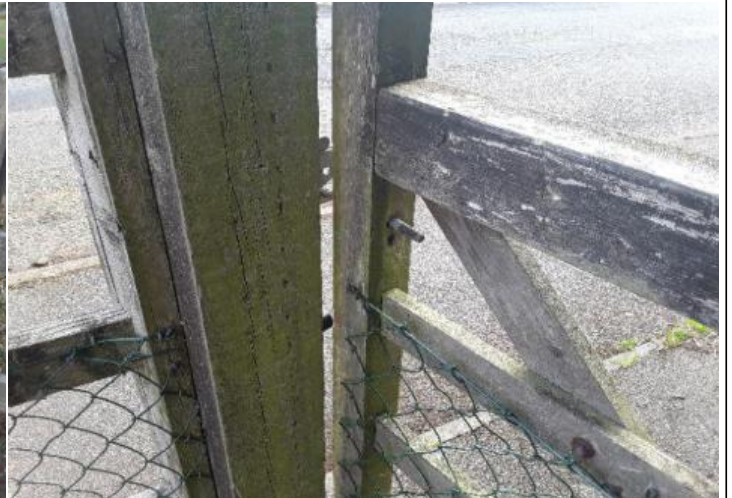
Finding: There is or are fixings missing on the item

Action: Replace all missing fixings

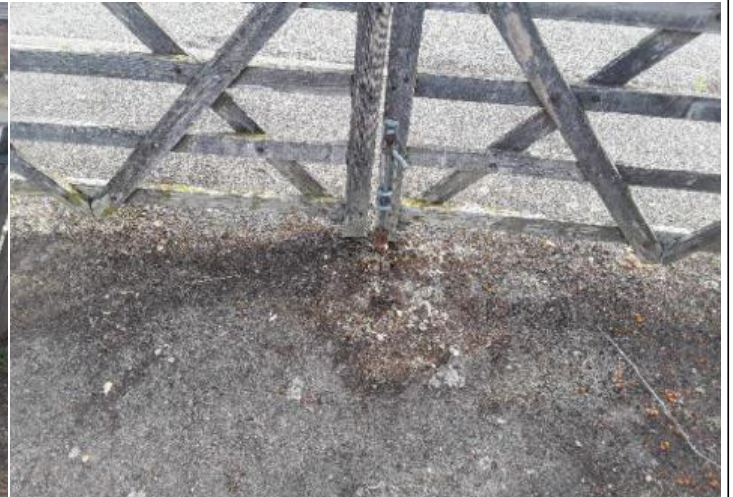
Finding: The area under the gate has eroded leaving uneven areas, or the concrete foundations exposed, resulting in trip hazards at the entrance/exit to the playground

Action: Reinstate to level with surrounding surfaces

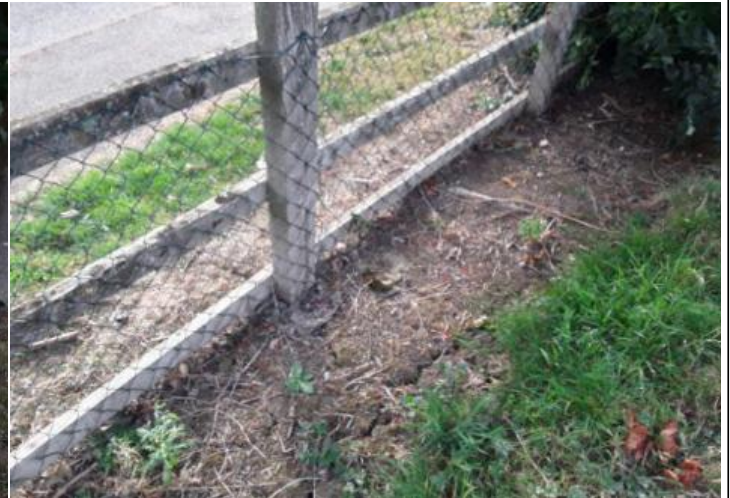
Finding: The surface has eroded and the foundations are exposed

Action: Reinstate surrounding surfaces to cover the foundations

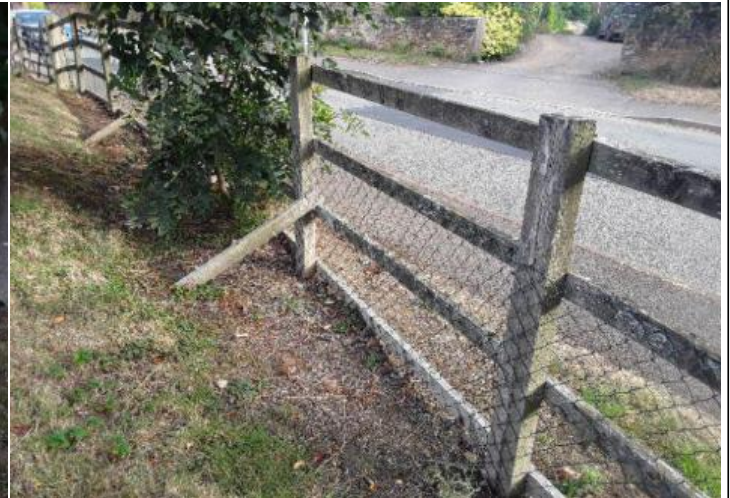
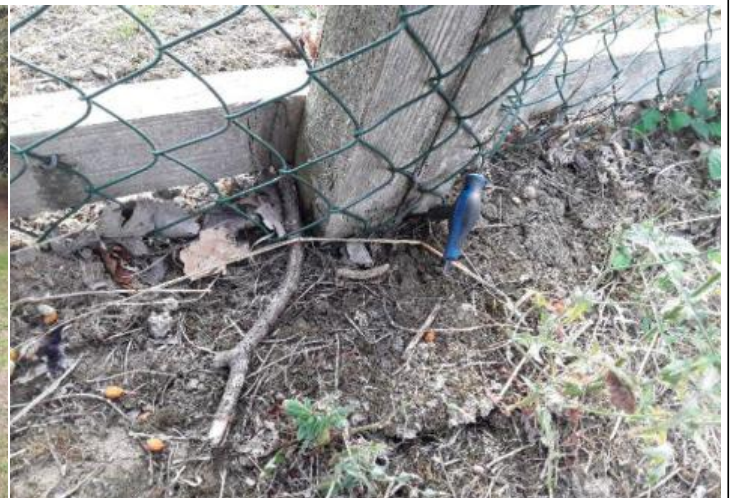
Finding: There are areas or parts of the timber on the structure that have rotted and snapped throughout the fenceline

Action: Replace all affected timbers

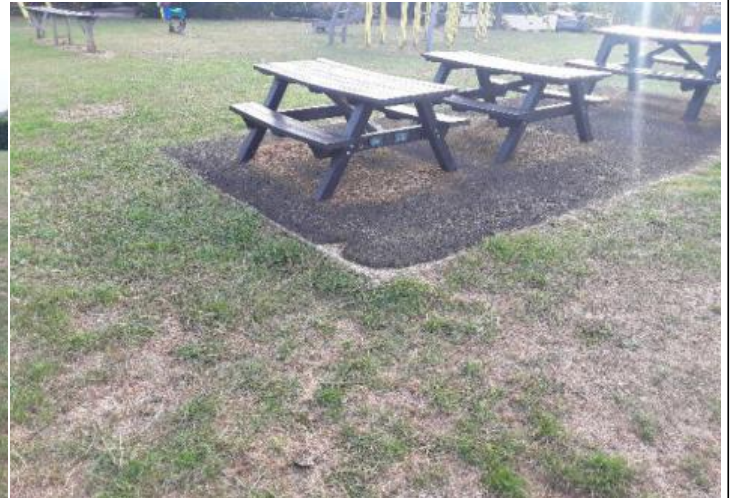
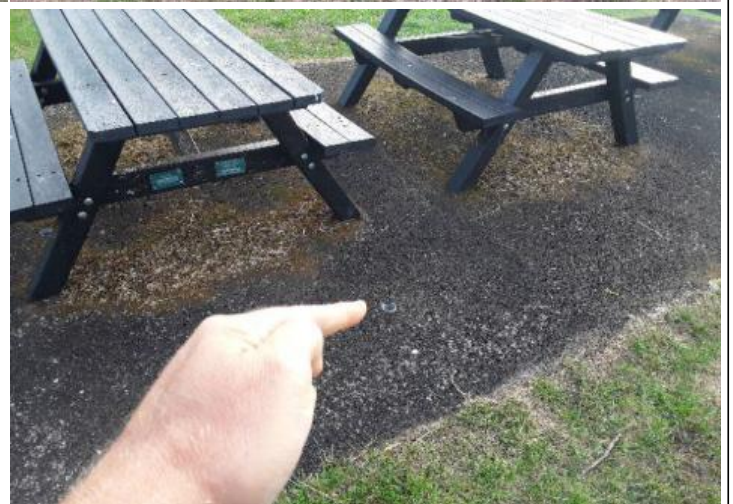
Finding: There are trip hazards present

Action: Remove trip hazard

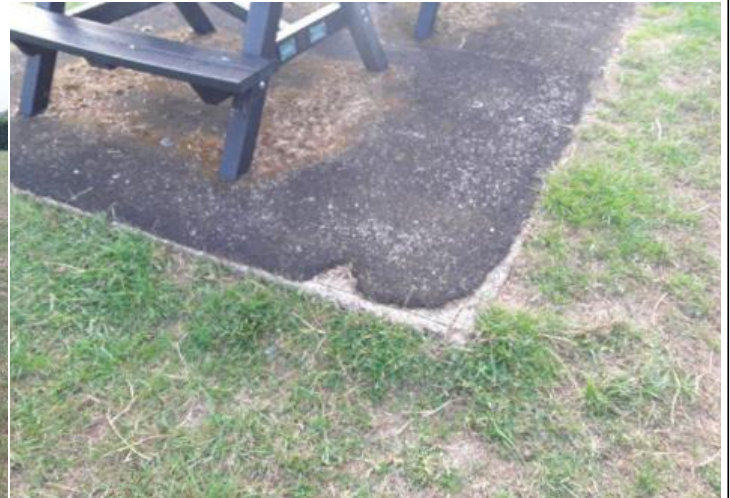
Finding: There is moderate damage to the surface

Action: Repair the damaged areas of surfacing

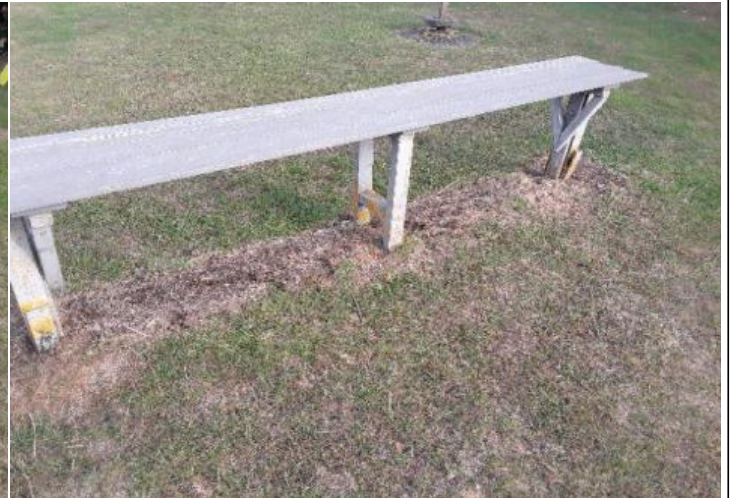
Finding: The surface has eroded and the foundations are exposed

Action: Reinstate surrounding surfaces to cover the foundations

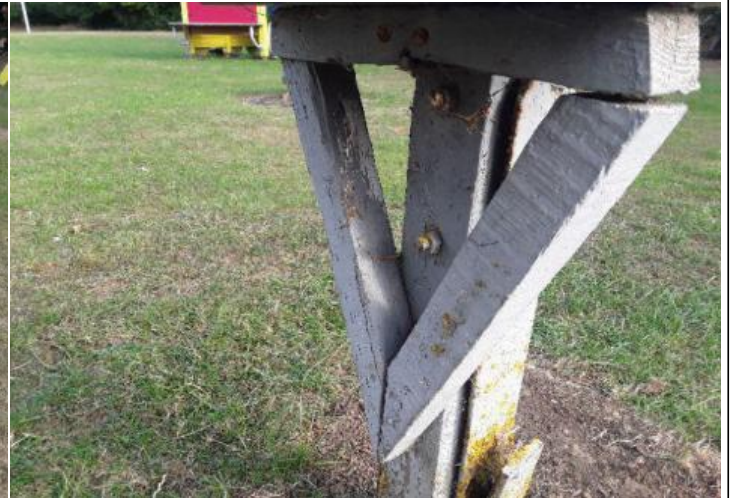
Finding: A number of fixing(s) have worked loose

Action: Secure all loose fixings

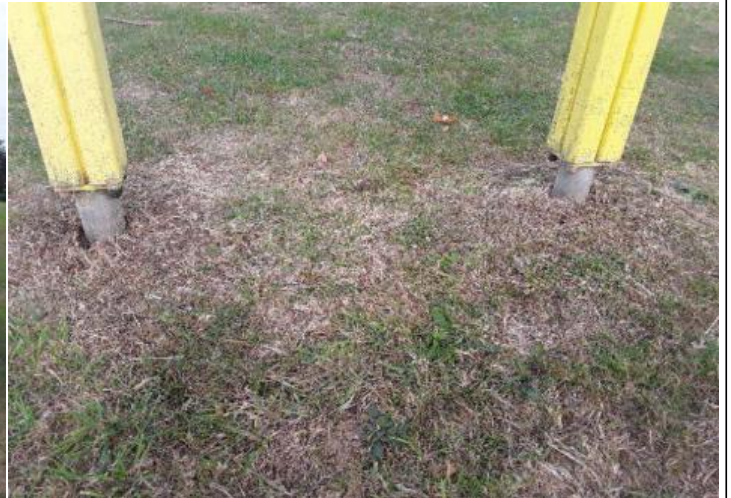
Finding: There is/are bolt cap covers missing or damaged on the item

Action: Replace missing or damaged bolt cap covers

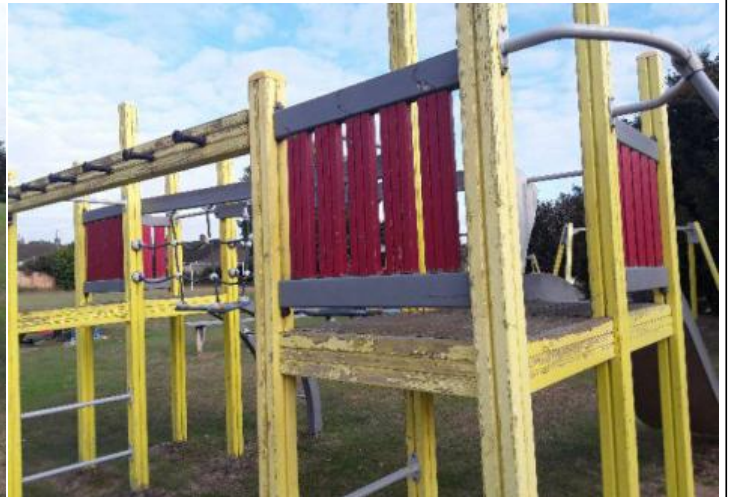
Finding: The timber stain is in poor condition

Action: Prepare all affected parts and re-stain with an appropriate preservative

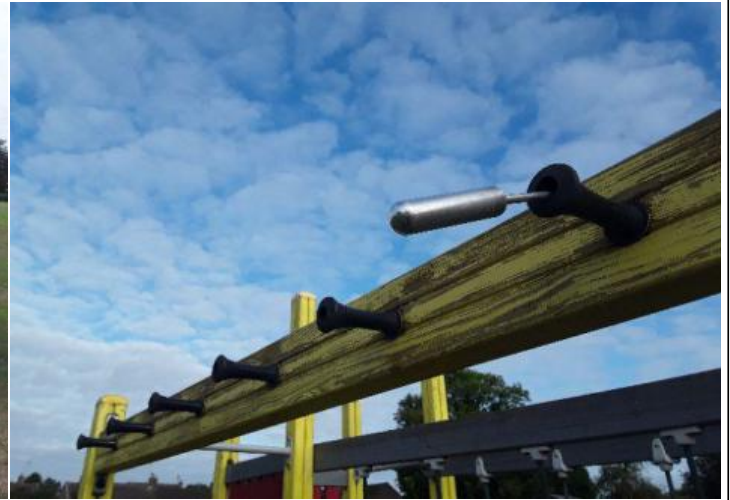
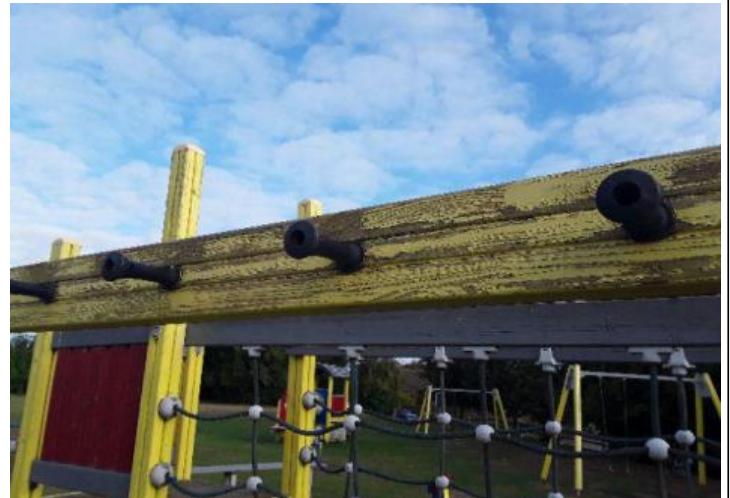
Finding: There is/are finger entrapment/s in the handgrips due to missing end caps and the item fails to meet the requirements of BS EN 1176 Part 1 4.2.7.6 Entrapment of fingers

Action: Replace missing caps to remove the entrapments

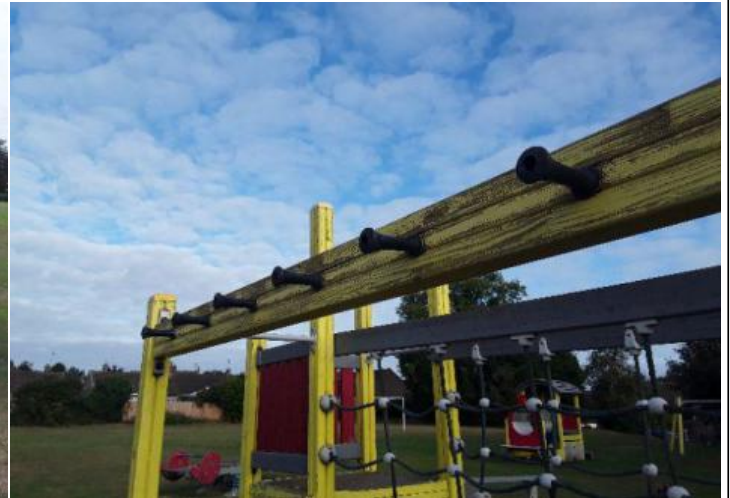
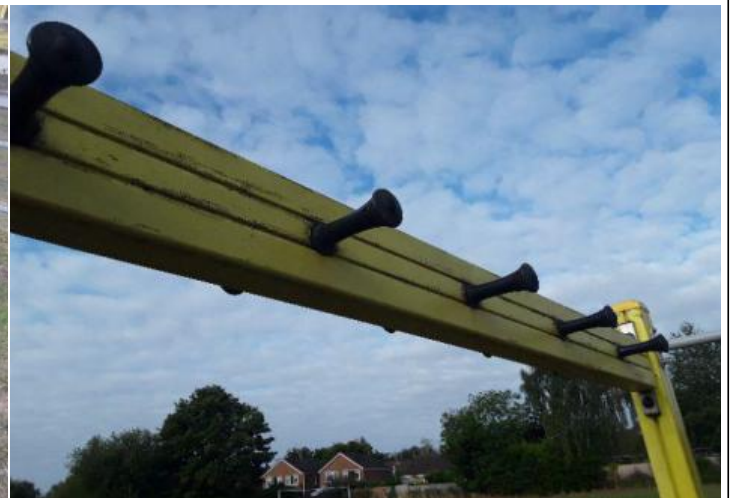
Finding: A number of fixing(s) have worked loose

Action: Secure all loose fixings

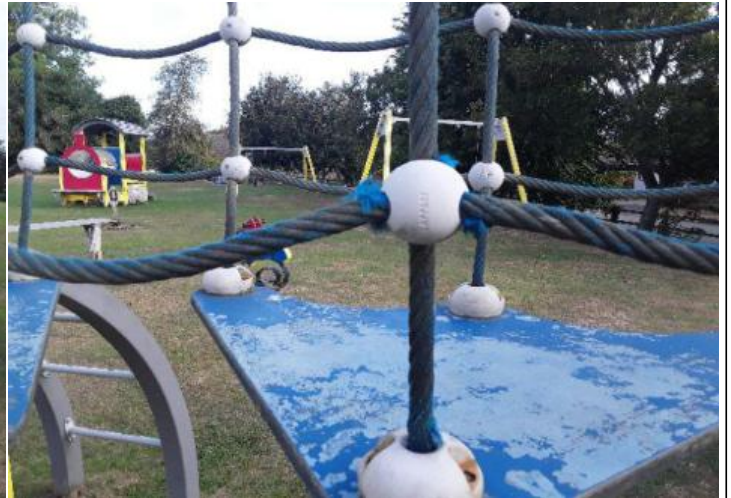
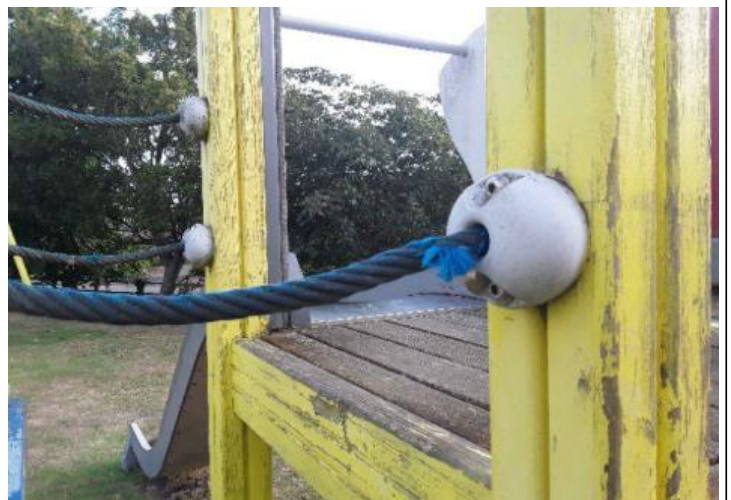
Finding: The ropes/nets are worn/damaged in places

Action: Monitor for any further deterioration and repair or replace as required

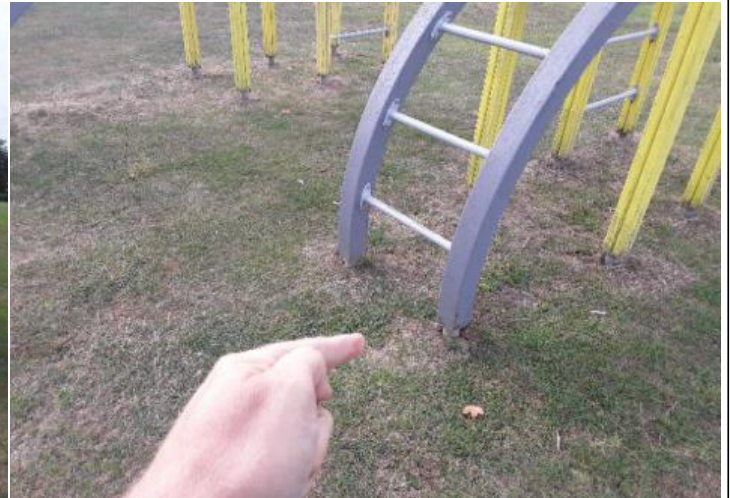
Finding: The surface has subsided in some areas

Action: Monitor for any further deterioration and repair as required

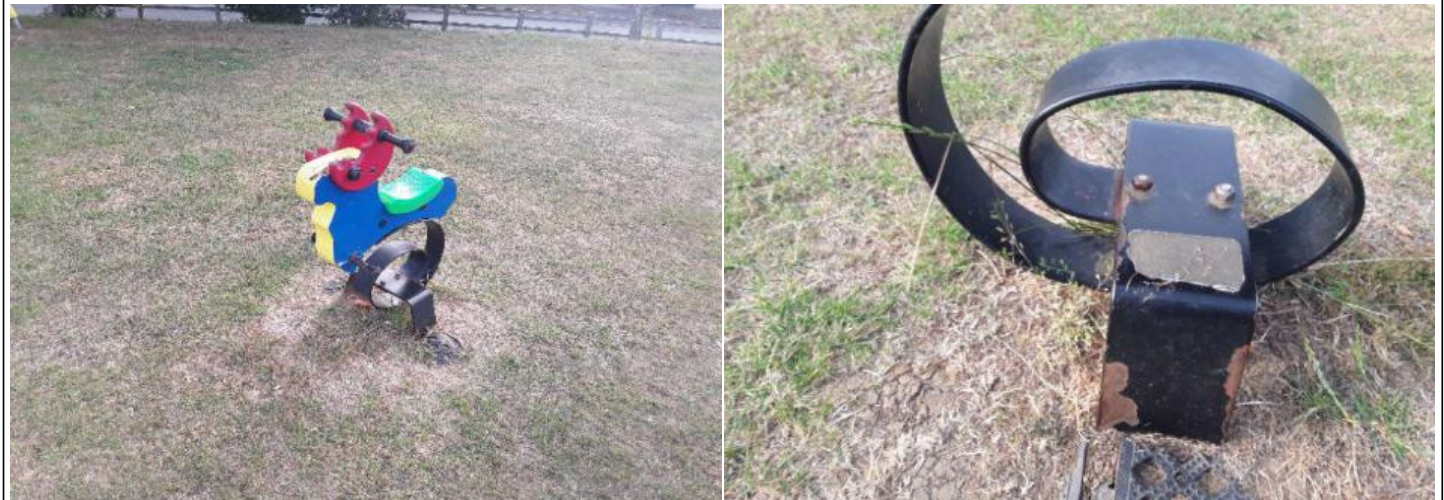
Finding: The paintwork on this item has been damaged or worn exposing the metal underneath which is rusting / corroding
Action: Treat affected areas and repaint

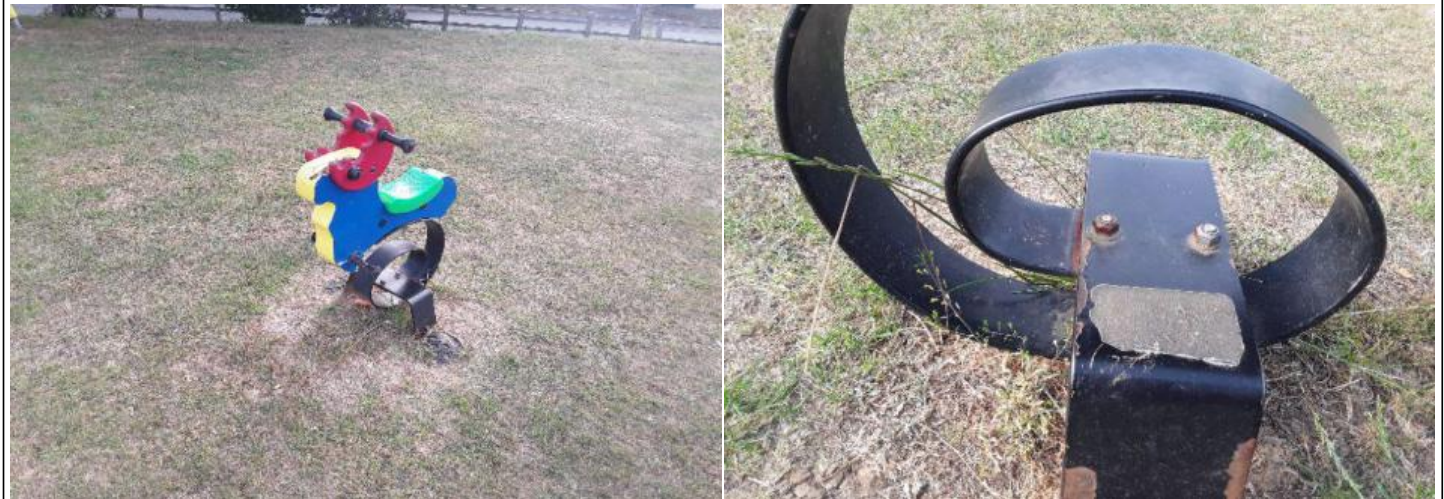
Finding: There is/are bolt cap covers missing or damaged on the item
Action: Replace missing or damaged bolt cap covers

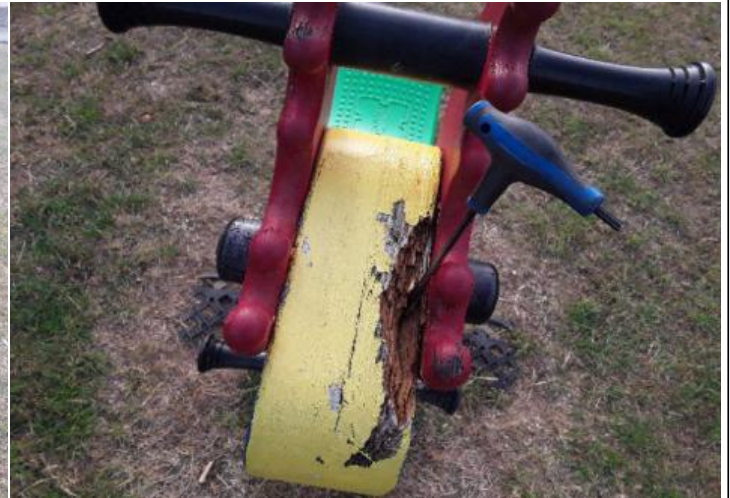
Finding: There are areas or parts of the timber on the structure that have rotted

Action: Replace all affected timbers

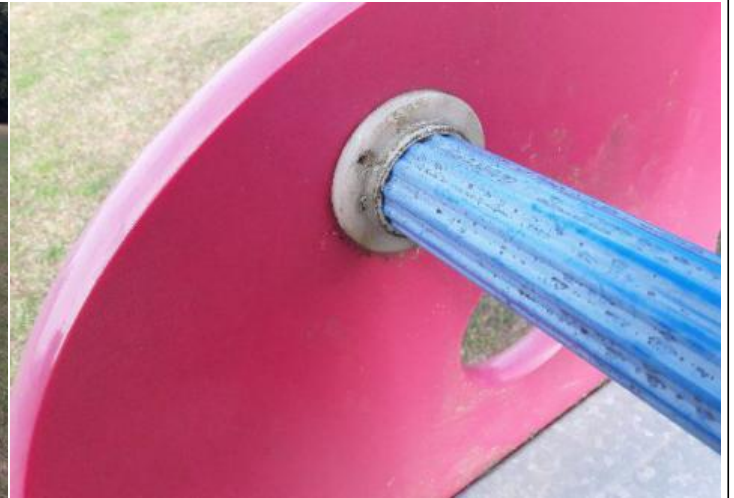
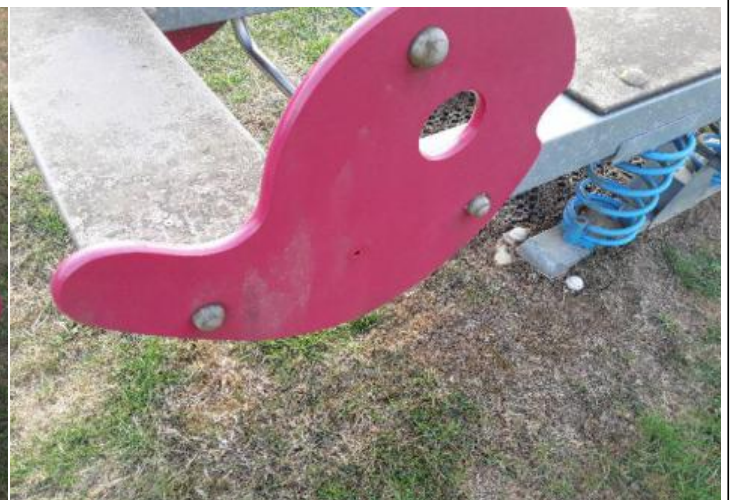
Finding: There is or are fixings missing on the item

Action: Replace all missing fixings

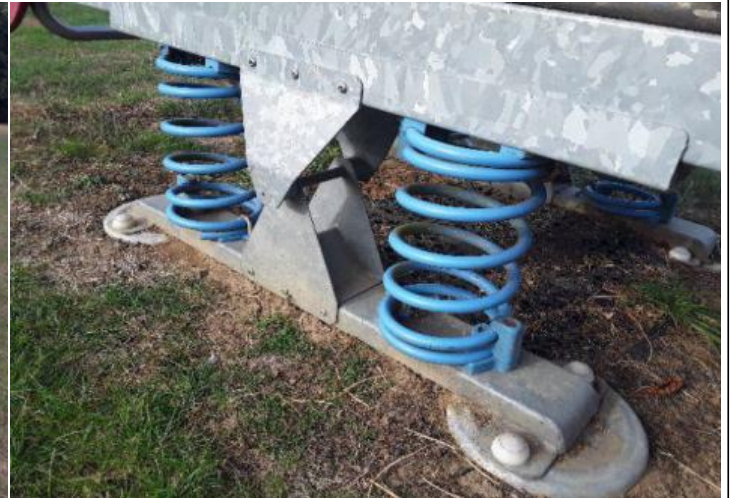
Finding: The spring clamps are loose

Action: Tighten all loose fixings

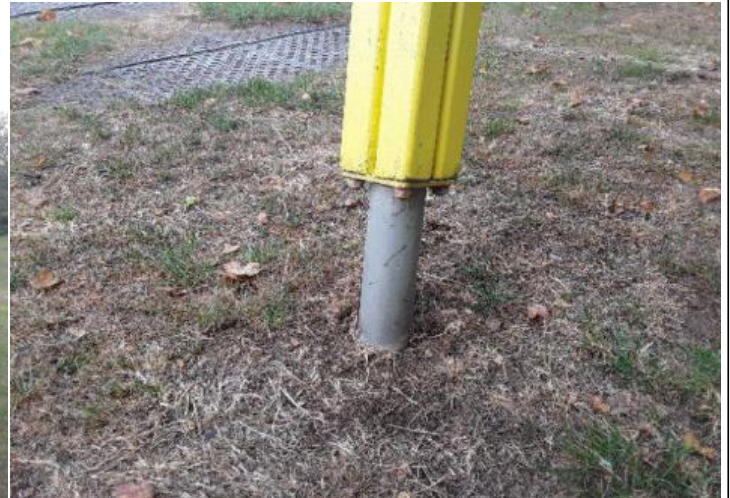
Finding: There is/are bolt cap covers missing or damaged on the item

Action: Replace missing or damaged bolt cap covers

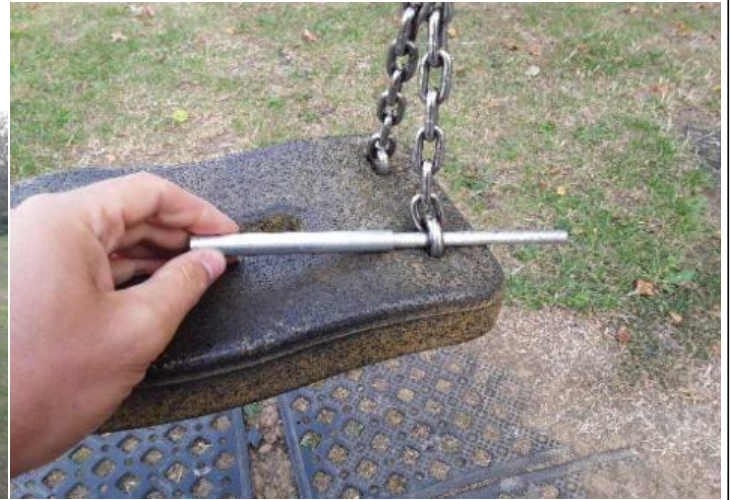
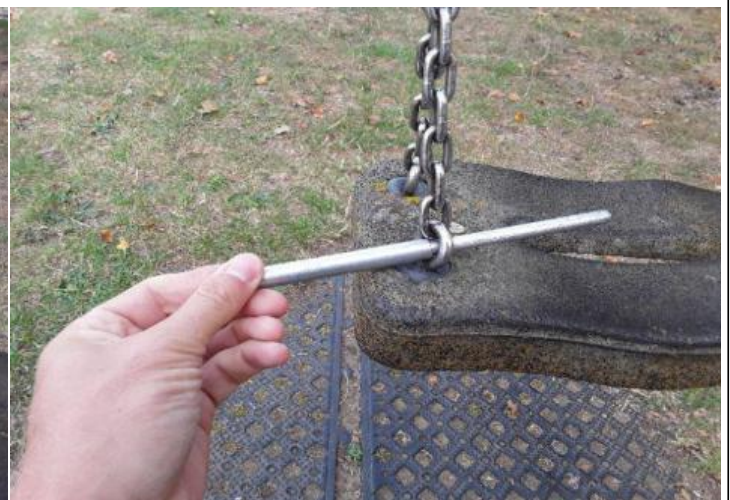
Finding: The connecting links are in excess of 8.6mm and less than 12mm and fail the requirements of BS EN 1176 Part 1; clause 4.2.13, Chains

Action: Monitor use and replace with compliant links at the next maintenance cycle

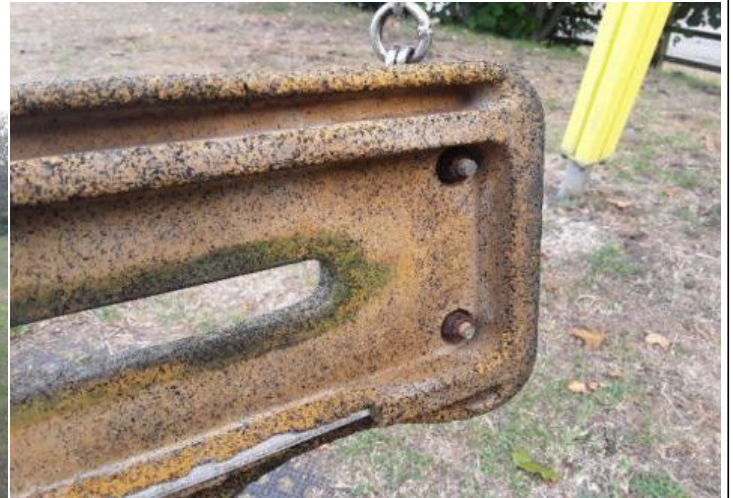
Finding: The fixings have corroded excessively

Action: Replace all corroded fixings

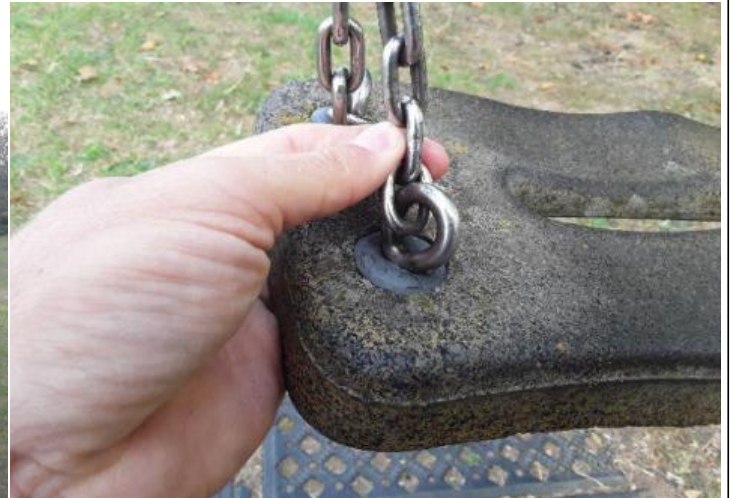
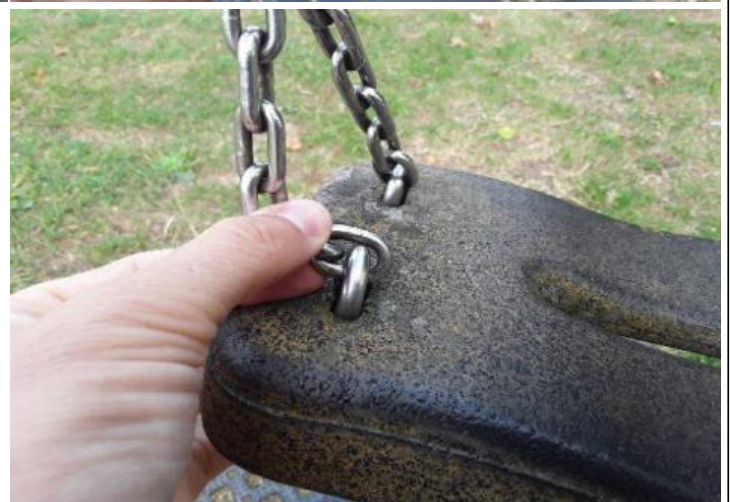
Finding: There is some notable evidence of chain wear

Action: Monitor for any further deterioration and replace when 40% worn

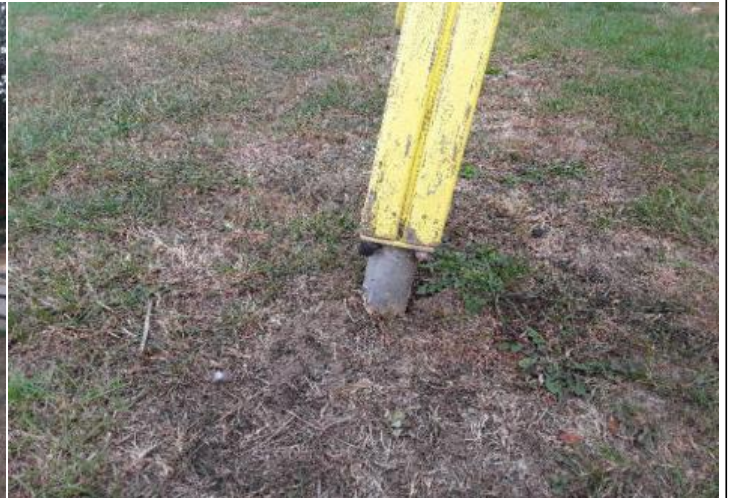
Finding: There is/are bolt cap covers missing or damaged on the item

Action: Replace missing or damaged bolt cap covers

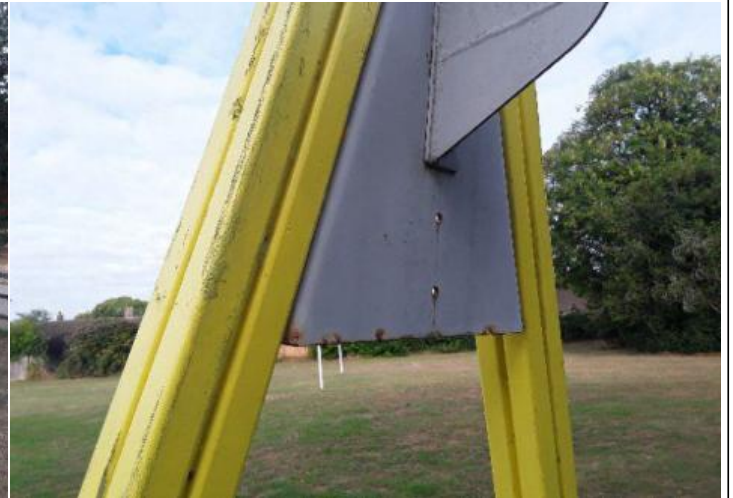
Finding: The paintwork on this item has been damaged or worn exposing the metal underneath which is rusting / corroding

Action: Treat affected areas and repaint

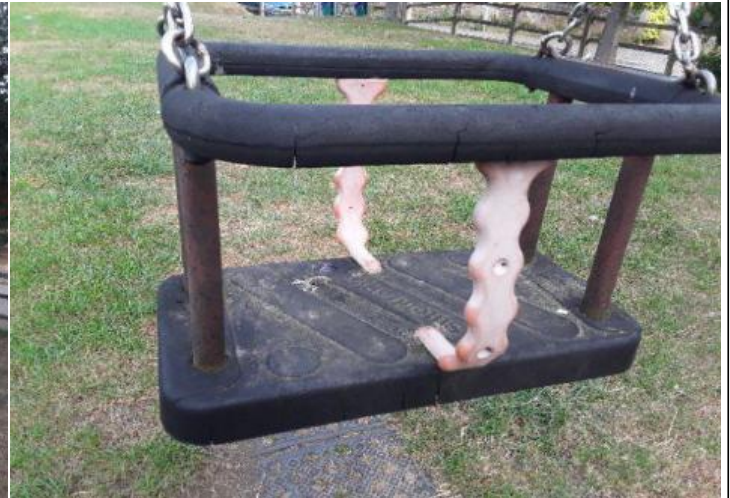
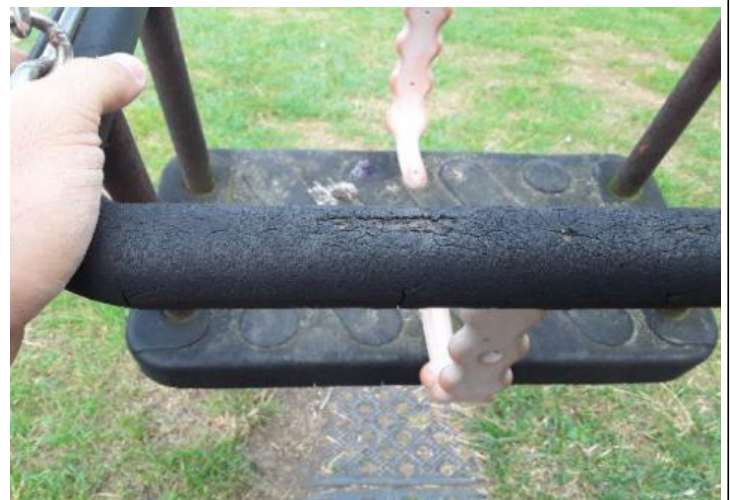
Finding: The seat has minor damage or wear

Action: Monitor for any further deterioration and replace as required

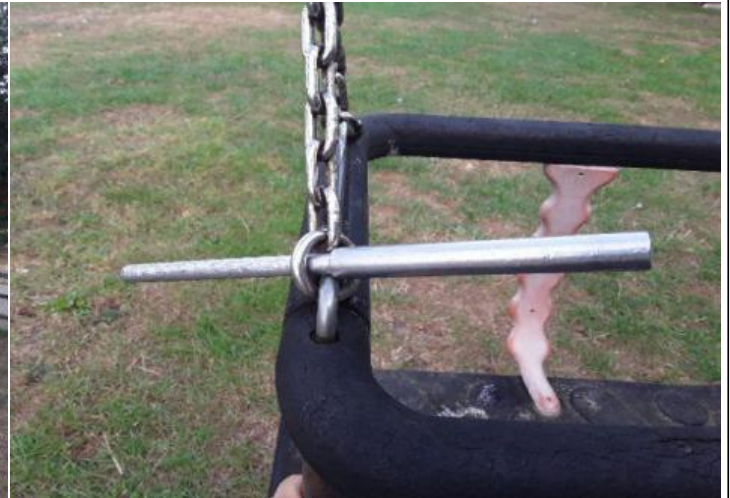
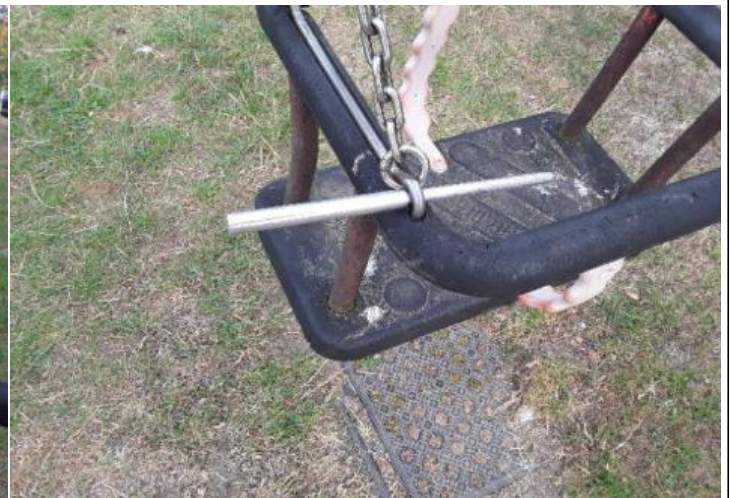
Finding: The connecting links are in excess of 8.6mm and less than 12mm and fail the requirements of BS EN 1176 Part 1; clause 4.2.13, Chains

Action: Monitor use and replace with compliant links at the next maintenance cycle

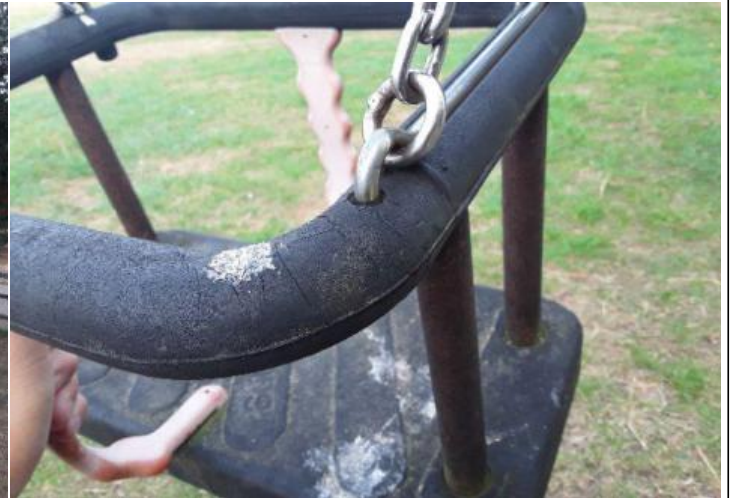
Finding: The swing seat connectors have some wear present

Action: Monitor for further deterioration and replace when 40% worn

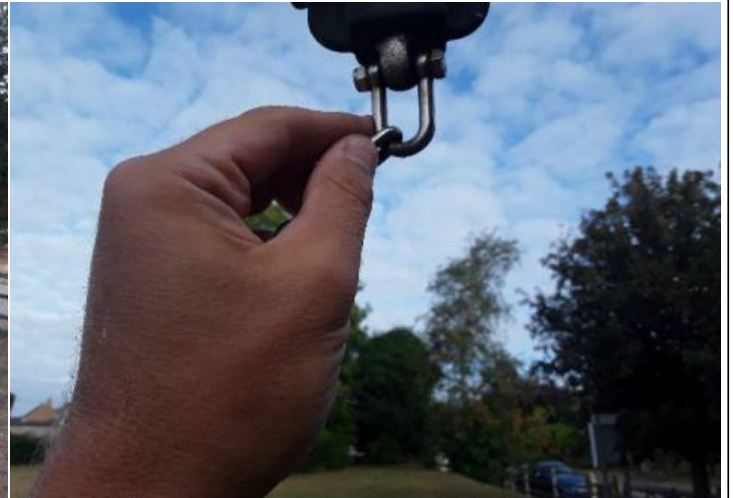
Finding: There is some wear to the shackles

Action: Monitor for any further deterioration and replace when 40% worn

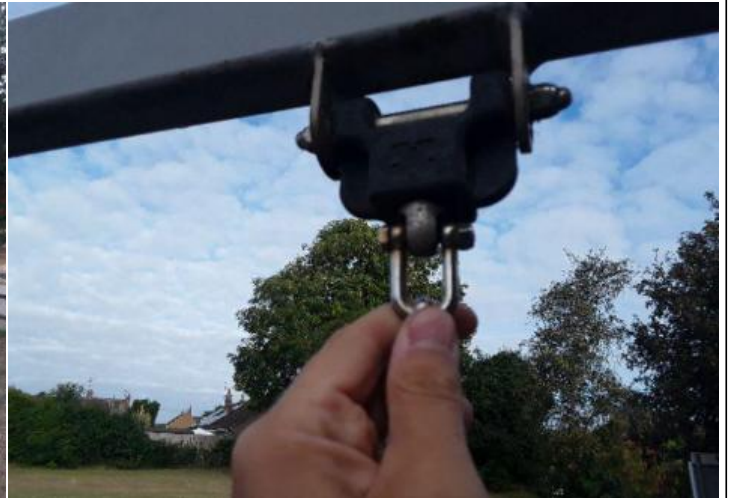
Finding: There is some wear to the suspension fixings which appear to be loose

Action: Monitor for any further deterioration, replace when worn and refer to manufacturer specifications for correct installation

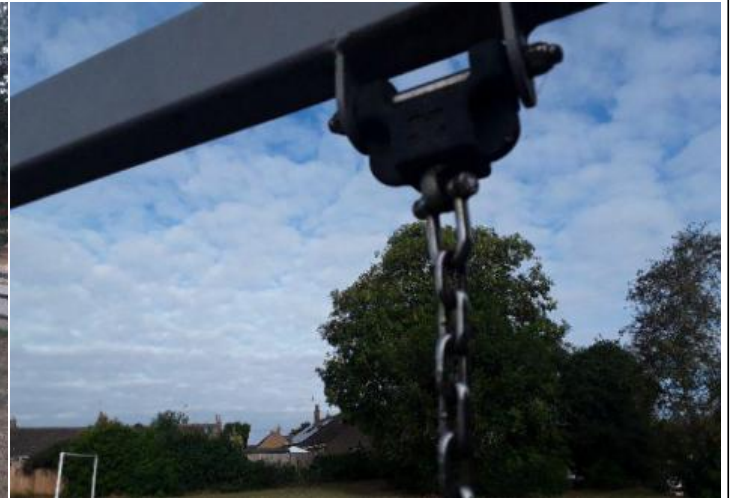
Finding: The bushes are worn or missing

Action: Replace worn or missing bushes

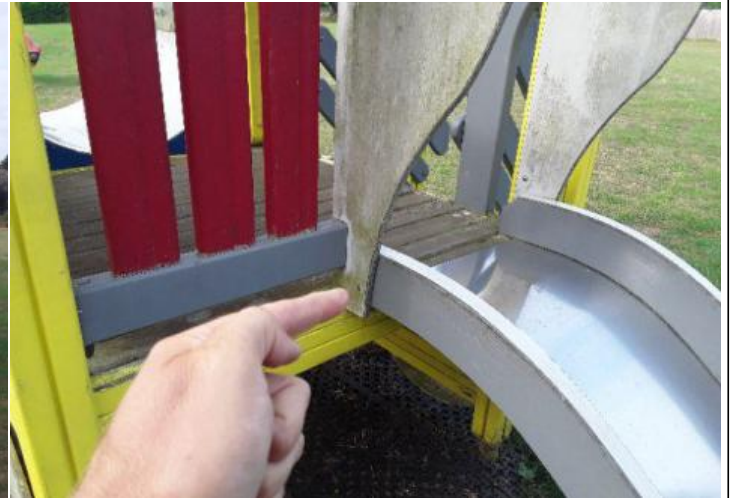
Finding: A number of fixing(s) have worked loose

Action: Secure all loose fixings

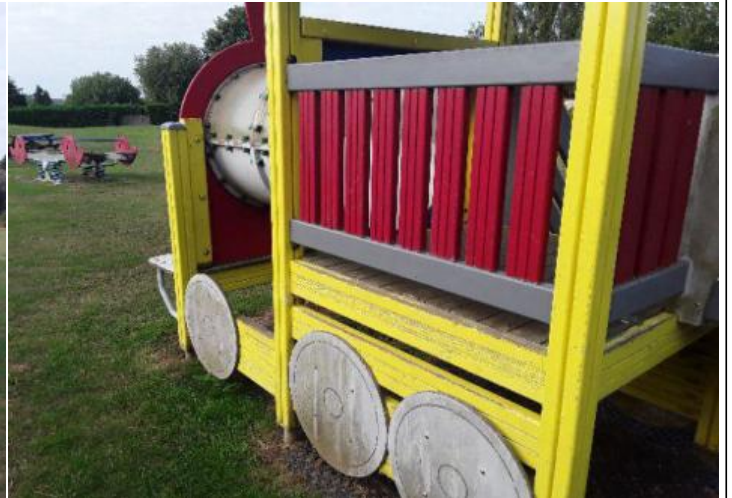
Finding: The timber stain is in poor condition

Action: Prepare all affected parts and re-stain with an appropriate preservative

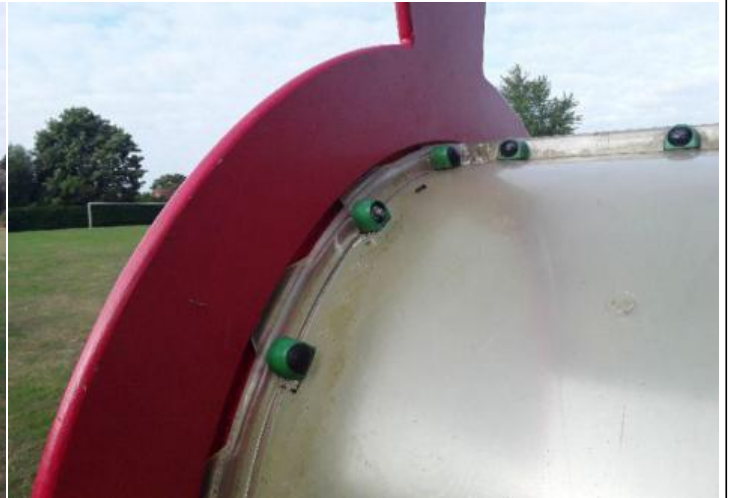
Finding: There is/are bolt cap covers missing or damaged on the item

Action: Replace missing or damaged bolt cap covers

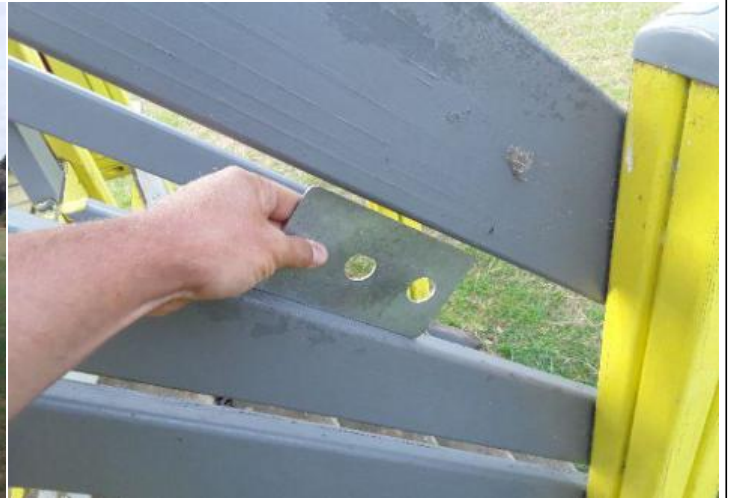
Finding: The item fails to meet the requirements of BS EN 1176 Part 1 4.2.7.2 head and neck entrapment in the barriers and/or steps

Action: Monitor - No action given the risk assessment

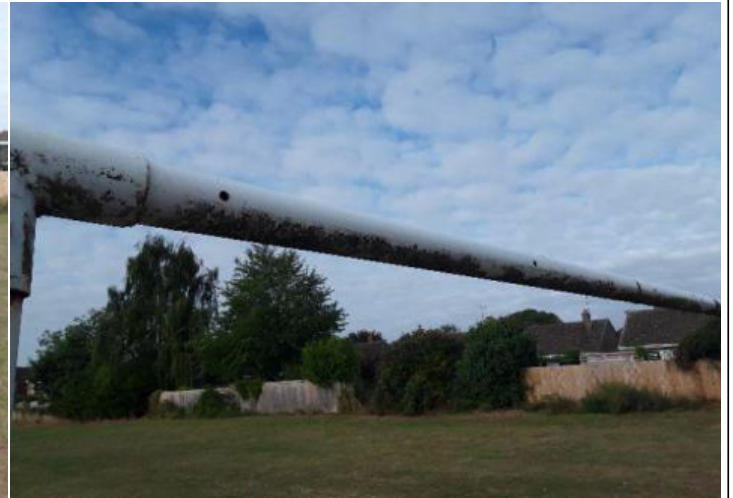
Finding: There is or are fixings missing on the item

Action: Replace all missing fixings

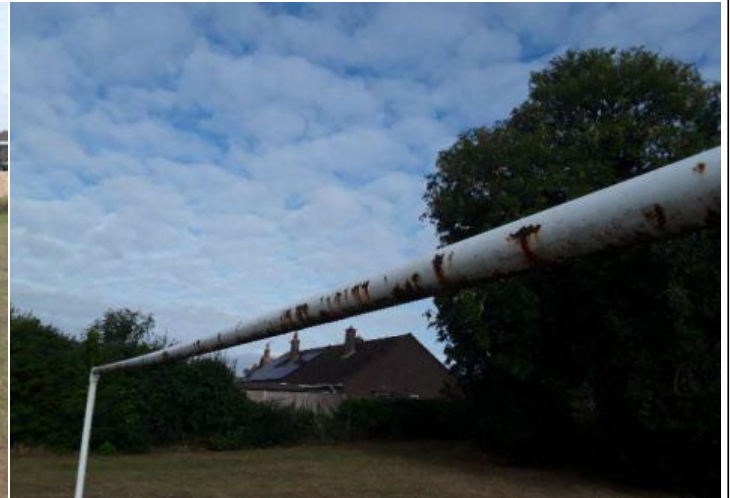
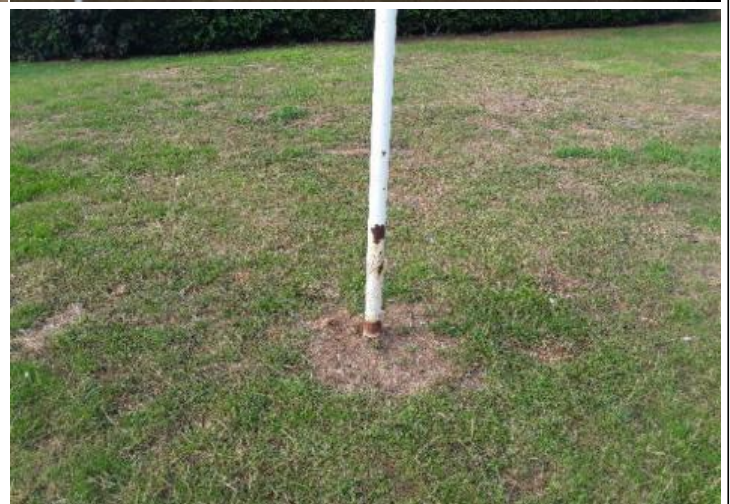
Finding: The paintwork on this item has been damaged or worn exposing the metal underneath which is rusting / corroding

Action: Treat affected areas and repaint

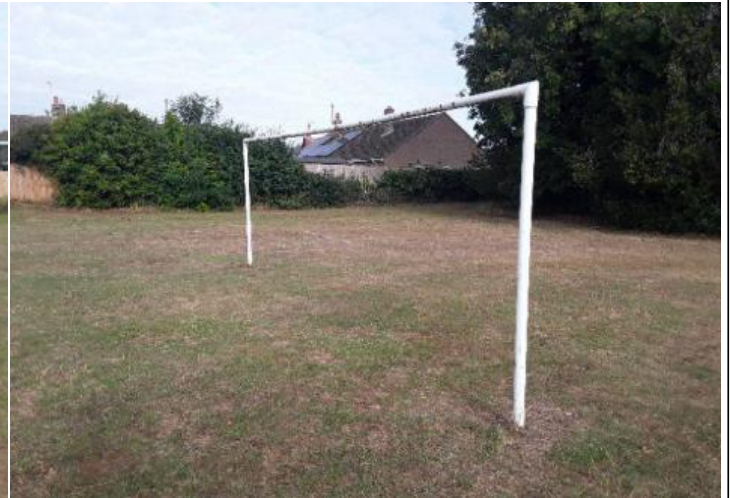
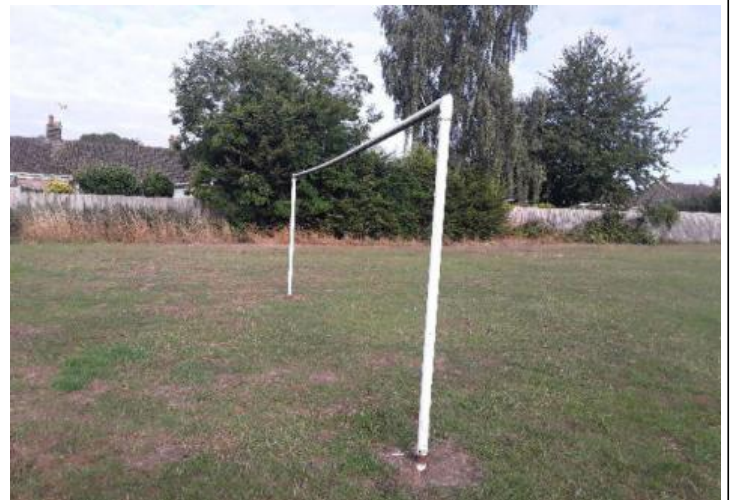
Finding: The item is slightly loose in its foundations

Action: Monitor for any further deterioration and repair as required

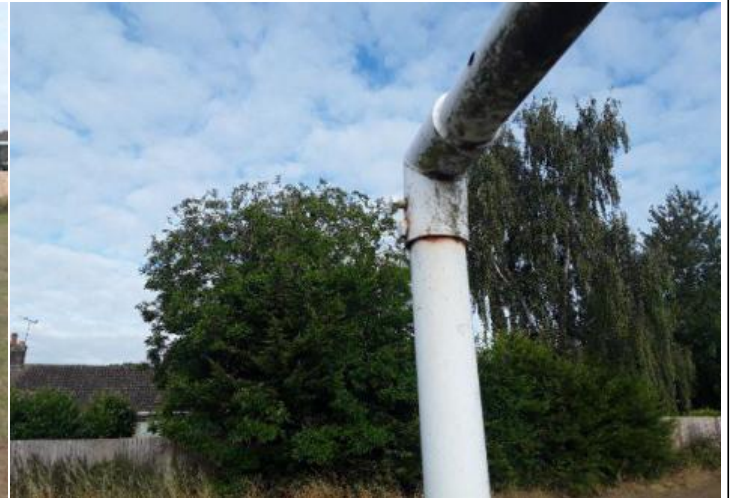
Finding: A number of fixing(s) have worked loose

Action: Secure all loose fixings

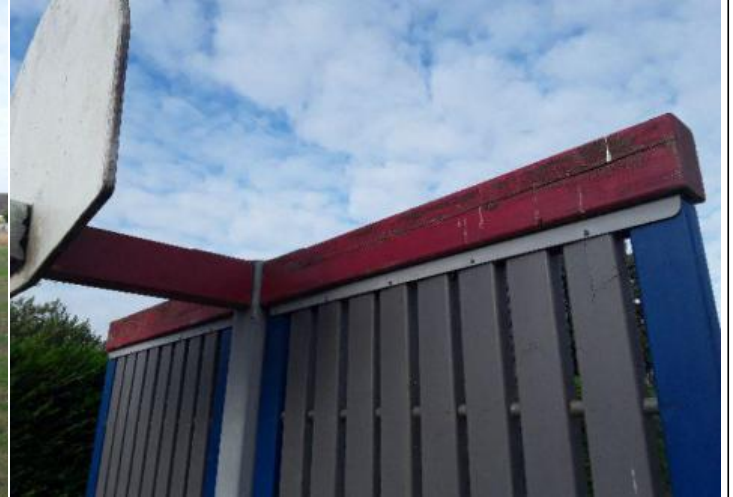
Finding: The timber has a number of splits/shakes or air cracks and this may affect the stability or allow water ingress which will accelerate the rotting process. Timber splits may also create rough / splintering edges.

Action: Monitor, sand down any rough edges and ensure the splits do not cross through fixing points of the structure and/or cause any instability

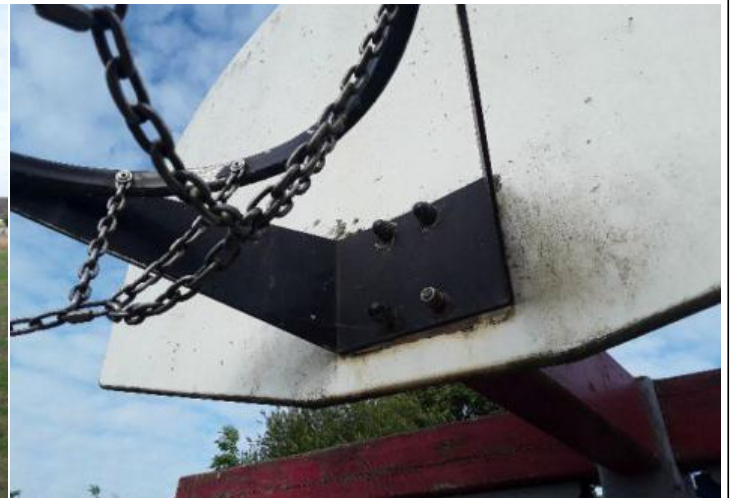
Finding: There is/are bolt cap covers missing or damaged on the item

Action: Replace missing or damaged bolt cap covers
