the **play inspection** company

Annual Inspection

Welton Parish Council

Welton Recreation Ground

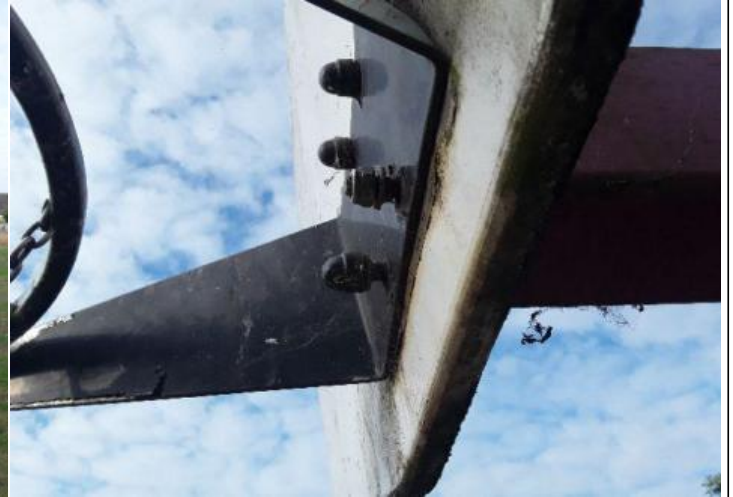
Finding: A number of fixing(s) have worked loose

Action: Secure all loose fixings

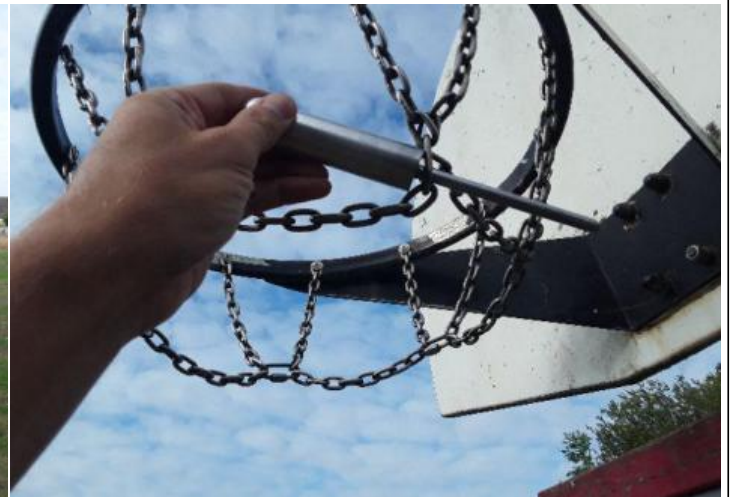
Finding: There is/are finger entrapments in the hoop chain and the item fails to meet the requirements of BS EN 15312 Clause 4.4.2.2 Entrapment of fingers

Action: Monitor - No action given the risk assessment

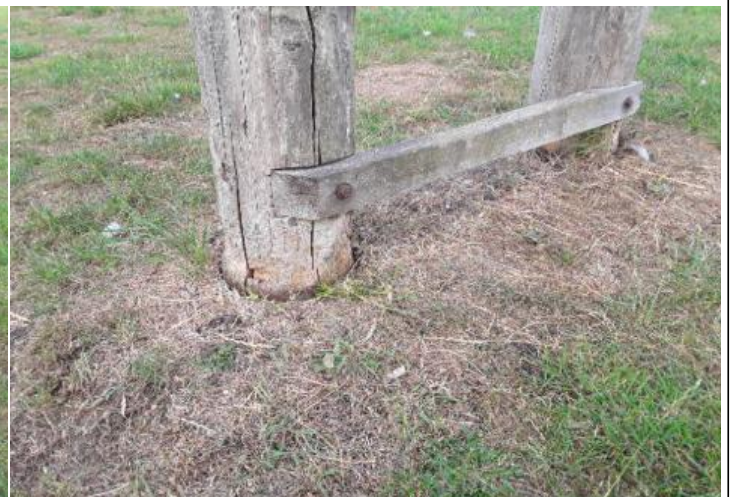
Finding: There is some strimmer / machinery damage apparent on the posts, this can penetrate the preservative applied to the timber and accelerate the rotting process

Action: Monitor for any deterioration (rot) and replace as required

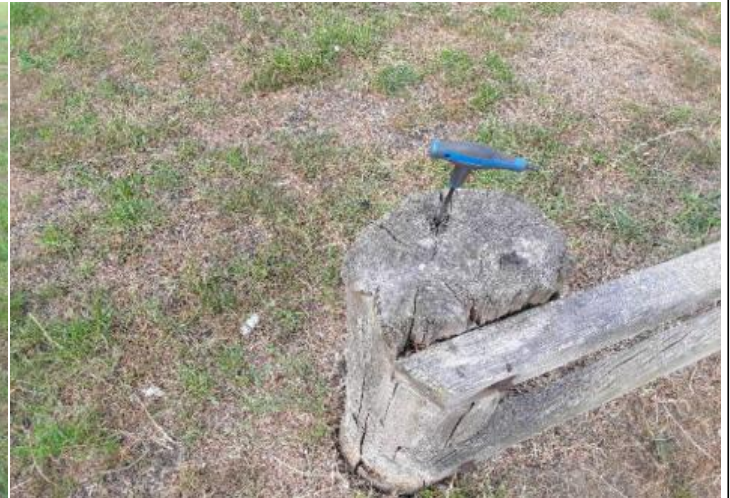
Finding: There is some evidence of rot in the timber

Action: Monitor for any further deterioration and replace as required

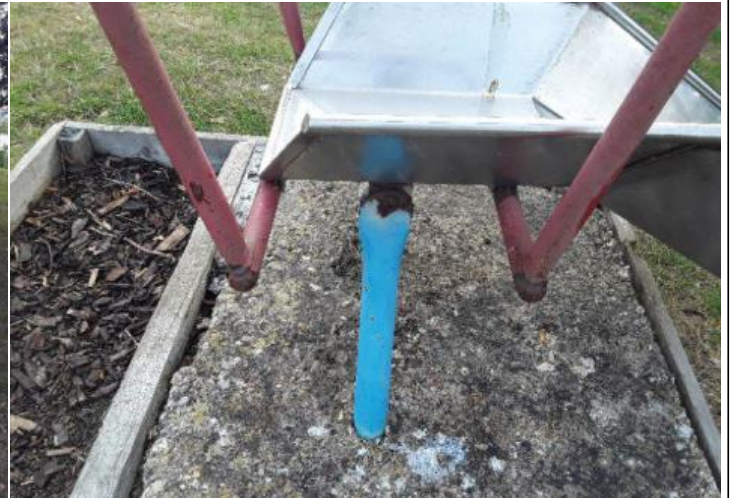
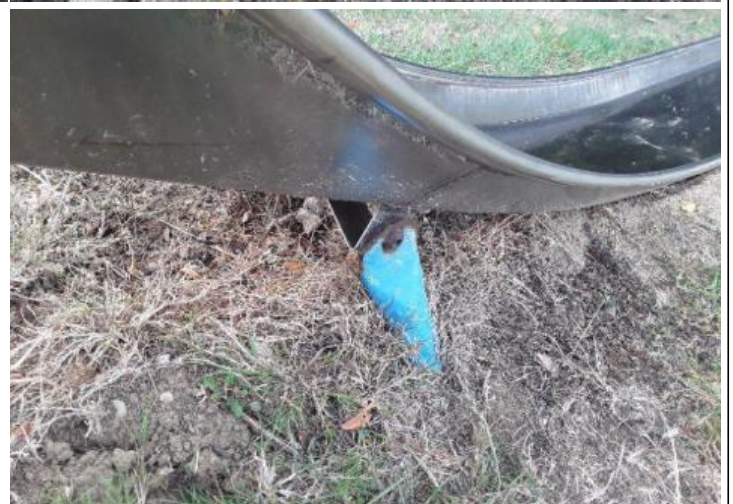
Finding: The paintwork on this item has been damaged or worn exposing the metal underneath which is rusting / corroding

Action: Treat affected areas and repaint

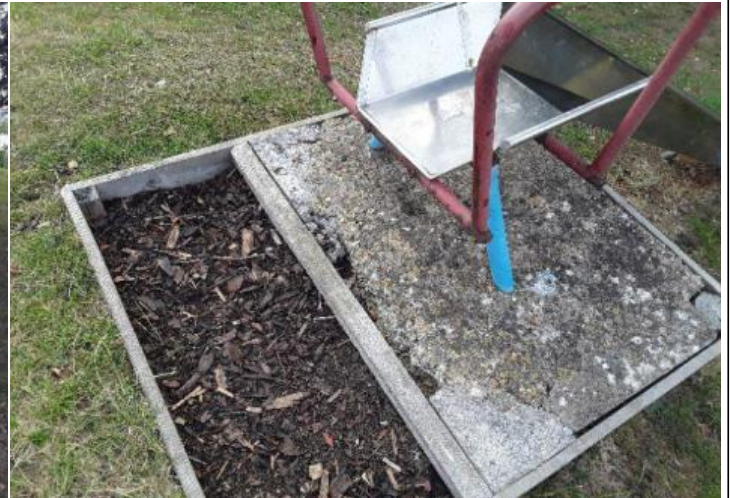
Finding: There is moderate damage to the surface

Action: Repair the damaged areas of surfacing

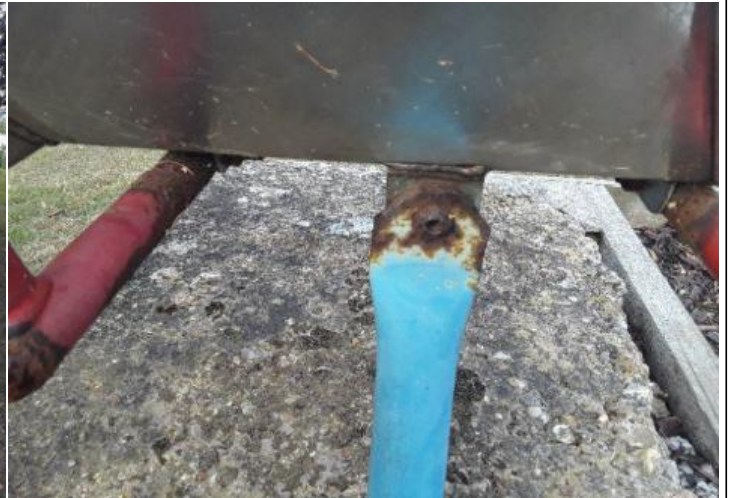
Finding: The fixings have corroded excessively

Action: Replace all corroded fixings

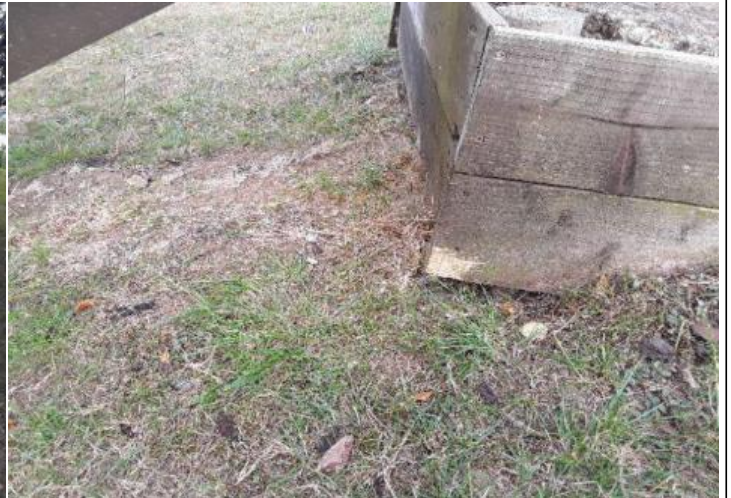
Finding: There is some strimmer / machinery damage apparent on the posts, this can penetrate the preservative applied to the timber and accelerate the rotting process

Action: Monitor for any deterioration (rot) and replace as required

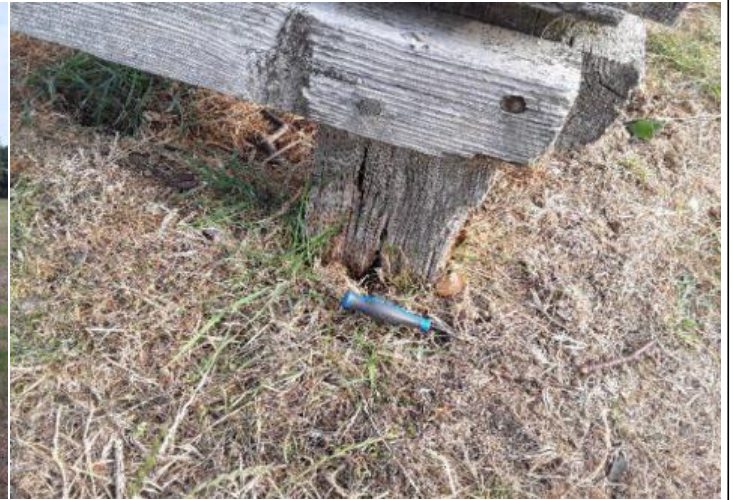
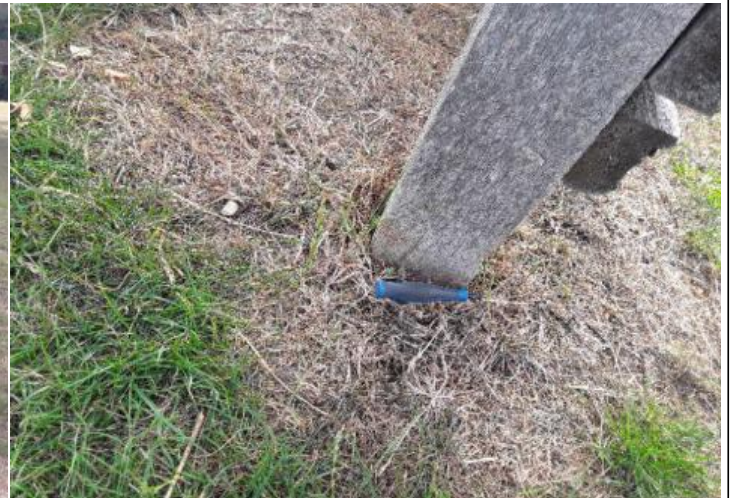
Finding: All of the timber posts on the structure have rotted **Action:** Replace all affected timbers
