the **play inspection** company

Annual Inspection

Welton Parish Council

Welton Recreation Ground

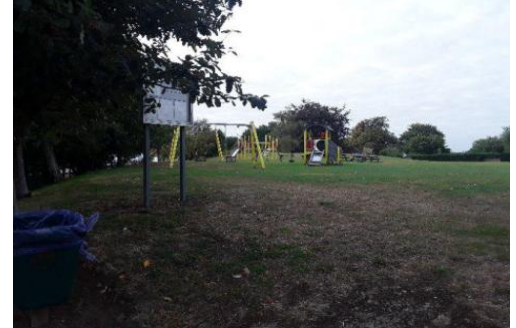
There is algae, silt or moss growth on the surface resulting in slippery conditions - Clean and treat appropriately

There is a risk of head and neck entrapment in the gates - Monitor - no remedial work recommended

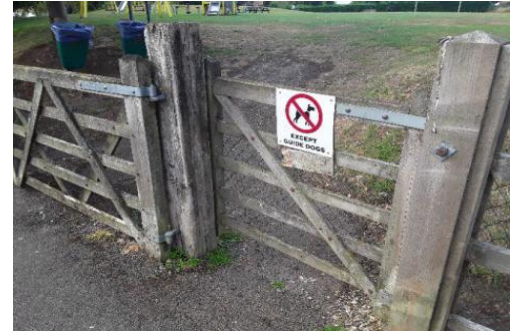
Parts of the timber are rough or splintered - Remove all rough or sharp edges

The timber has a number of splits/shakes or air cracks and this may affect the stability or allow water ingress which will accelerate the rotting process. Timber splits may also create rough / splintering edges. - Monitor, sand down any rough edges and ensure the splits do not cross through fixing points of the structure and/or cause any instability

There is or are fixings missing on the item - Replace all missing fixings

There are areas or parts of the timber on the structure that have rotted - Replace all affected timbers

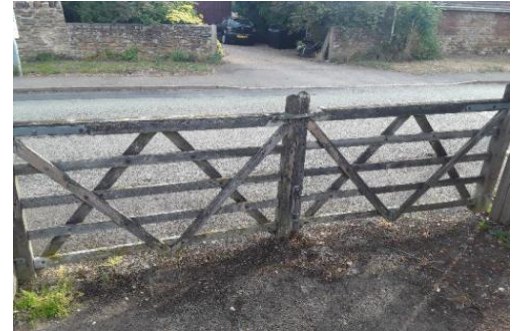
The area under the gate has eroded leaving uneven areas, or the concrete foundations exposed, resulting in trip hazards at the entrance/exit to the playground - Reinstate to level with surrounding surfaces

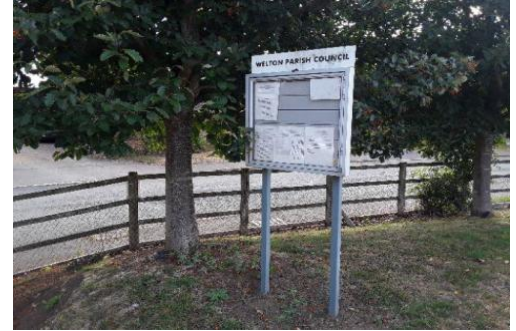
It is recommended that signage, with information including the site address, contact information for maintenance issues and emergency contact details are provided for the facility - Provide in accordance with the recommendations

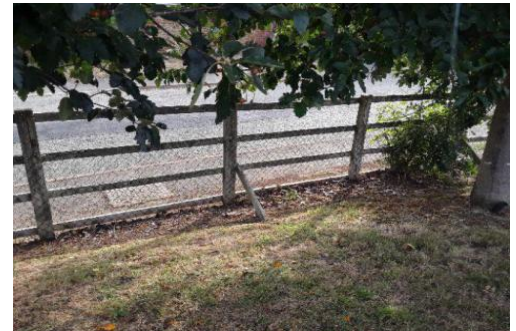
The surface has eroded and the foundations are exposed - Reinststate surrounding surfaces to cover the foundations

There are areas or parts of the timber on the structure that have rotted and snapped throughout the fenceline - Replace all affected timbers

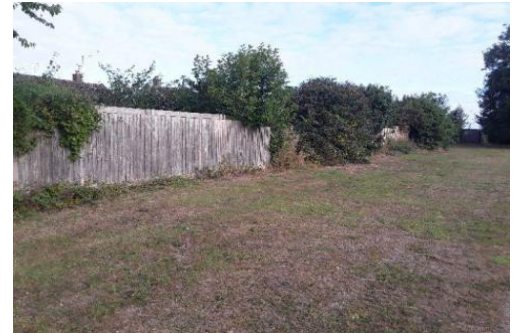
The adjacent foliage is overhanging - Cut back and maintain

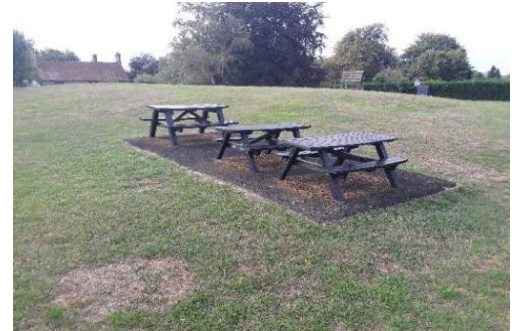
There are trip hazards present - Remove trip hazard

There is moderate damage to the surface - Repair the damaged areas of surfacing

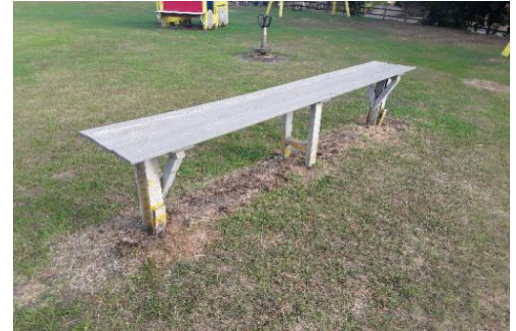
The surface has eroded and the foundations are exposed - Reinstate surrounding surfaces to cover the foundations

The paintwork on this item has been damaged or worn exposing the metal underneath which is rusting / corroding - Treat affected areas and repaint

A number of fixing(s) have worked loose - Secure all loose fixings

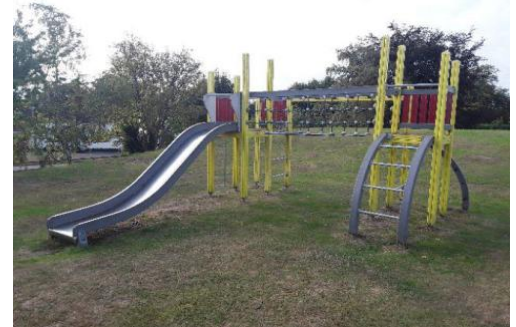
There is/are bolt cap covers missing or damaged on the item - Replace missing or damaged bolt cap covers

The timber stain is in poor condition - Prepare all affected parts and re-stain with an appropriate preservative

There is/are finger entrapment/s in the handgrips due to missing end caps and the item fails to meet the requirements of BS EN 1176 Part 1 4.2.7.6 Entrapment of fingers - Replace missing caps to remove the entrapments

A number of fixing(s) have worked loose - Secure all loose fixings

The ropes/nets are worn/damaged in places - Monitor for any further deterioration and repair or replace as required

The surface has subsided in some areas - Monitor for any further deterioration and repair as required

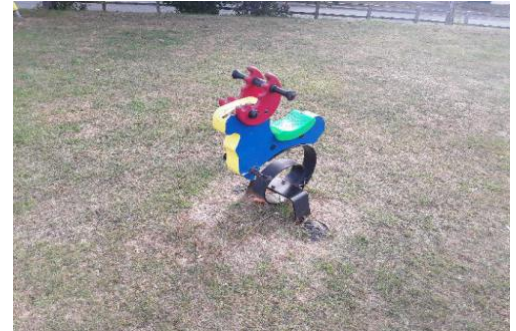
The paintwork on this item has been damaged or worn exposing the metal underneath which is rusting / corroding - Treat affected areas and repaint

There is/are bolt cap covers missing or damaged on the item - Replace missing or damaged bolt cap covers

The end caps are missing on the Handgrips/Footrests - Replace missing end caps

The Handgrips/Footrests rotate and may cause an unexpected movement for the user - Secure Handgrips/Footrests to prevent rotation.

There are areas or parts of the timber on the structure that have rotted - Replace all affected timbers

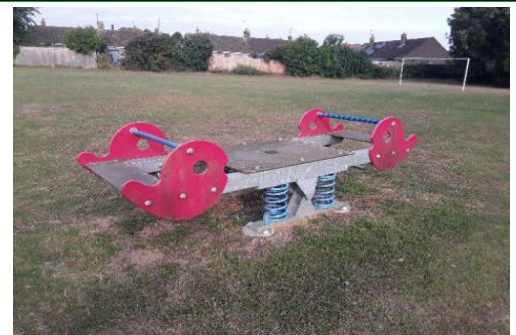
The surface has subsided in some areas - Monitor for any further deterioration and repair as required

There is or are fixings missing on the item - Replace all missing fixings

The spring clamps are loose - Tighten all loose fixings

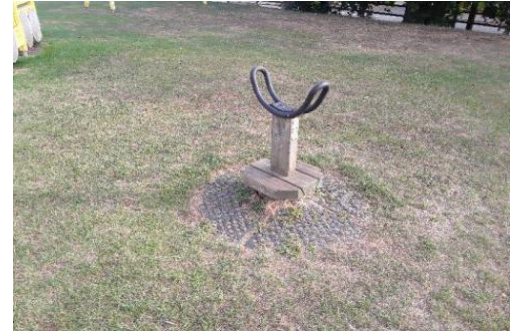
The bearing is showing signs of wear - Monitor for any
further deterioration and replace as required

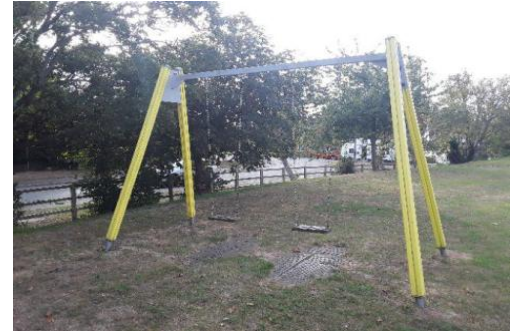
The grass mats are silted up, the soil is compacted and the area will become very slippery when the soil is wet. - Reinstate as required

There is/are bolt cap covers missing or damaged on the item - Replace missing or damaged bolt cap covers

The paintwork on this item has been damaged or worn exposing the metal underneath which is rusting / corroding - Treat affected areas and repaint

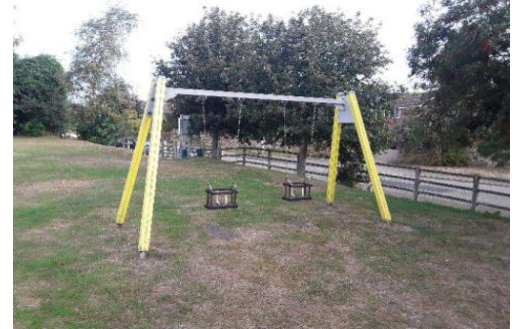
The grass mats are silted up, the soil is compacted and the area will become very slippery when the soil is wet. - Reinstate as required

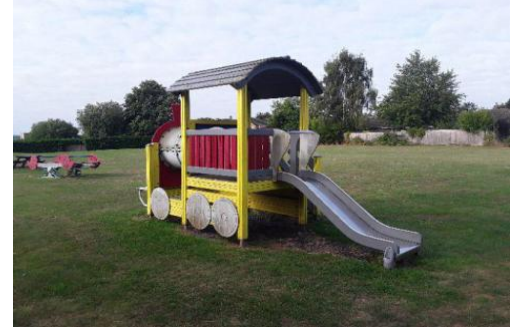
The grass mats are silted up, the soil is compacted and the area will become very slippery when the soil is wet. - Reinstate as required

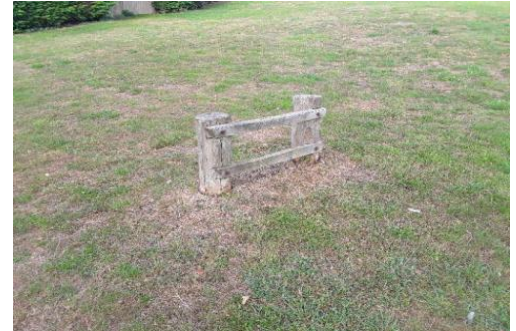
There is some strimmer / machinery damage apparent on the posts, this can penetrate the preservative applied to the timber and accelerate the rotting process - Monitor for any deterioration (rot) and replace as required

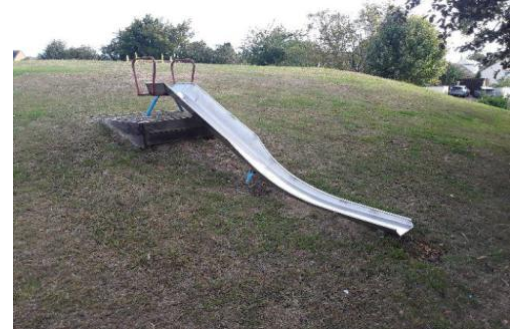
The grass has eroded within the impact area of the equipment and may not provide the necessary impact attenuating properties for the equipment fall height; the surface may also be slippery in wet weather - Reinstate the grass or provide an all weather surface

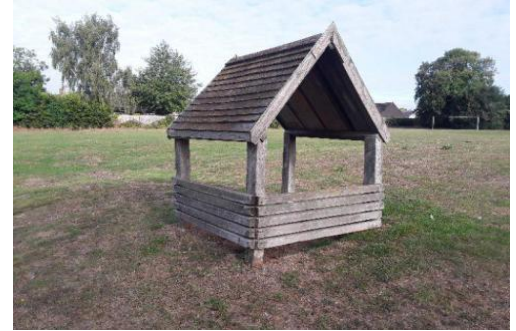
There is some strimmer / machinery damage apparent on the posts, this can penetrate the preservative applied to the timber and accelerate the rotting process - Monitor for any deterioration (rot) and replace as required

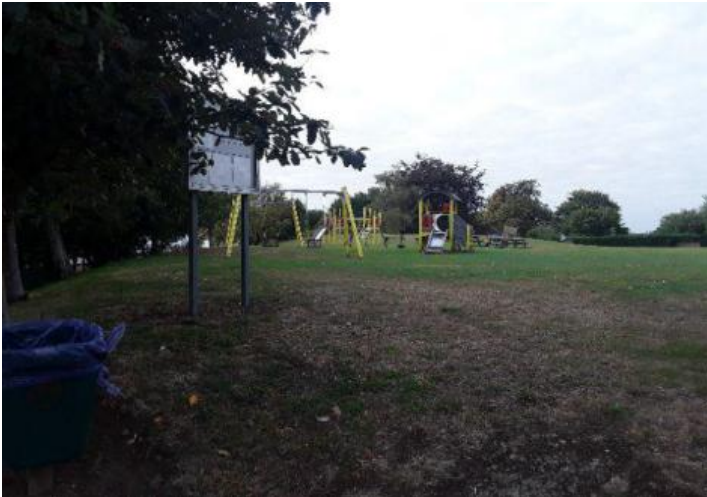
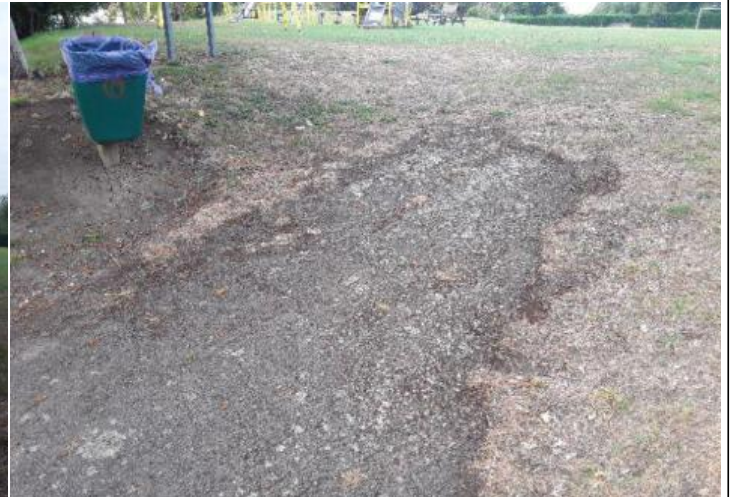
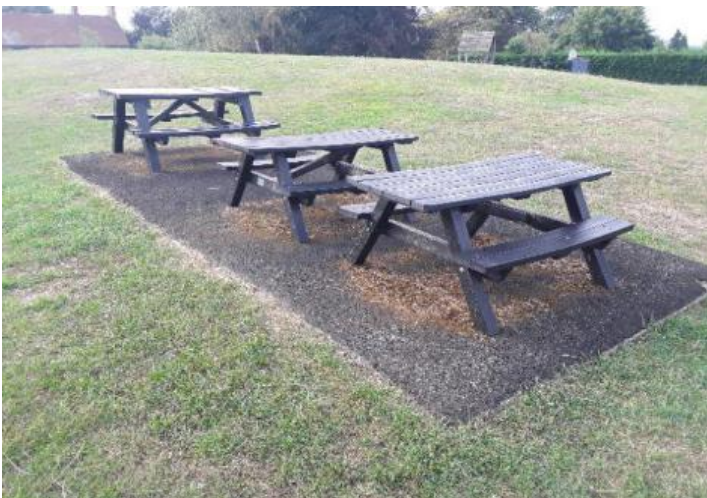
Finding: There is algae, silt or moss growth on the surface resulting in slippery conditions

Action: Clean and treat appropriately

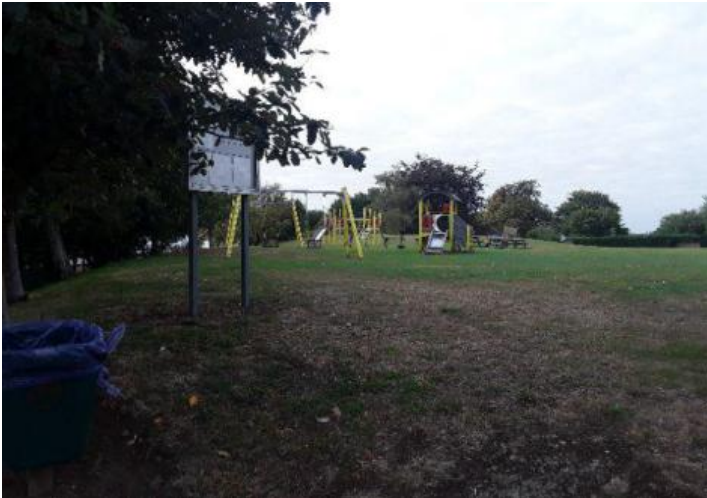
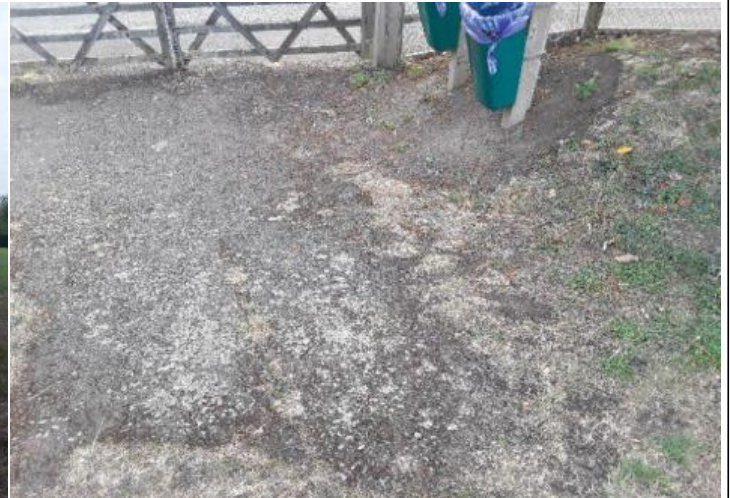
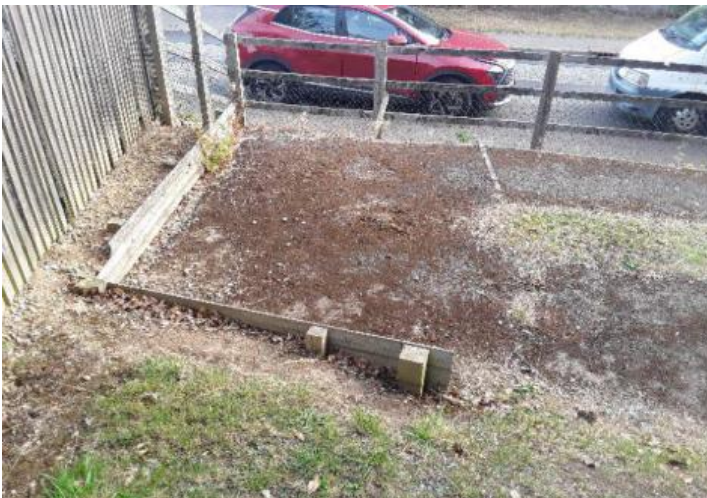
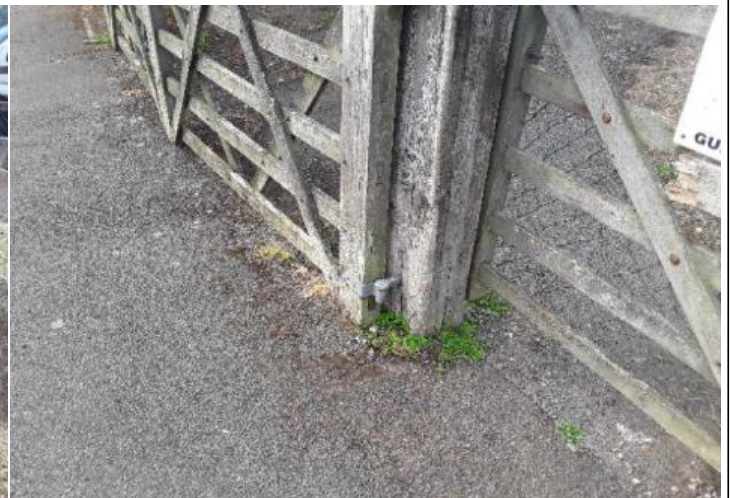
Finding: There is weed / vegetation growth within the surface

Action: Remove weed / vegetation growth

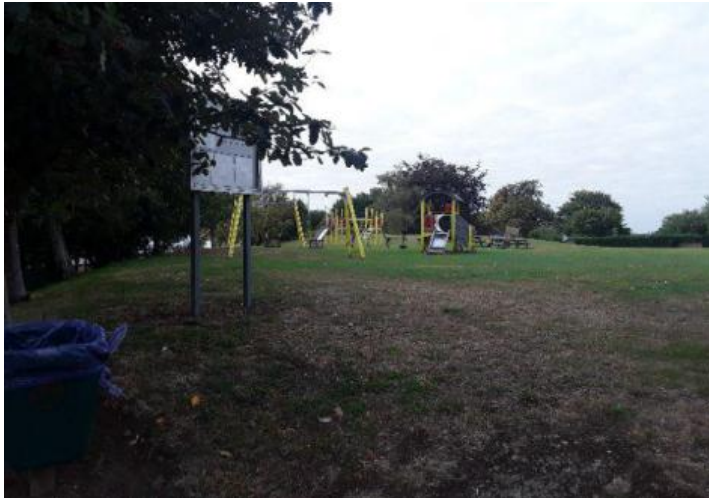
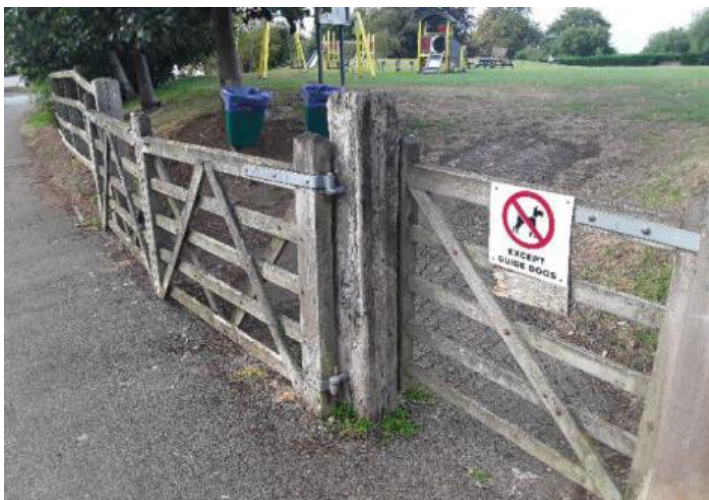
Finding: There is a risk of head and neck entrapment in the gates **Action:** Monitor - no remedial work recommended

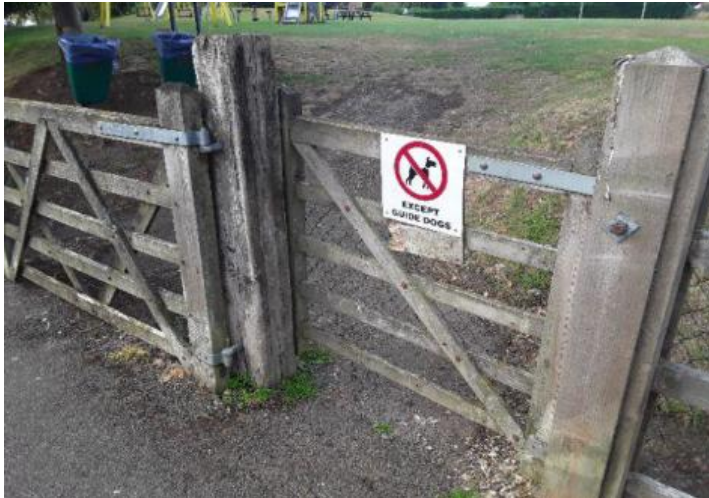
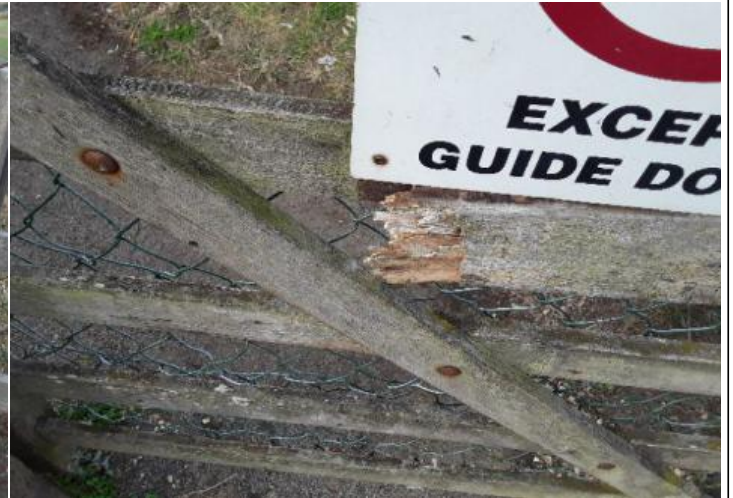
Finding: Parts of the timber are rough or splintered

Action: Remove all rough or sharp edges

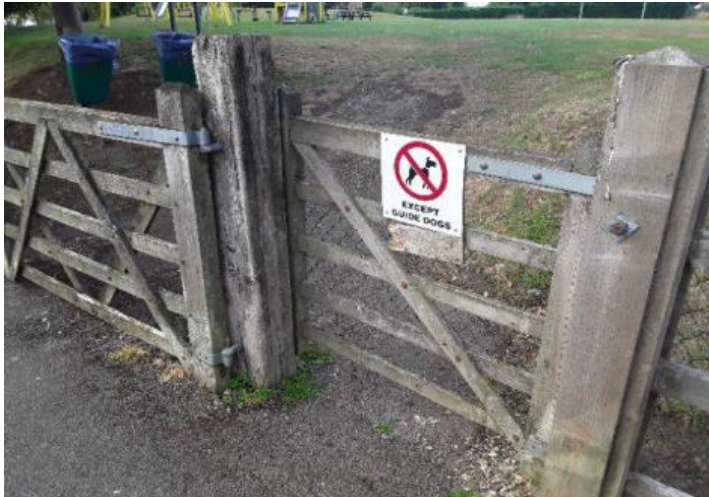
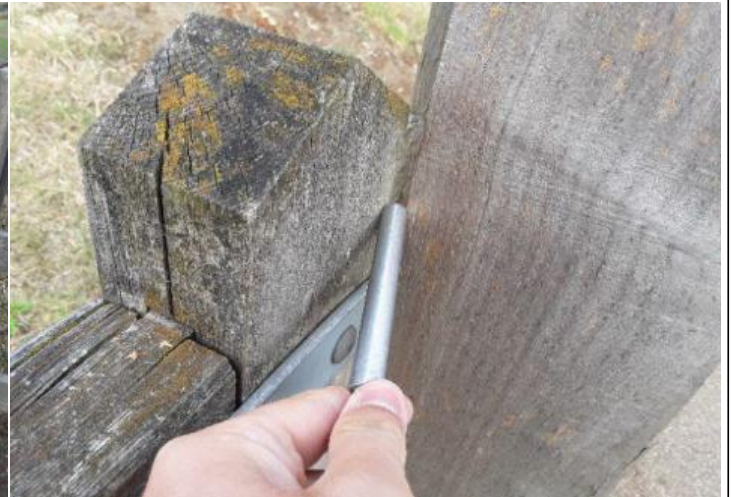
Finding: There are openings that are less than 12mm that could trap or crush fingers

Action: Provide a 12mm gap throughout full range of motion at both sides of gate

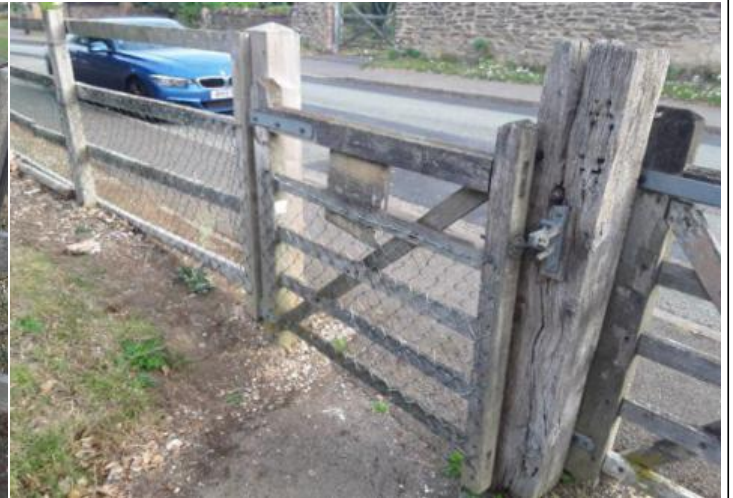
Finding: The gate is closing too quickly (less than 4 seconds)

Action: Take corrective action to ensure that the gate closes in 4-8 seconds from 90 degrees

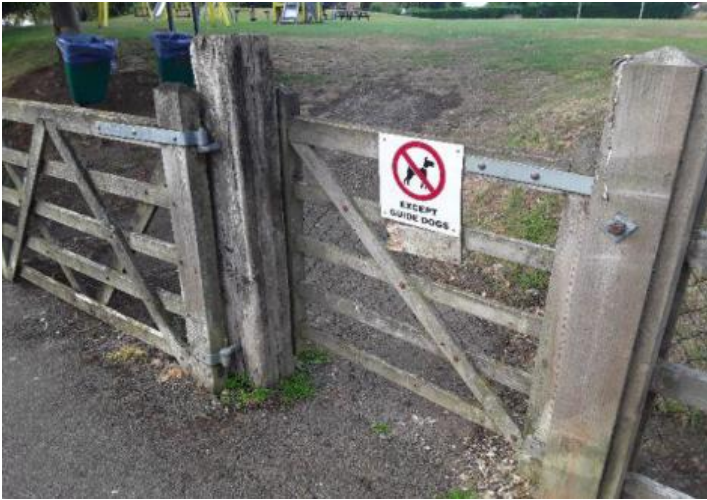
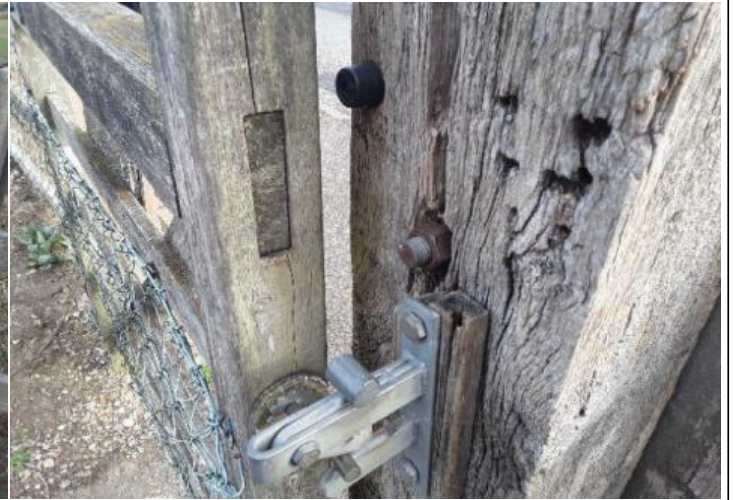
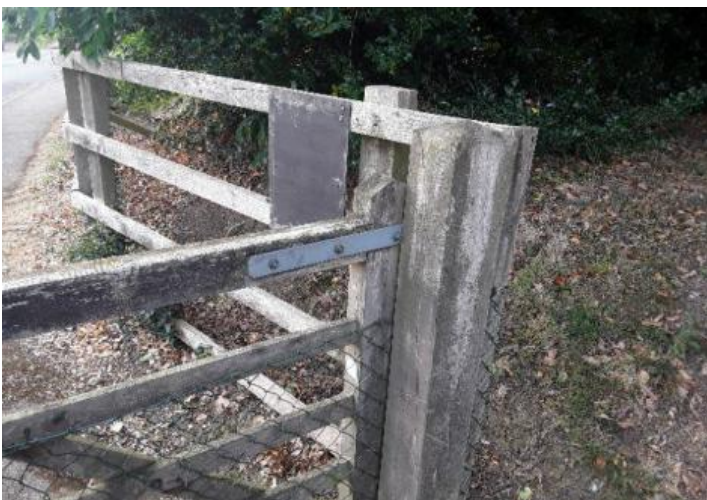
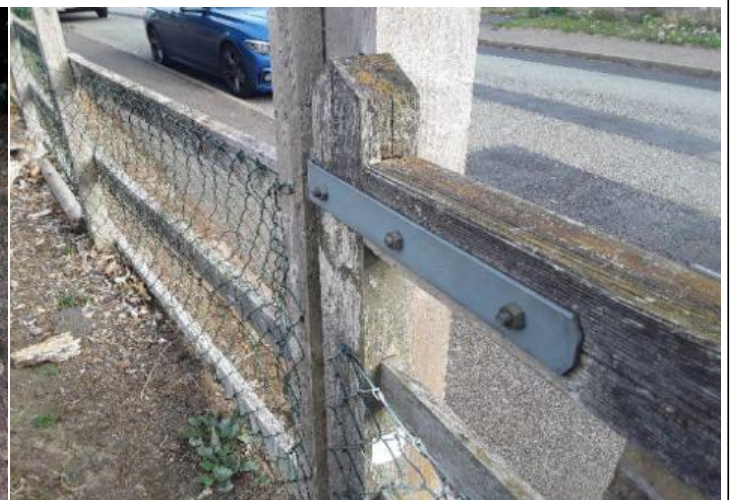
Finding: There are projecting bolt thread(s) present

Action: Remove excess thread length and deburr or provide cap

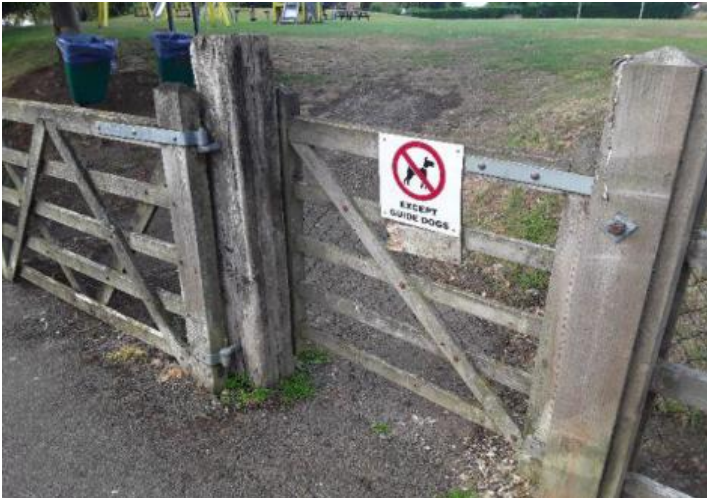
Finding: The timber has a number of splits/shakes or air cracks and this may affect the stability or allow water ingress which will accelerate the rotting process. Timber splits may also create rough / splintering edges.

Action: Monitor, sand down any rough edges and ensure the splits do not cross through fixing points of the structure and/or cause any instability

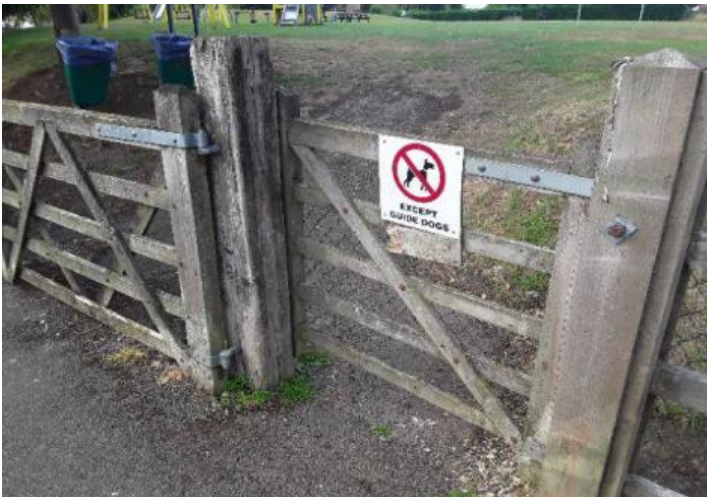
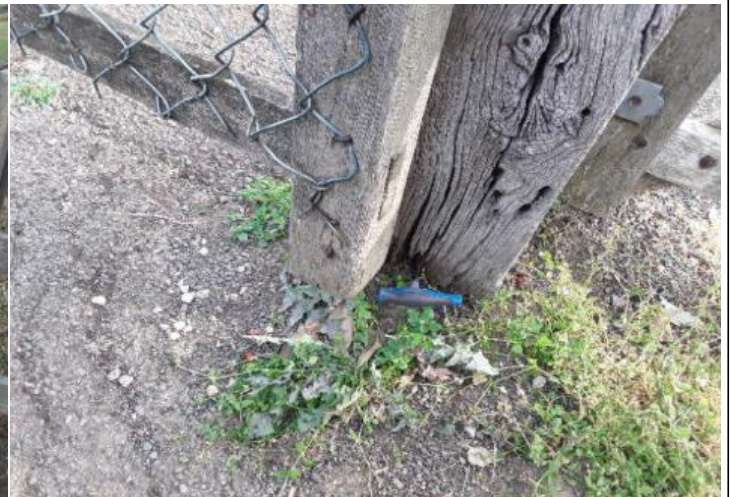
Finding: There are areas or parts of the timber on the structure that have rotted

Action: Replace all affected timbers

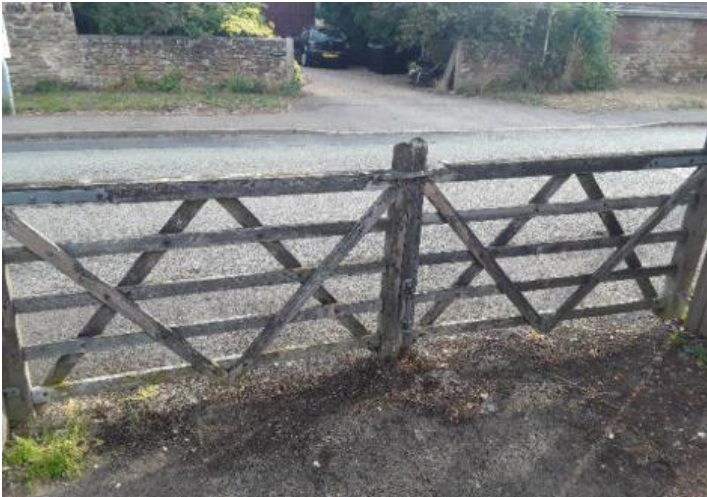
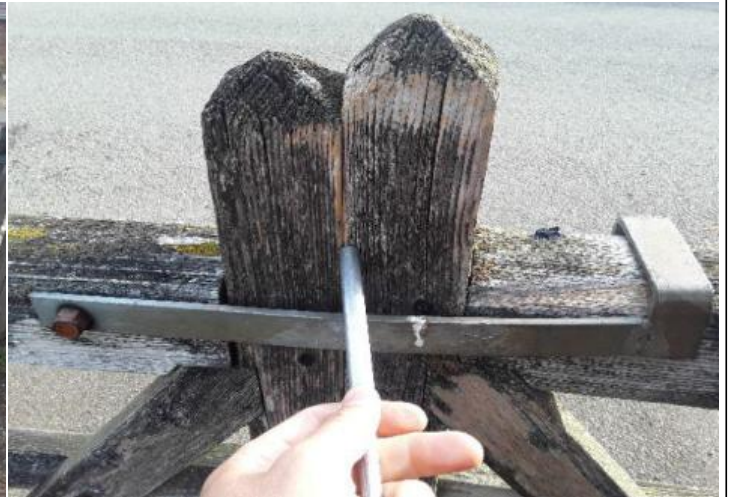
Finding: There are openings that are less than 12mm that could trap or crush fingers

Action: Provide a 12mm gap throughout full range of motion at both sides of gate

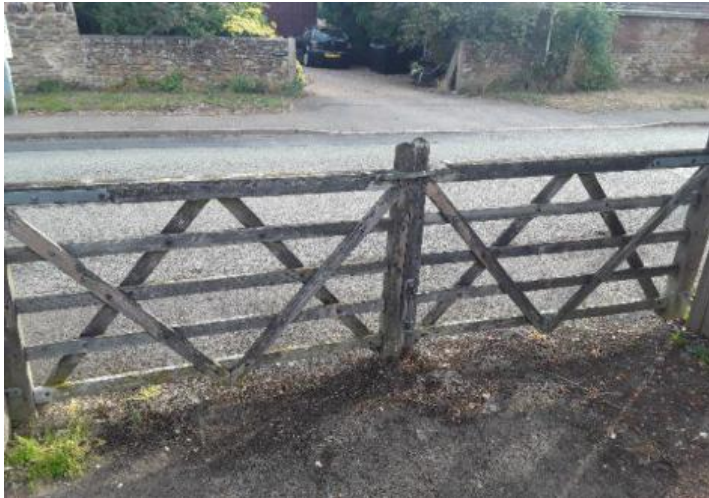
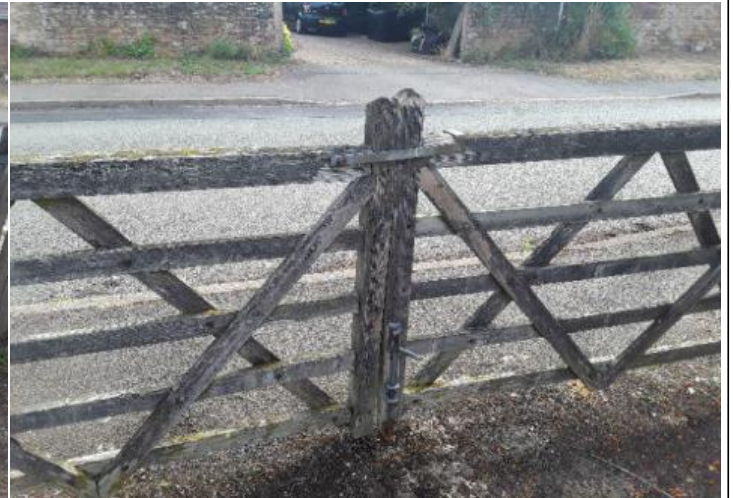
Finding: There is no padlock on the maintenance gate

Action: Provide a padlock to secure the gate

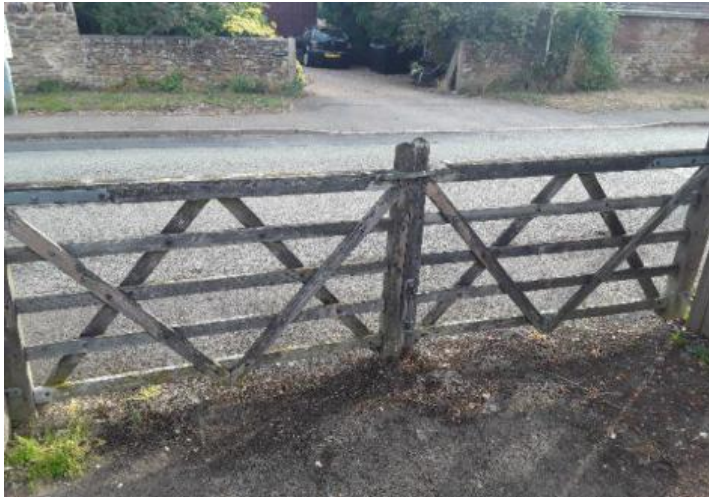
Finding: The area under the gate has eroded leaving uneven areas, or the concrete foundations exposed, resulting in trip hazards at the entrance/exit to the playground

Action: Reinstate to level with surrounding surfaces

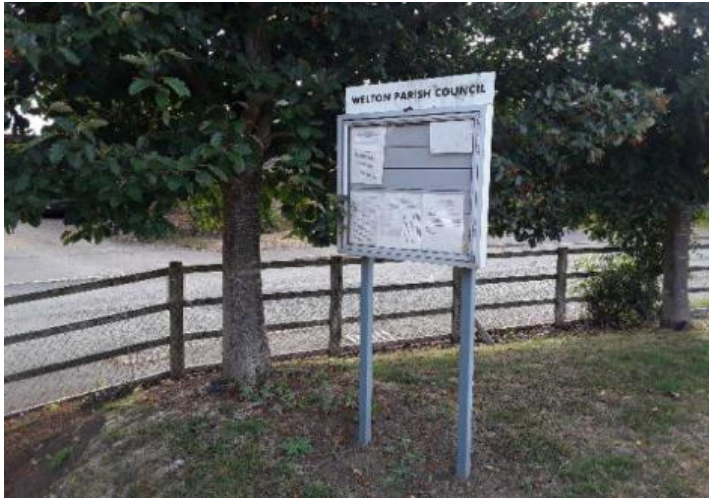
Finding: It is recommended that signage, with information including the site address, contact information for maintenance issues and emergency contact details are provided for the facility

Action: Provide in accordance with the recommendations

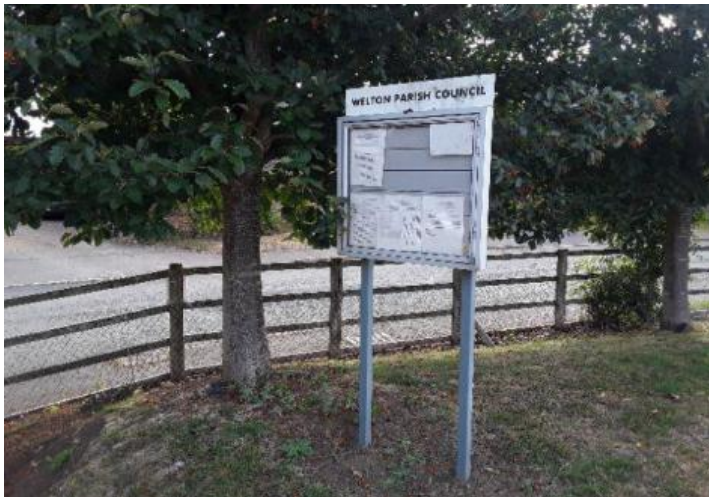
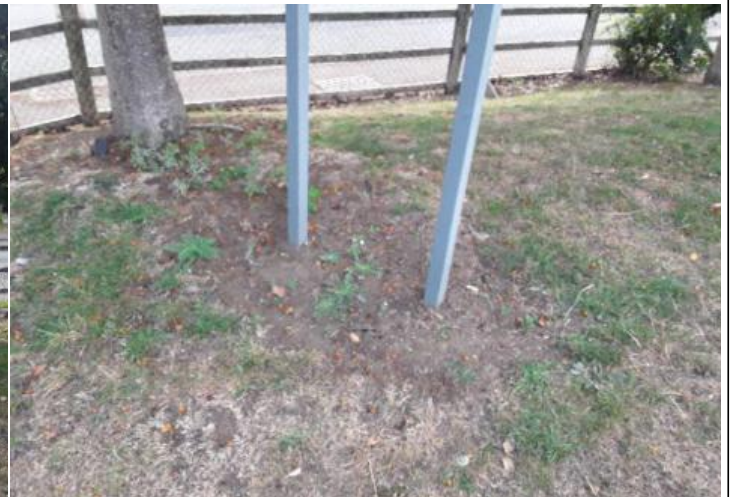
Finding: The area around the item has eroded and may become slippery

Action: Reinststate eroded area

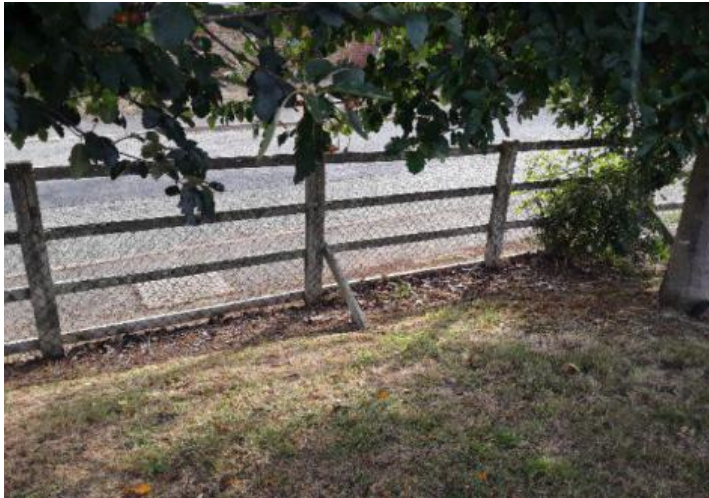
Finding: The surface has eroded and the foundations are exposed

Action: Reinstate surrounding surfaces to cover the foundations

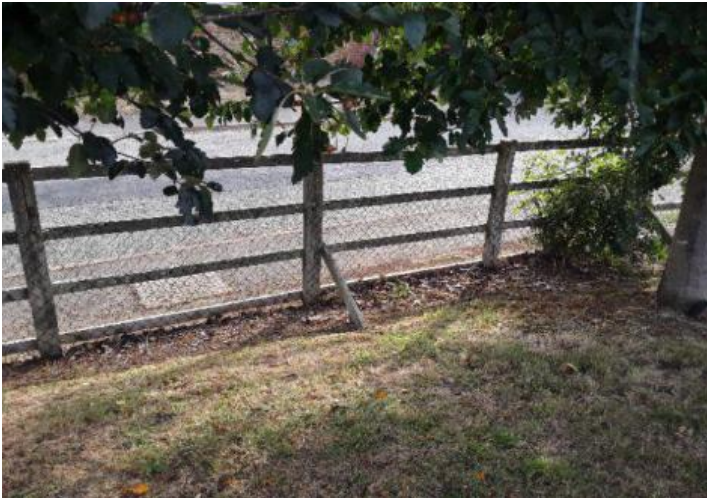
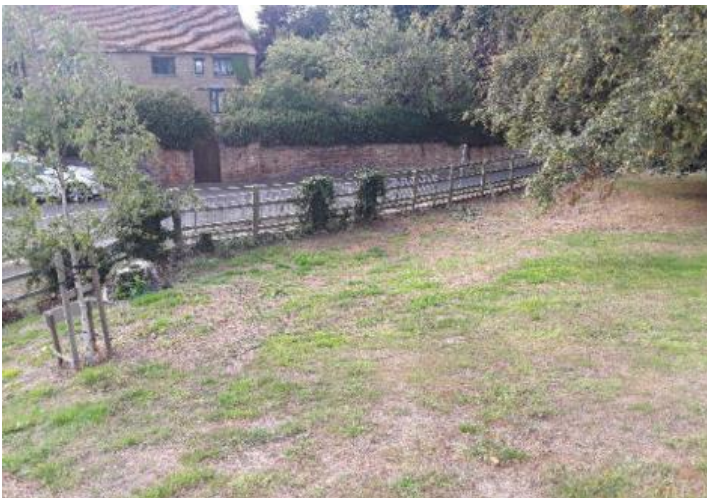
Finding: There are areas or parts of the timber on the structure that have rotted and snapped throughout the fenceline

Action: Replace all affected timbers

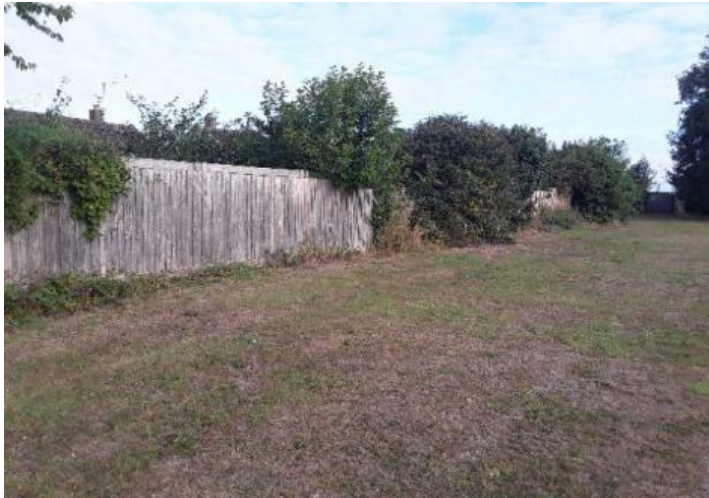
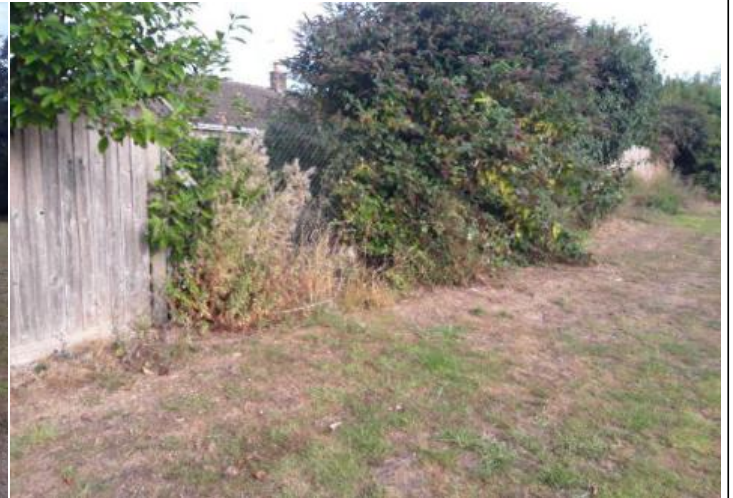
Finding: The adjacent foliage is overhanging

Action: Cut back and maintain

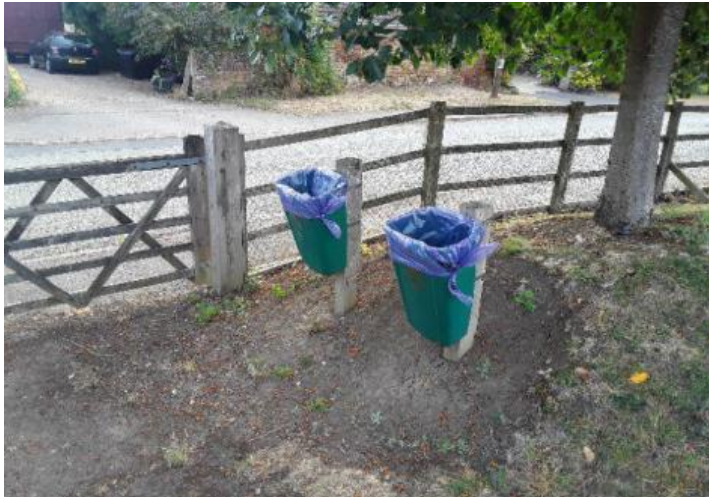
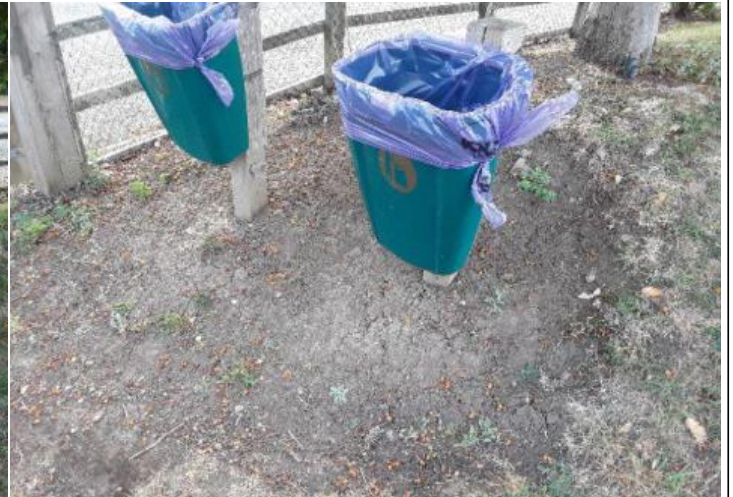
Finding: The area around the item has eroded and may become slippery

Action: Reinstate eroded area

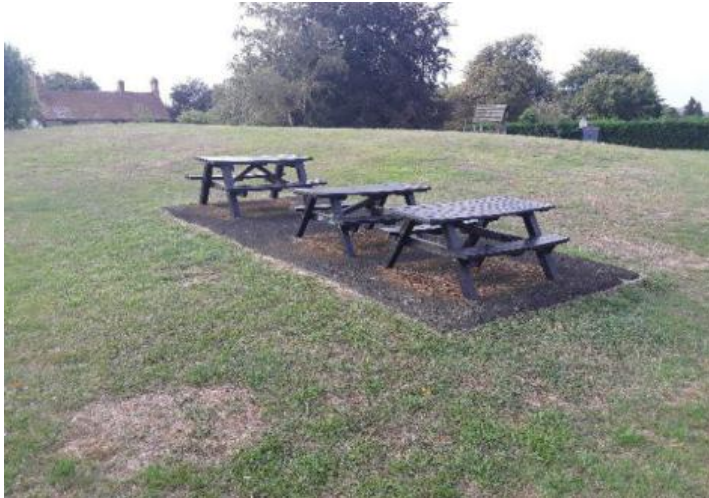
Finding: There are trip hazards present

Action: Remove trip hazard

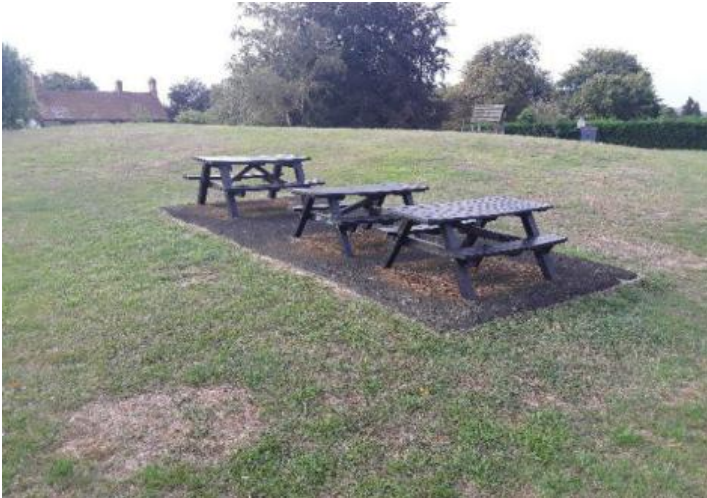
Finding: There is moderate damage to the surface

Action: Repair the damaged areas of surfacing

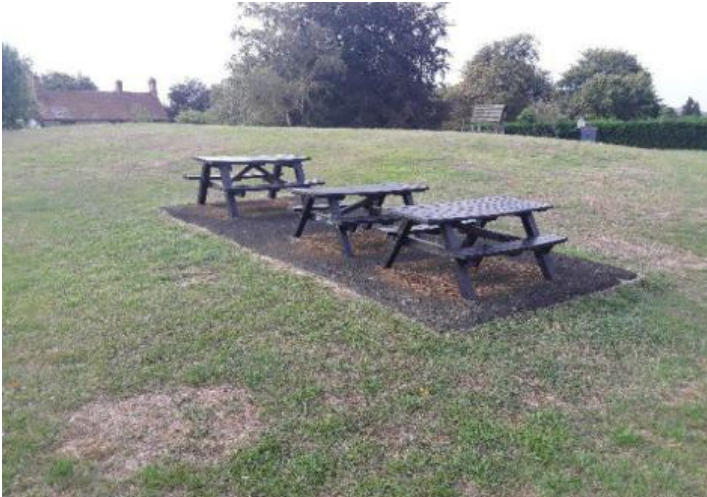
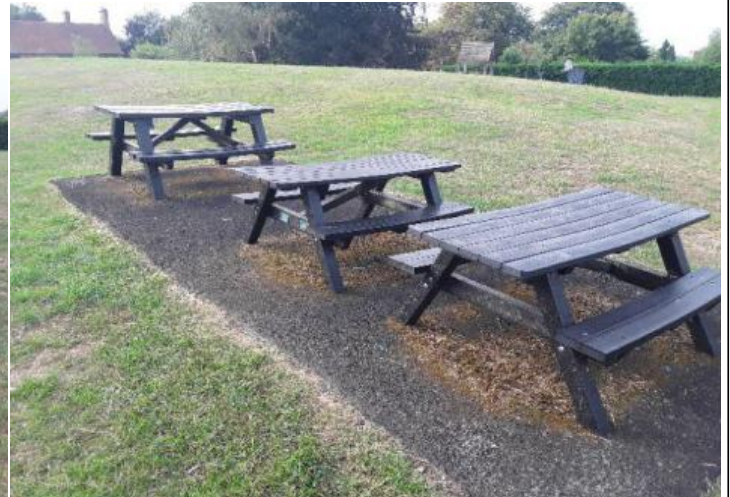
Finding: The table/s is/are not secured to the ground and there is some potential for the item/s to be moved within falling spaces of equipment

Action: Secure to the ground

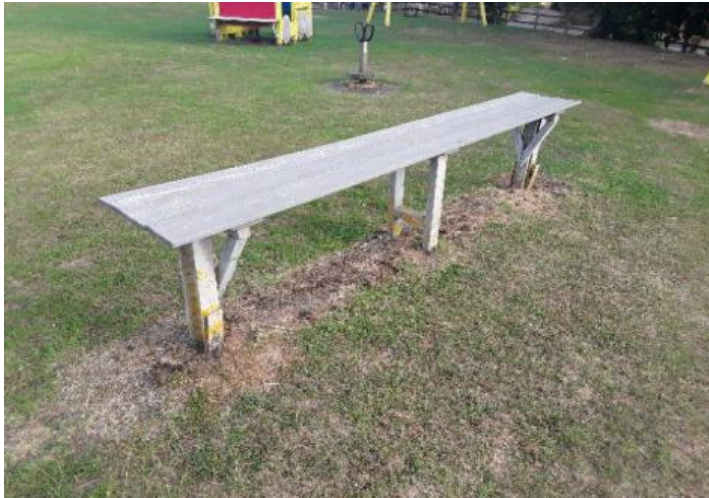
Finding: The surface has eroded and the foundations are exposed

Action: Reinstate surrounding surfaces to cover the foundations

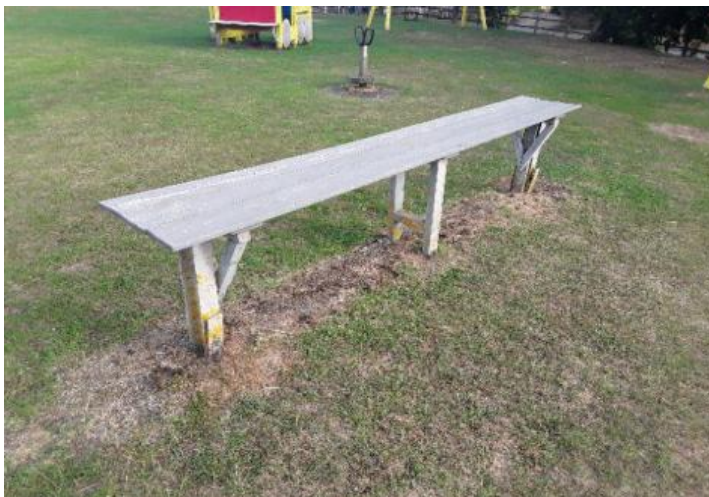
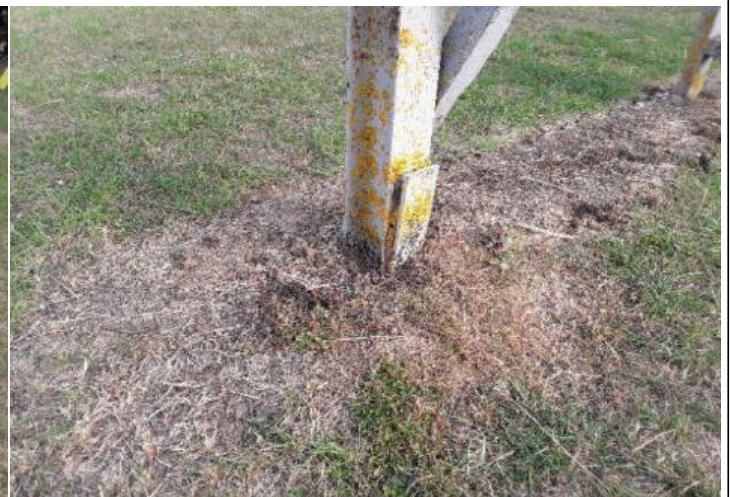
Finding: The paintwork on this item has been damaged or worn exposing the metal underneath which is rusting / corroding

Action: Treat affected areas and repaint

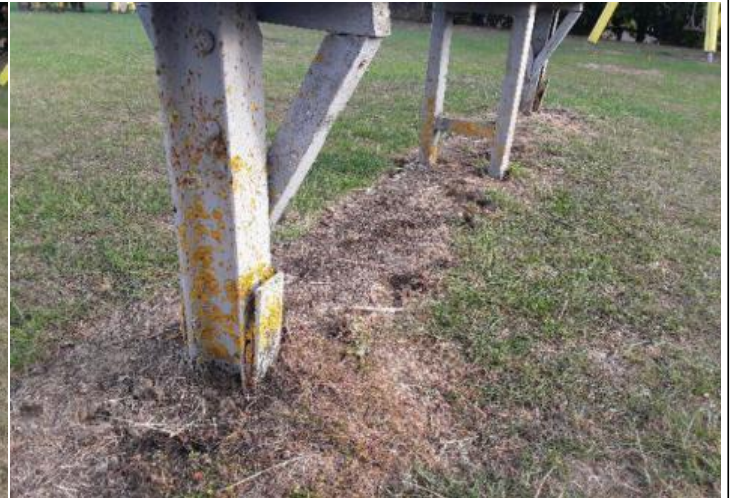
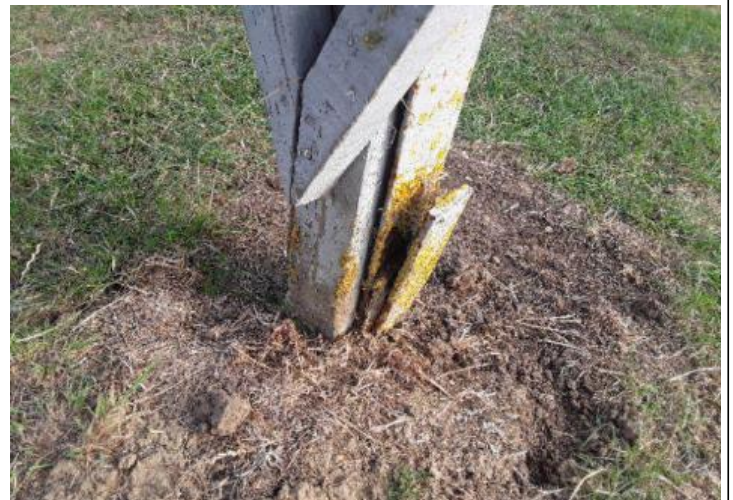
Finding: Brackets are projecting

Action: Remove all projections

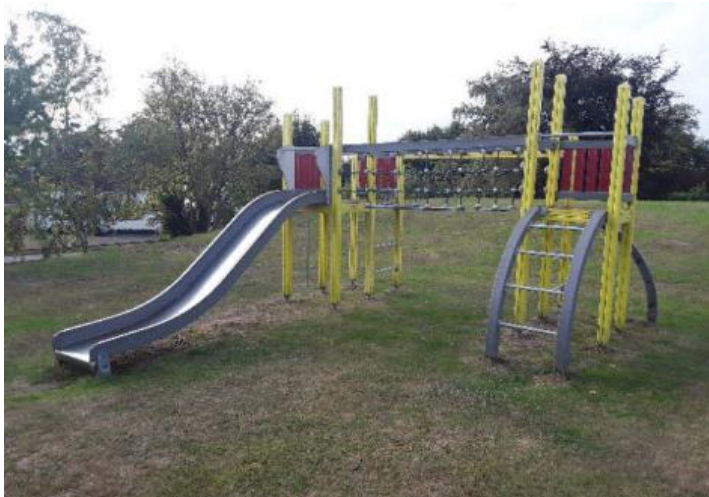
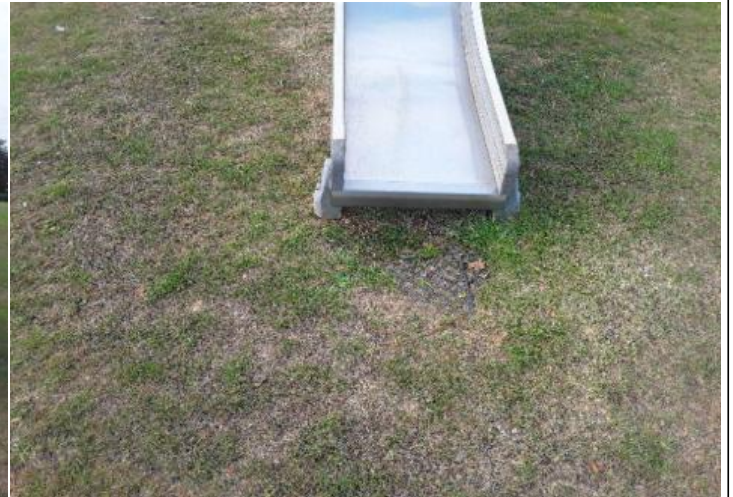
Finding: The grass mats are silted up, the soil is compacted and the area will become very slippery when the soil is wet.

Action: Reinstate as required

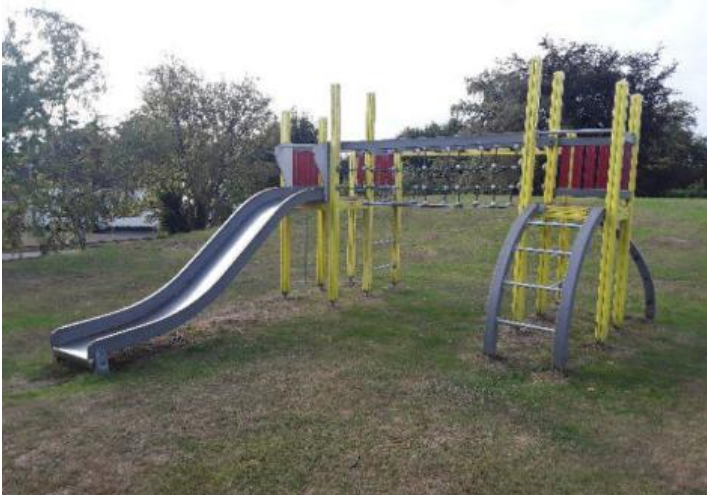
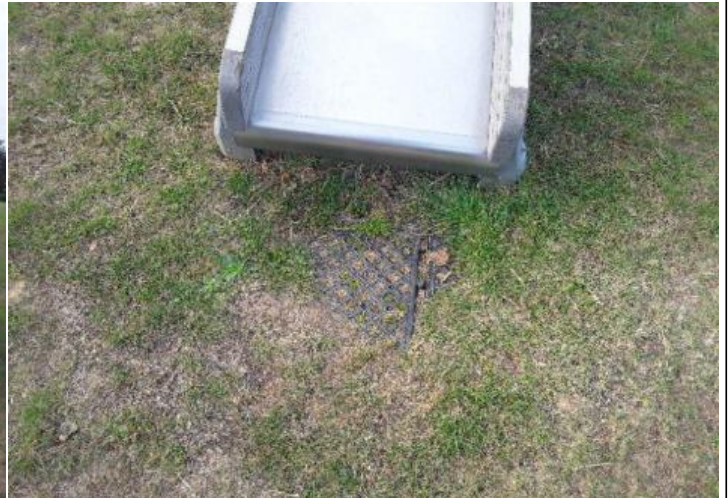
Finding: There are gaps opening between the grass mat tiles

Action: Provide additional ties or secure / reinstate surface tiles
