the **play inspection** company

Annual Inspection

Welton Parish Council

Welton Recreation Ground

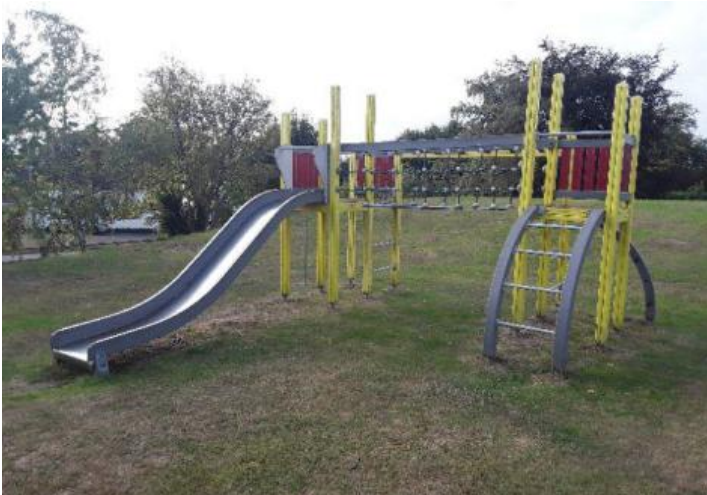
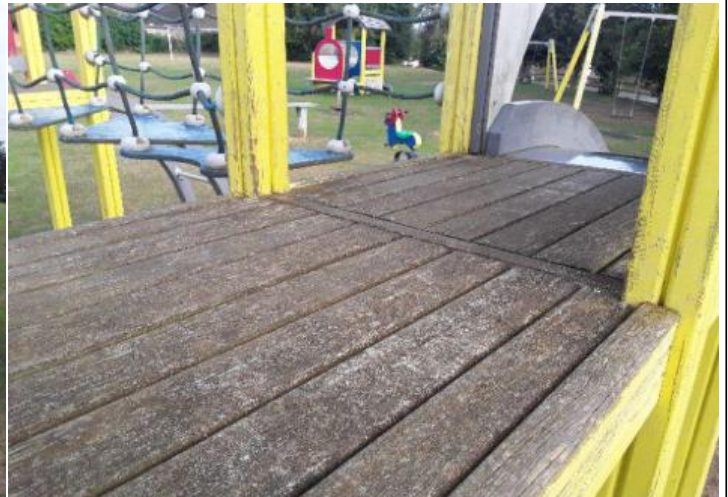
Finding: There is algae or moss on the surface of the equipment

Action: Clean and treat appropriately

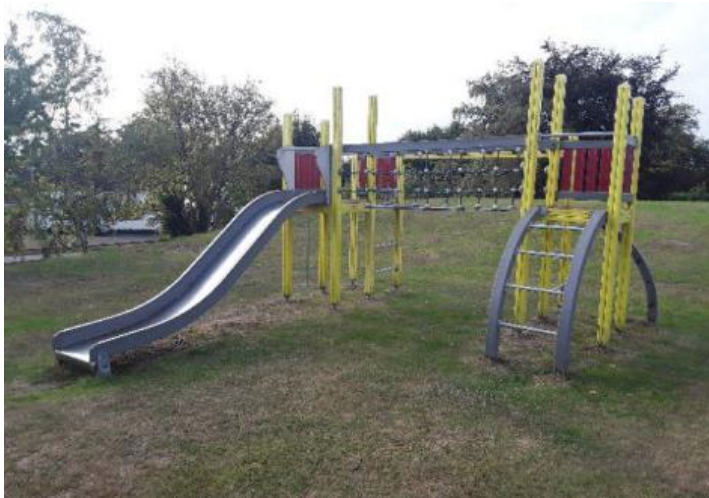
Finding: There is/are bolt cap covers missing or damaged on the item

Action: Replace missing or damaged bolt cap covers

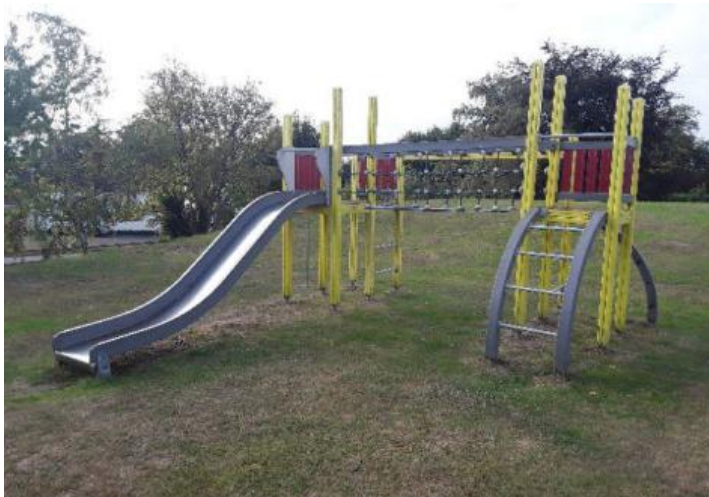
Finding: The timber stain is in poor condition

Action: Prepare all affected parts and re-stain with an appropriate preservative

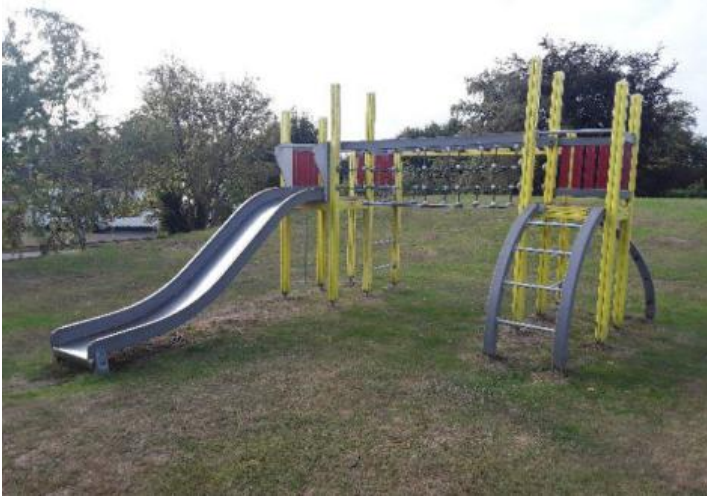
Finding: There is/are finger entrapment/s in the handgrips due to missing end caps and the item fails to meet the requirements of BS EN 1176 Part 1 4.2.7.6 Entrapment of fingers

Action: Replace missing caps to remove the entrapments

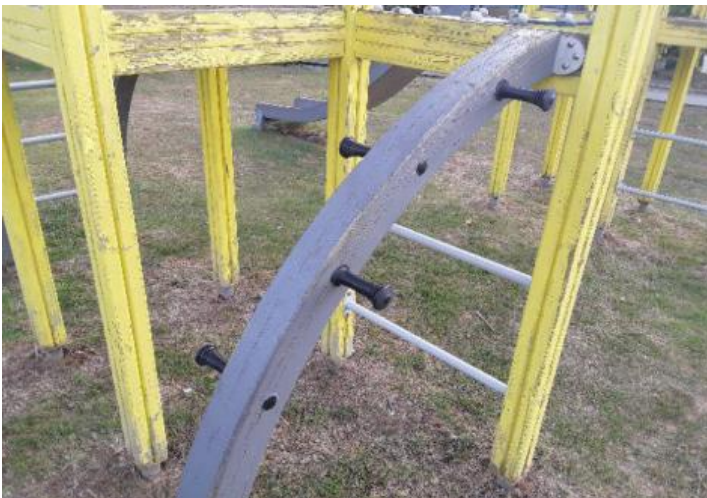
Item: Activity Equipment - Multi Play (Junior)
Manufacturer: Lappset UK Ltd

Finding: A number of fixing(s) have worked loose

Action: Secure all loose fixings

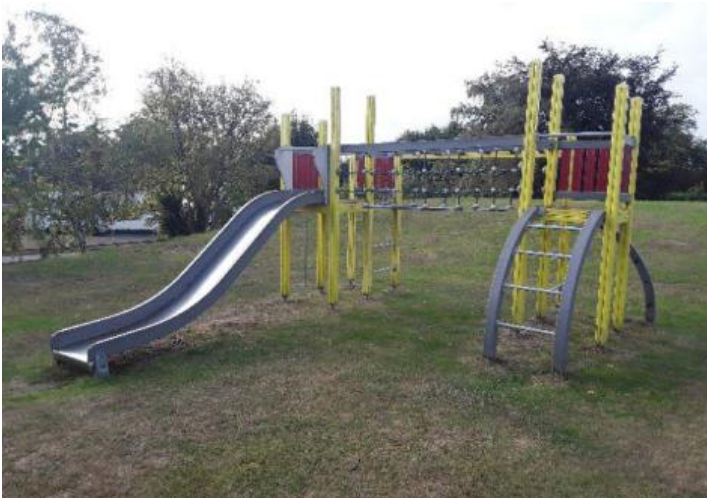
Item: Activity Equipment - Multi Play (Junior)
Manufacturer: Lappset UK Ltd

Finding: The ropes/nets are worn/damaged in places

Action: Monitor for any further deterioration and repair or replace as required

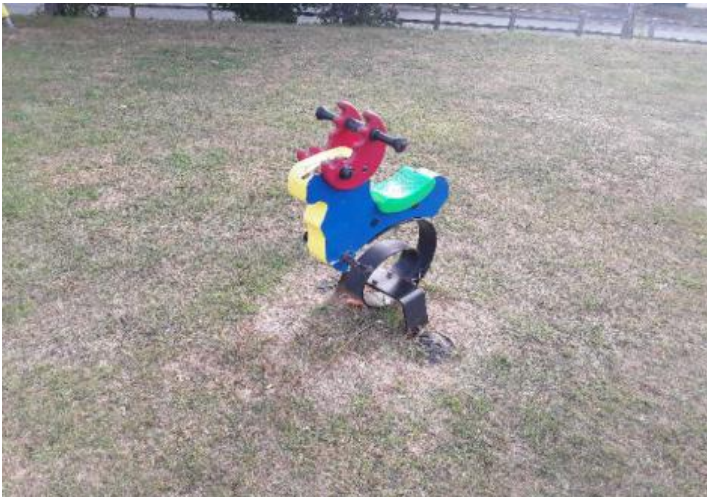
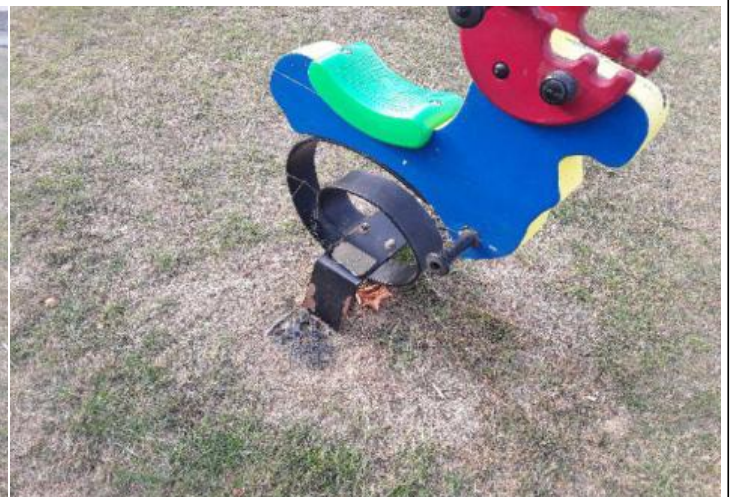
Item: Rocking Equipment - Spring Reindeer
Manufacturer: Lappset UK Ltd

Finding: There are gaps opening between the grass mat tiles

Action: Provide additional ties or secure / reinstate surface

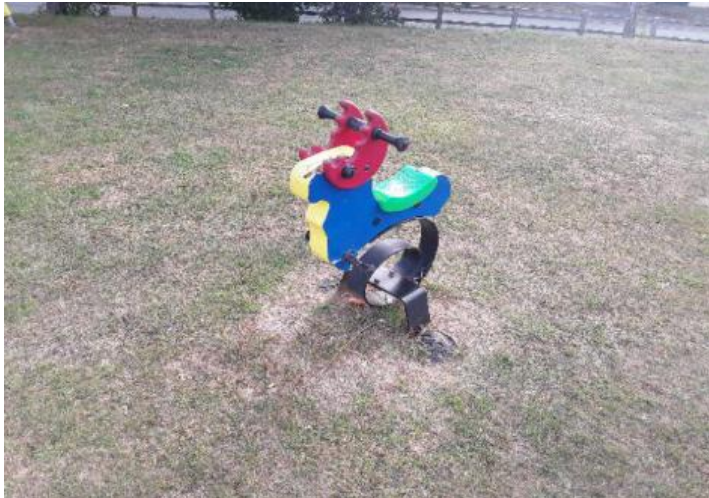
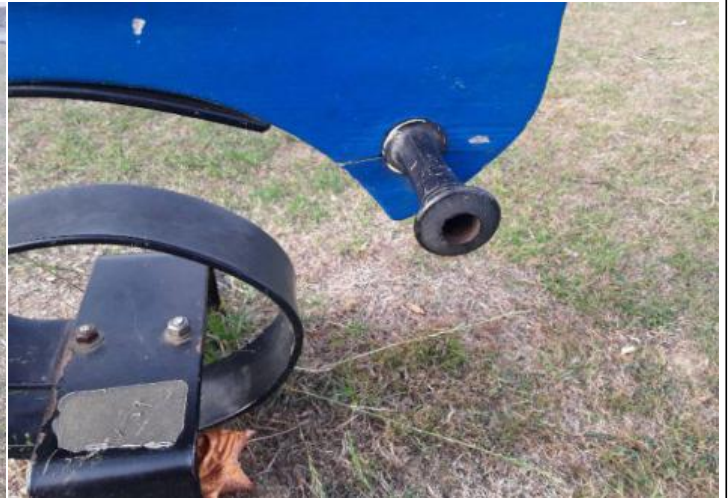
Item: Rocking Equipment - Spring Reindeer
Manufacturer: Lappset UK Ltd

Finding: The end caps are missing on the Handgrips/Footrests

Action: Replace missing end caps

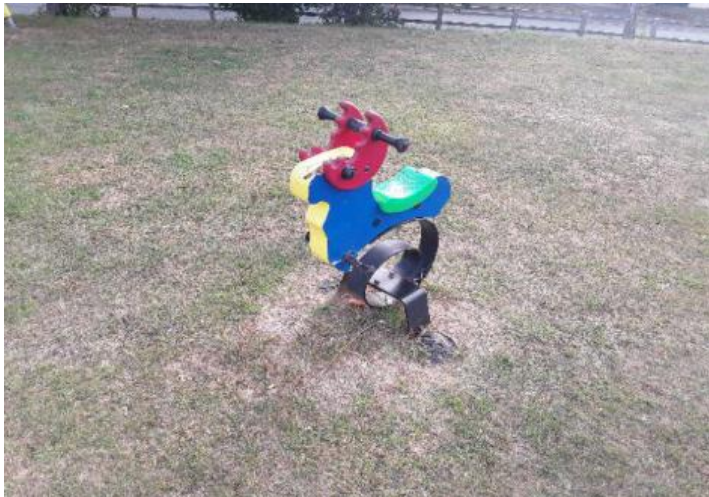
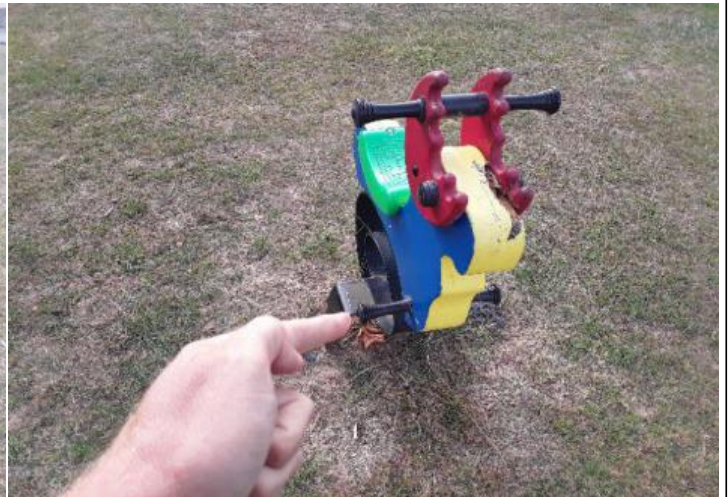
Item: Rocking Equipment - Spring Reindeer
Manufacturer: Lappset UK Ltd

Finding: The Handgrips/Footrests rotate and may cause an unexpected movement for the user

Action: Secure Handgrips/Footrests to prevent rotation.

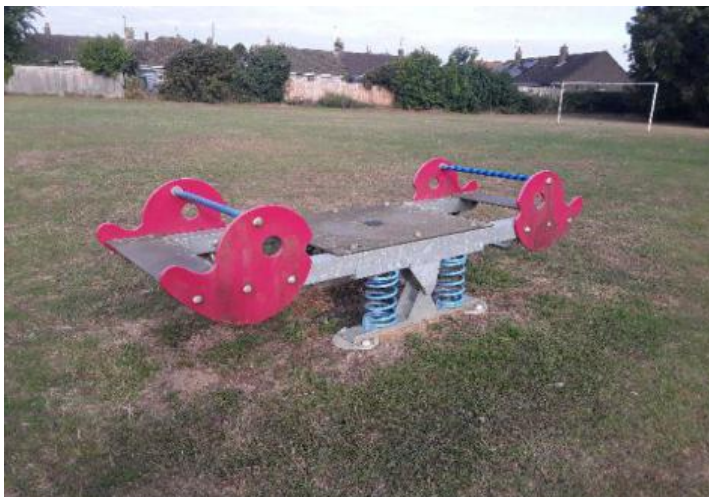
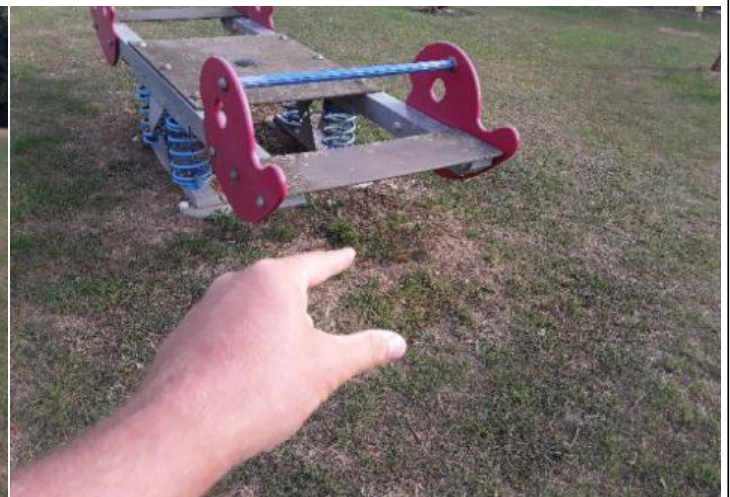
Item: Rocking Equipment - Spring See-Saw
Manufacturer: Kompan Ltd

Finding: The surface has subsided in some areas

Action: Monitor for any further deterioration and repair as required

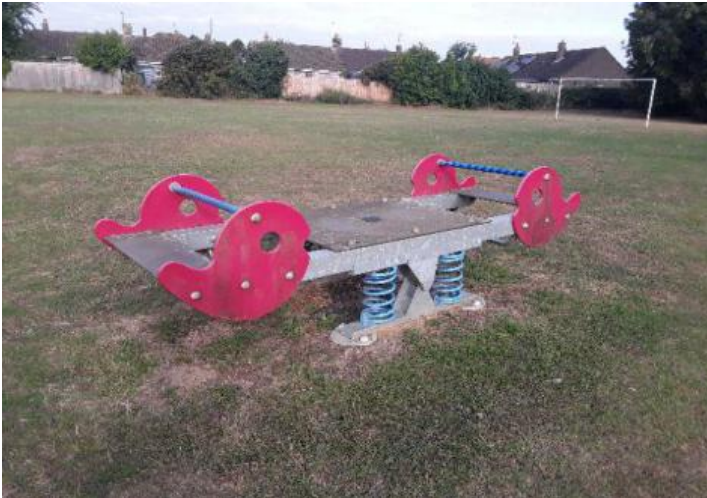
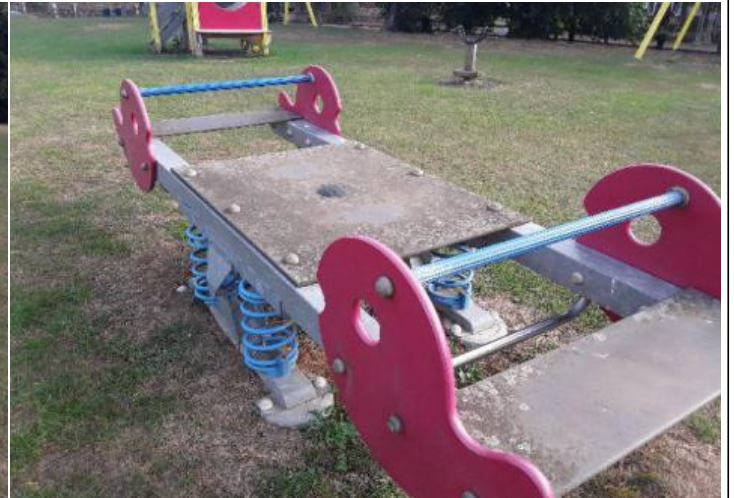
Item: Rocking Equipment - Spring See-Saw
Manufacturer: Kompan Ltd

Finding: There is algae or moss on the surface of the equipment

Action: Clean and treat appropriately

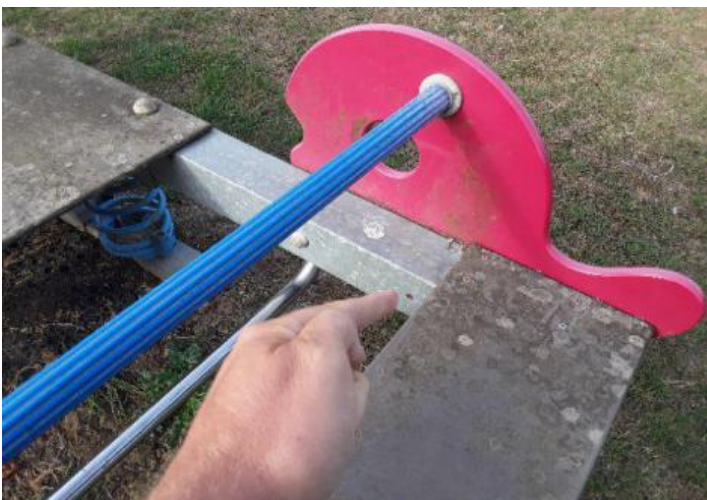
Item: Rocking Equipment - Spring See-Saw
Manufacturer: Kompan Ltd

Finding: There is or are fixings missing on the item

Action: Replace all missing fixings

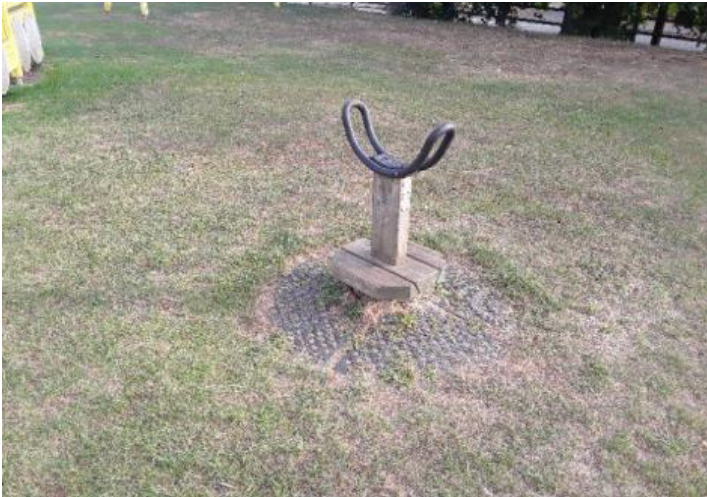
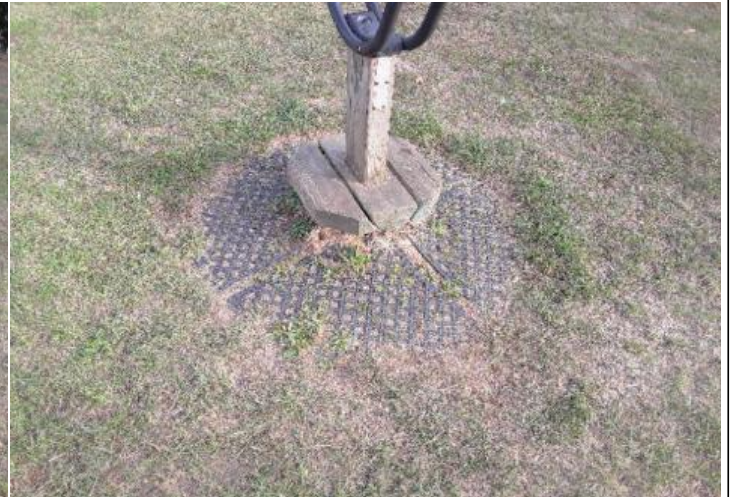
Item: Rotor Play - Low Rotator
Manufacturer: Lappset UK Ltd

Finding: There are gaps opening between the grass mat tiles

Action: Provide additional ties or secure / reinstate surface

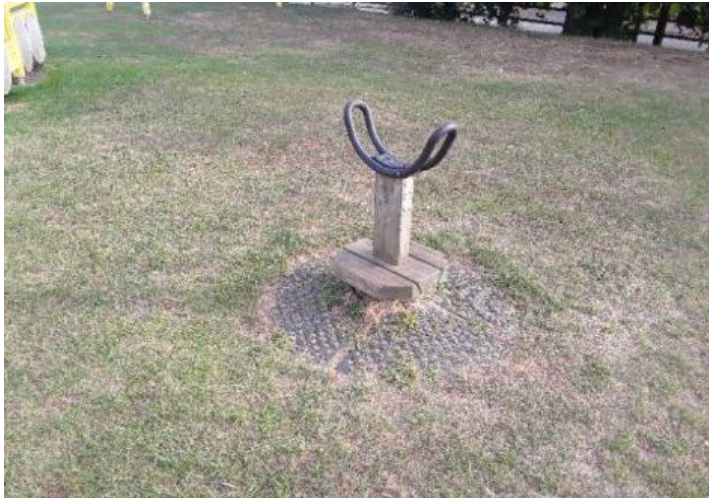
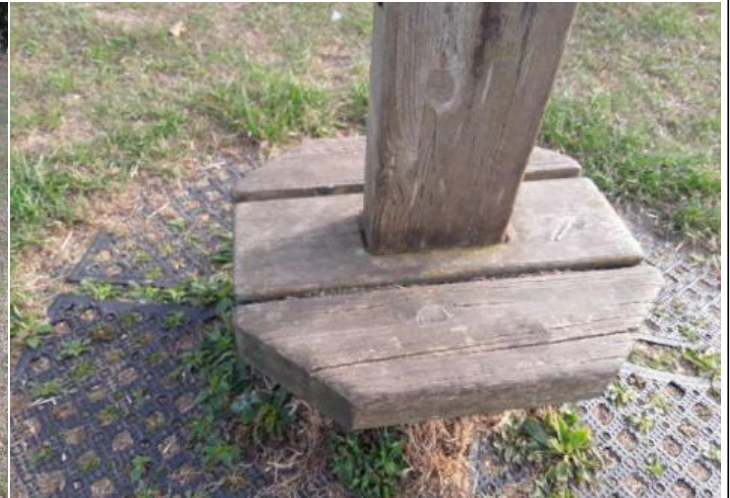
Item: Rotor Play - Low Rotator
Manufacturer: Lappset UK Ltd

Finding: There is algae or moss on the surface of the equipment

Action: Clean and treat appropriately

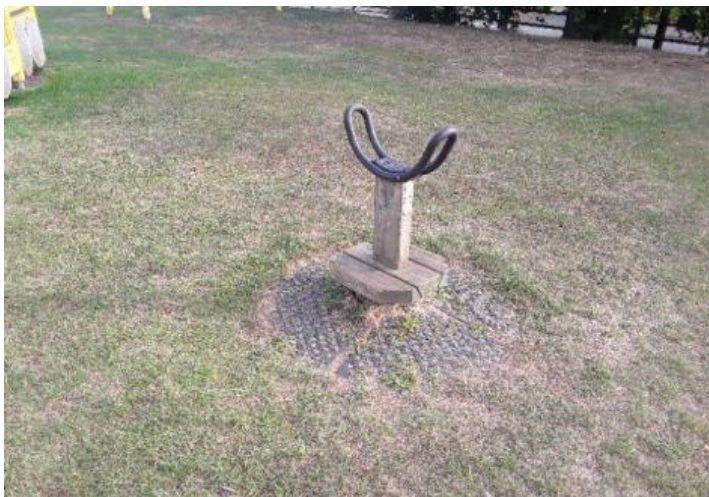
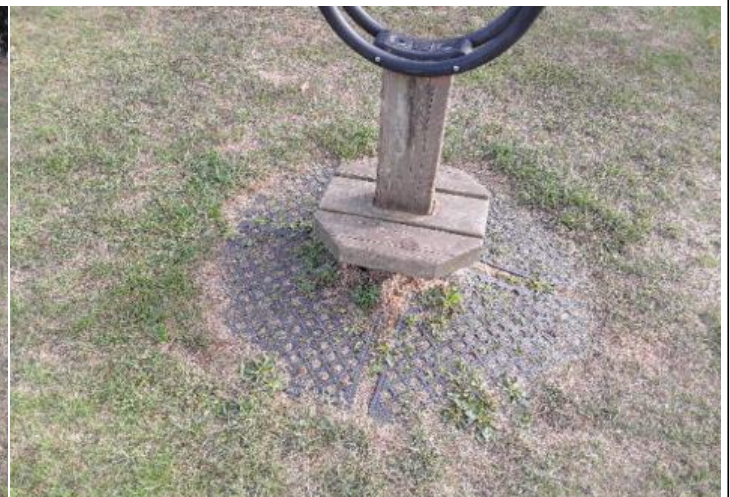
Item: Rotor Play - Low Rotator
Manufacturer: Lappset UK Ltd

Finding: The bearing is showing signs of wear

Action: Monitor for any further deterioration and replace as required

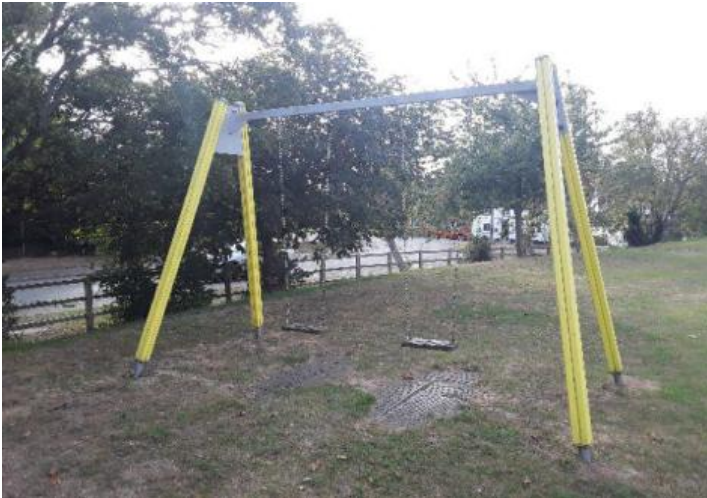
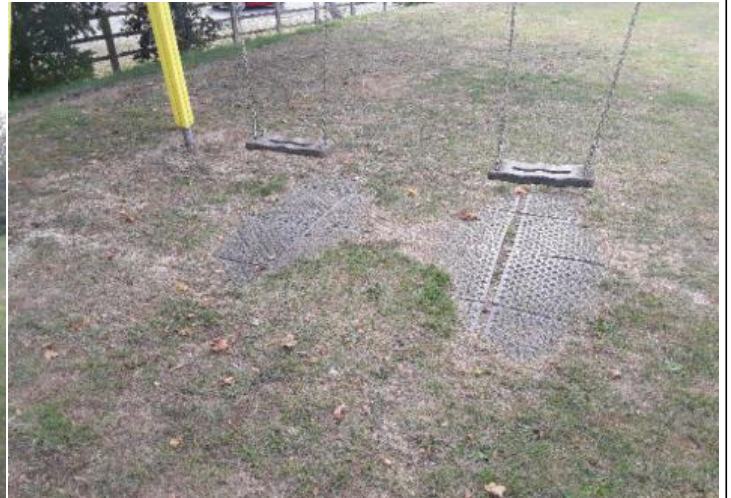
Item: Swings - 1 Bay 2 Seat (Flat)
Manufacturer: Lappset UK Ltd

Finding: The grass mats are silted up, the soil is compacted and the area will become very slippery when the soil is wet. **Action:** Reinstate as required

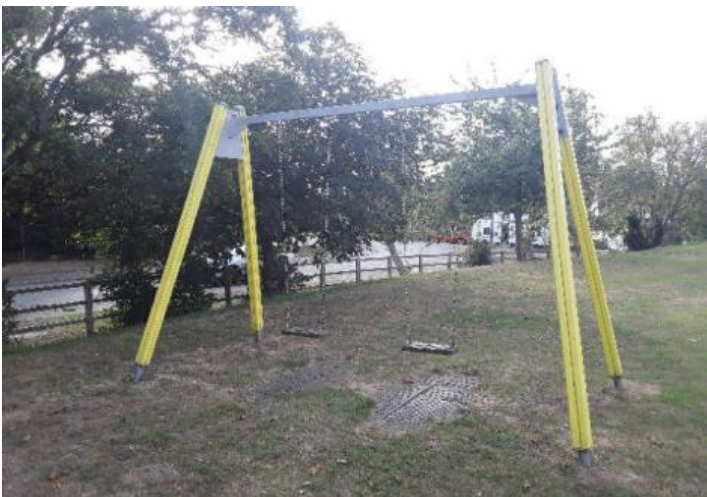
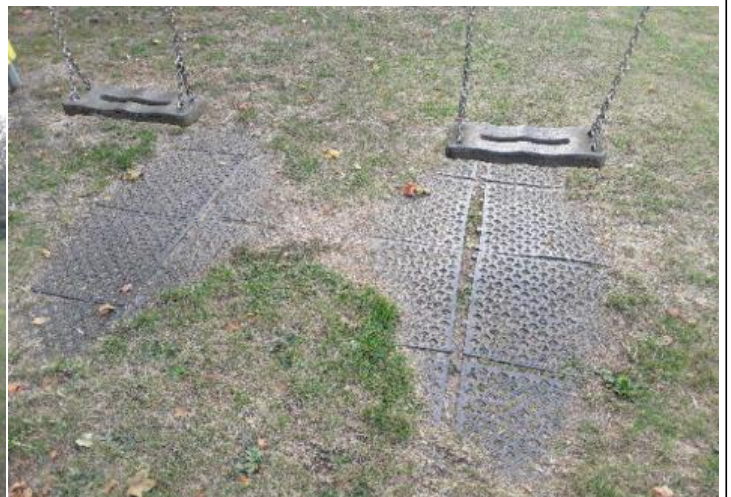
Item: Swings - 1 Bay 2 Seat (Flat)
Manufacturer: Lappset UK Ltd

Finding: There are gaps opening between the grass mat tiles which are also lifting **Action:** Provide additional ties or secure / reinstate surface

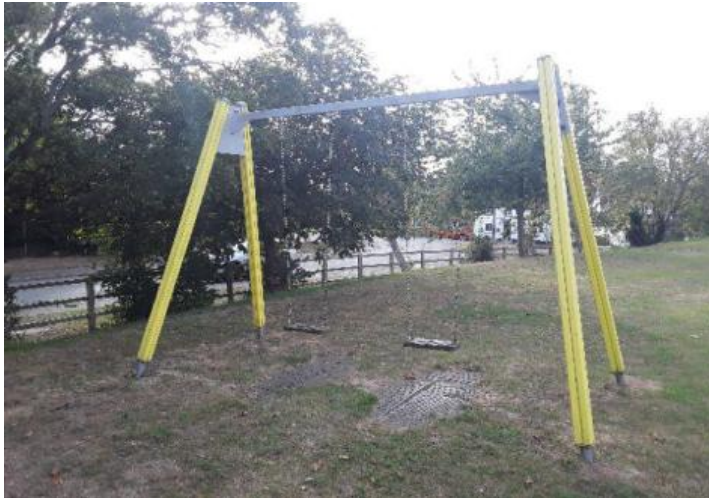
Item: Swings - 1 Bay 2 Seat (Flat)
Manufacturer: Lappset UK Ltd

Finding: There is/are bolt cap covers missing or damaged on the item

Action: Replace missing or damaged bolt cap covers

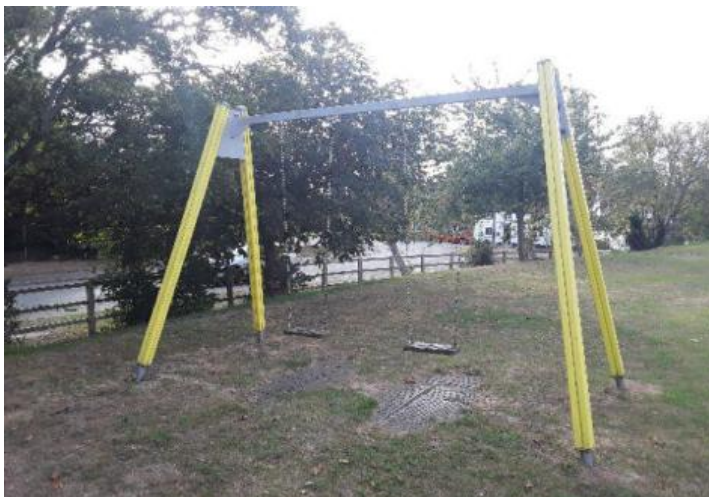
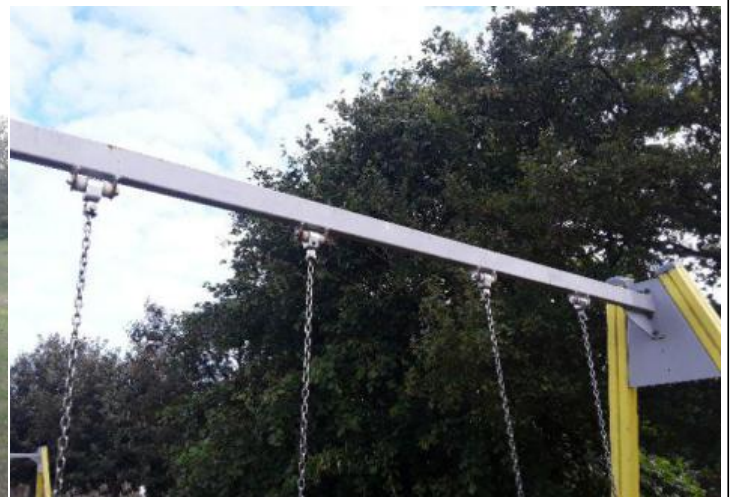
Item: Swings - 1 Bay 2 Seat (Flat)
Manufacturer: Lappset UK Ltd

Finding: The paintwork on this item has been damaged or worn exposing the metal underneath which is rusting / corroding

Action: Treat affected areas and repaint

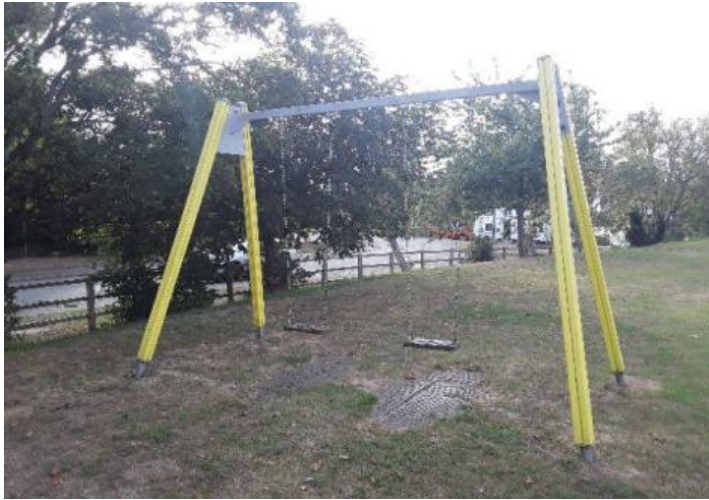
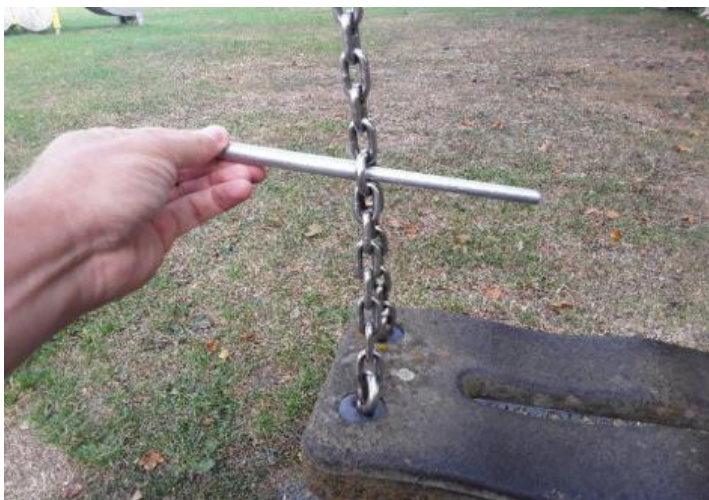
Item: Swings - 1 Bay 2 Seat (Flat)
Manufacturer: Lappset UK Ltd

Finding: The connecting links are in excess of 8.6mm and less than 12mm and fail the requirements of BS EN 1176 Part 1; clause 4.2.13, Chains

Action: Monitor use and replace with compliant links at the next maintenance cycle

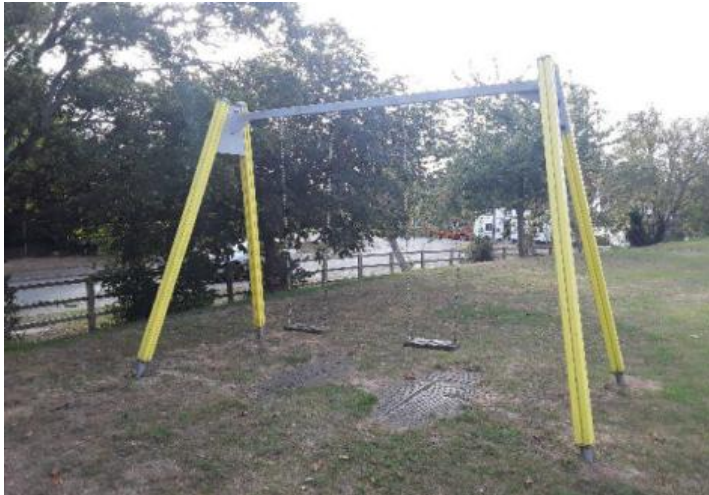
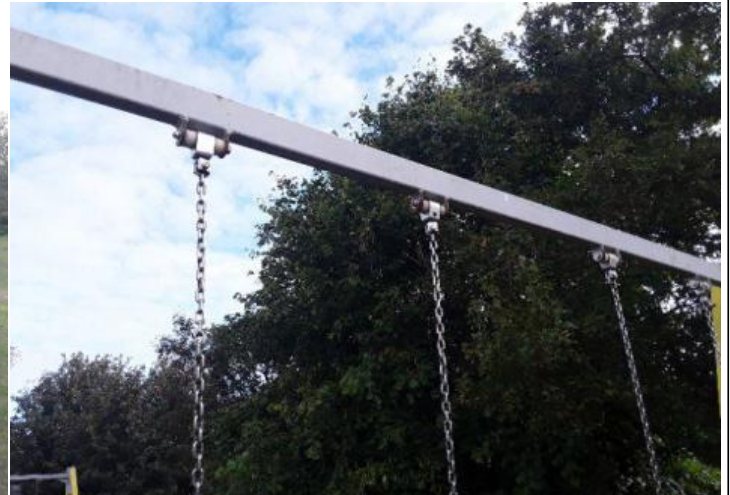
Item: Swings - 1 Bay 2 Seat (Flat)
Manufacturer: Lappset UK Ltd

Finding: There is some wear to the suspension fixings

Action: Monitor for any further deterioration and replace when 40% worn

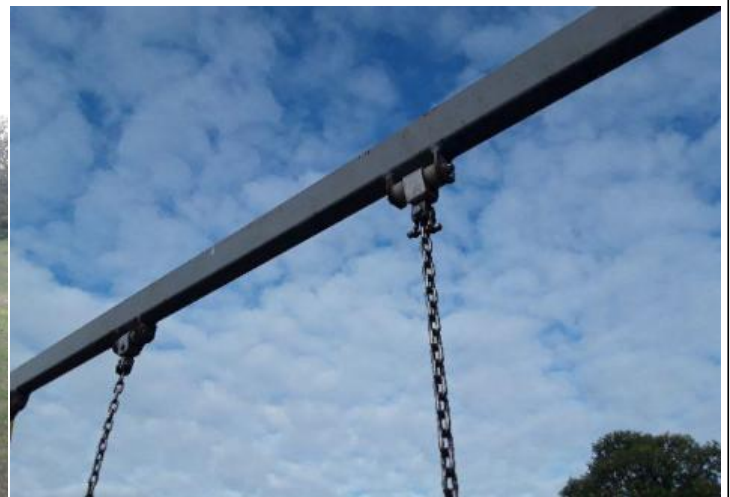
Item: Swings - 1 Bay 2 Seat (Flat)
Manufacturer: Lappset UK Ltd

Finding: There is some wear to the shackles

Action: Monitor for any further deterioration and replace when 40% worn

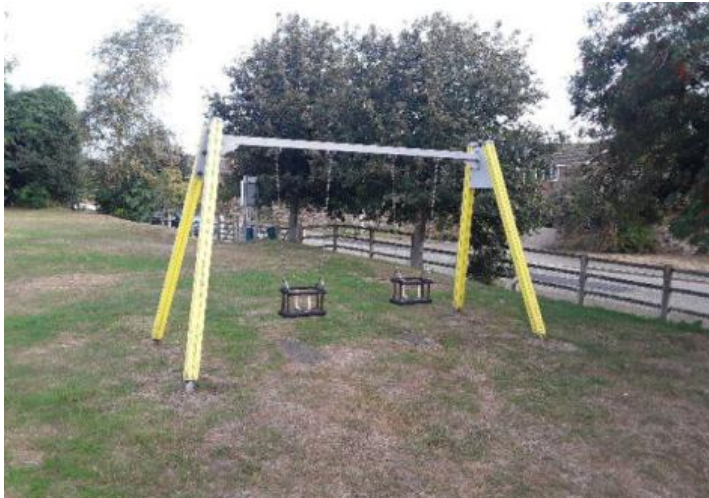
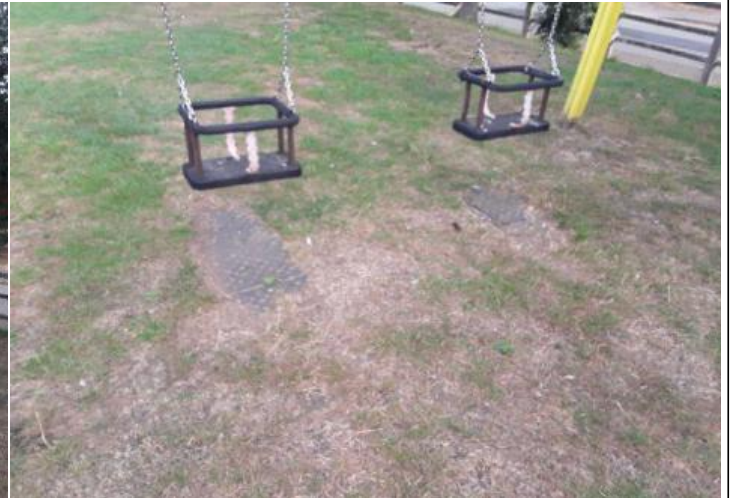
Item: Swings - 1 Bay 2 Seat (Cradle)
Manufacturer: Lappset UK Ltd

Finding: The grass mats are silted up, the soil is compacted and the area will become very slippery when the soil is wet. **Action:** Reinstate as required

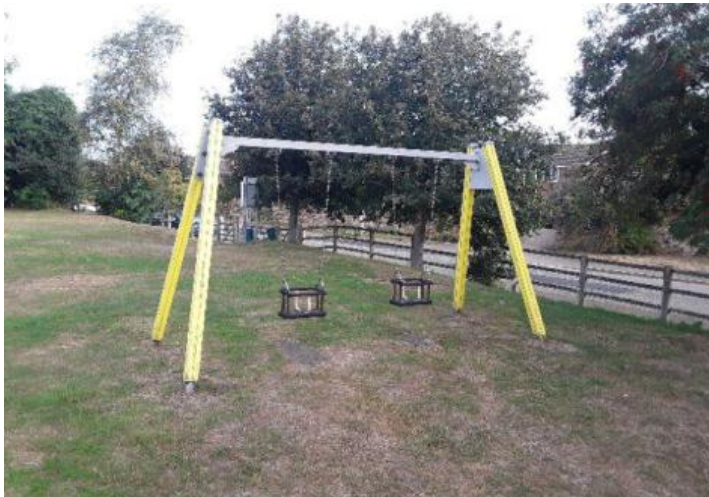
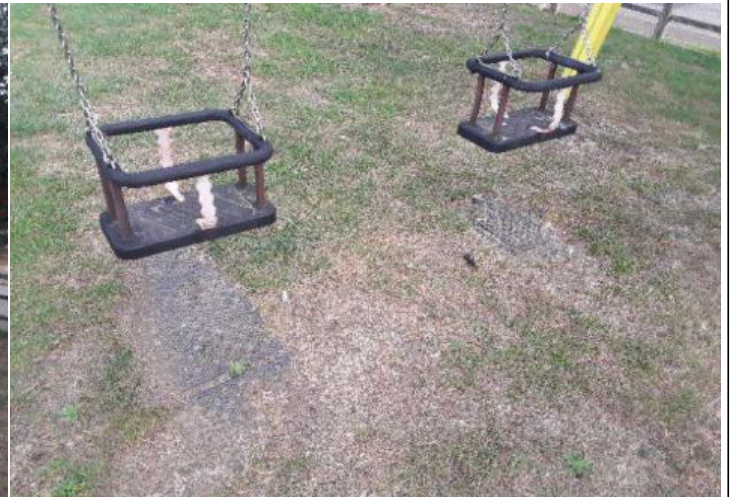
Item: Swings - 1 Bay 2 Seat (Cradle)
Manufacturer: Lappset UK Ltd

Finding: There are gaps opening between the grass mat tiles **Action:** Provide additional ties or secure / reinstate surface

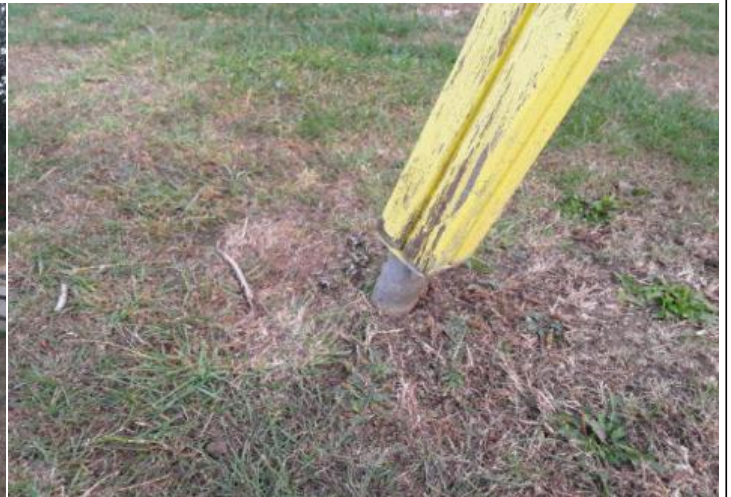
Item: Swings - 1 Bay 2 Seat (Cradle)
Manufacturer: Lappset UK Ltd

Finding: There is some strimmer / machinery damage apparent on the posts, this can penetrate the preservative applied to the timber and accelerate the rotting process

Action: Monitor for any deterioration (rot) and replace as required

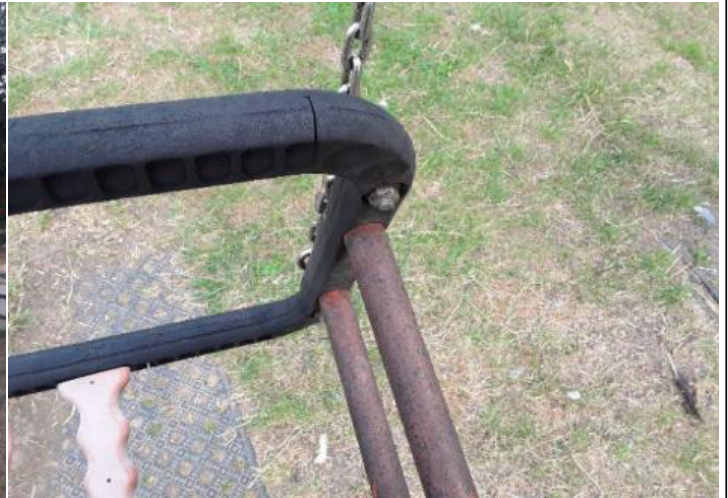
Item: Swings - 1 Bay 2 Seat (Cradle)
Manufacturer: Lappset UK Ltd

Finding: There are caps missing from the underside of the seats

Action: Replace missing caps under the seats

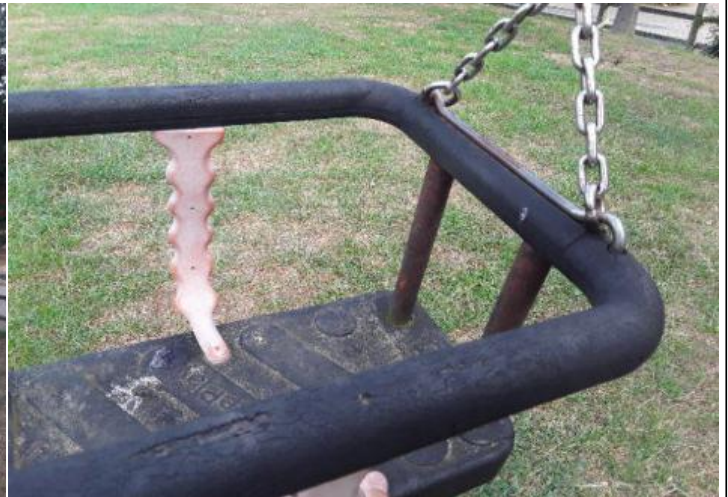
Item: Swings - 1 Bay 2 Seat (Cradle)
Manufacturer: Lappset UK Ltd

Finding: The swing seat frames are corroding

Action: Monitor for any further deterioration and replace as required

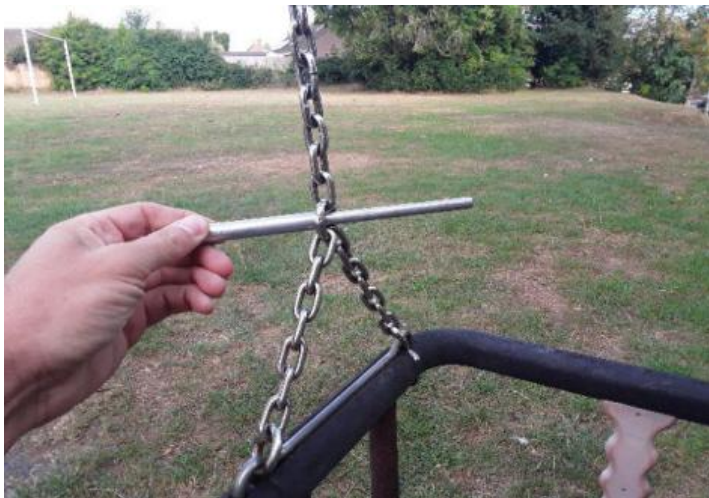
Item: Swings - 1 Bay 2 Seat (Cradle)
Manufacturer: Lappset UK Ltd

Finding: The connecting links are in excess of 8.6mm and less than 12mm and fail the requirements of BS EN 1176 Part 1; clause 4.2.13, Chains

Action: Monitor use and replace with compliant links at the next maintenance cycle

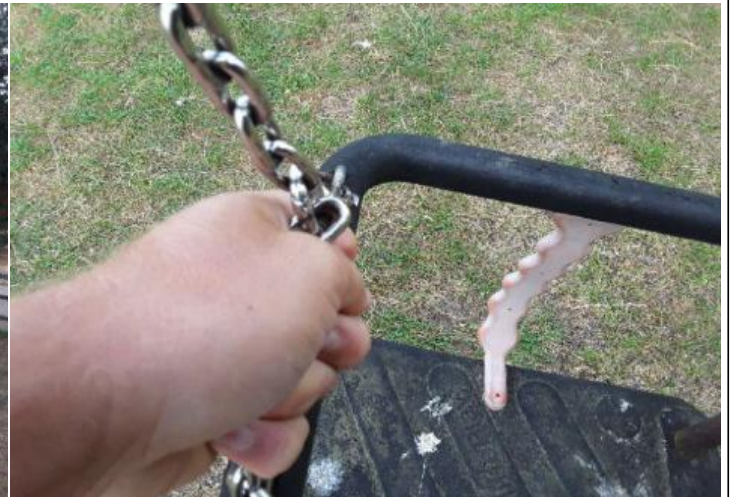
Item: Swings - 1 Bay 2 Seat (Cradle)
Manufacturer: Lappset UK Ltd

Finding: There is some notable evidence of chain wear

Action: Monitor for any further deterioration and replace when 40% worn

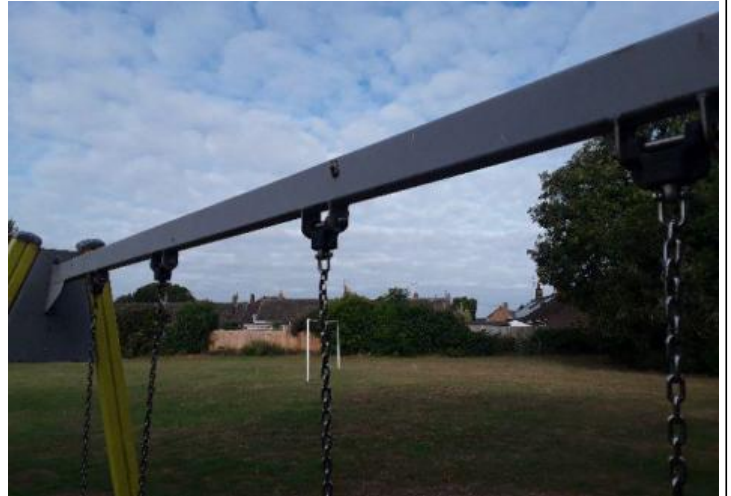
Finding: There is some wear to the suspension fixings which appear to be loose

Action: Monitor for any further deterioration, replace when worn and refer to manufacturer specifications for correct installation

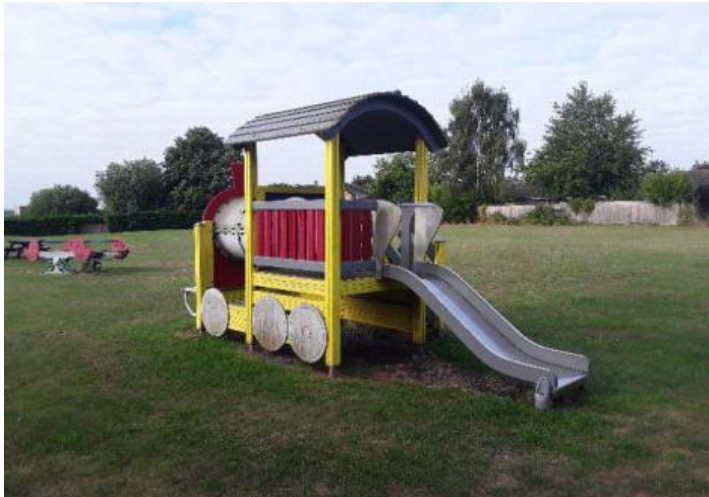
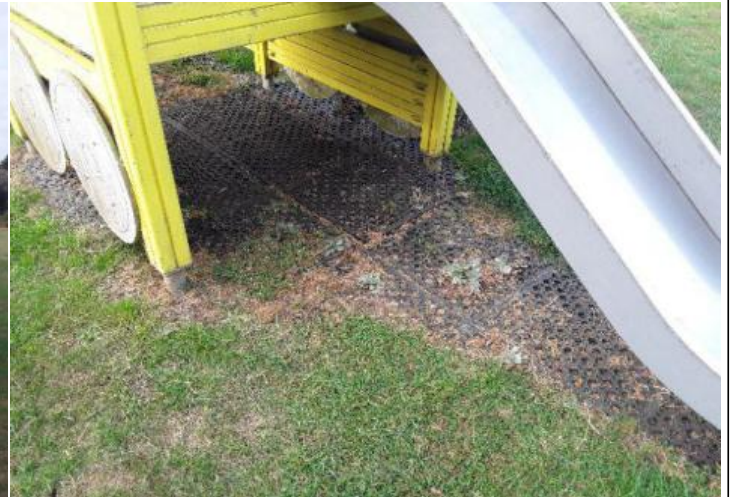
Finding: The grass mats are silted up, the soil is compacted and the area will become very slippery when the soil is wet.

Action: Reinstate as required

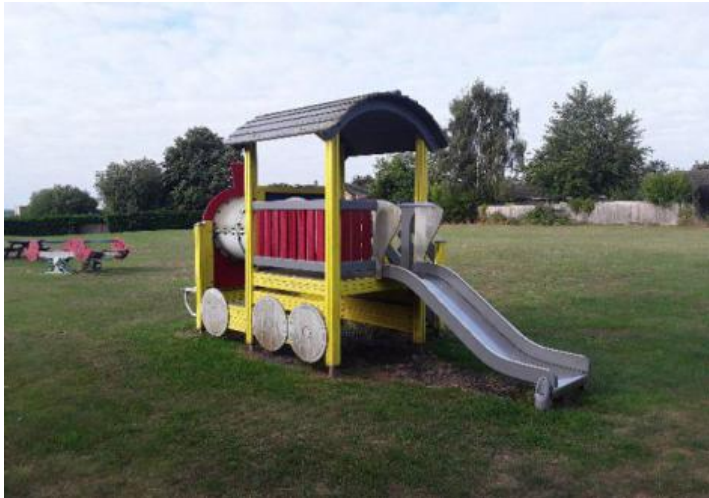
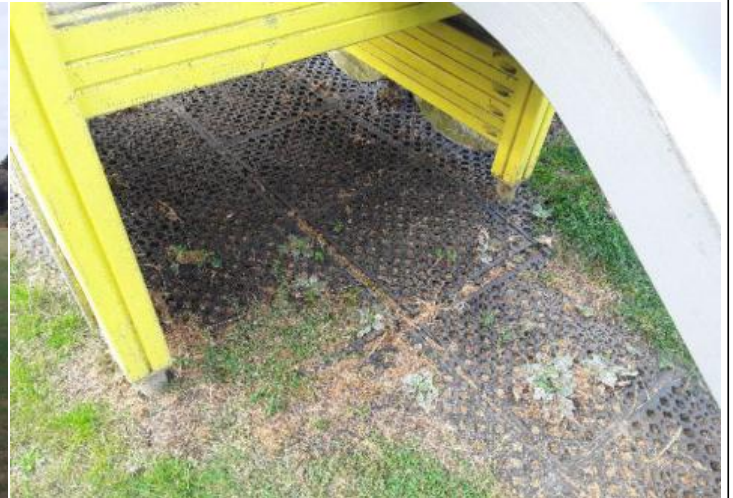
Finding: There are gaps opening between the grass mat tiles which are also lifting

Action: Provide additional ties or secure / reinstate surface

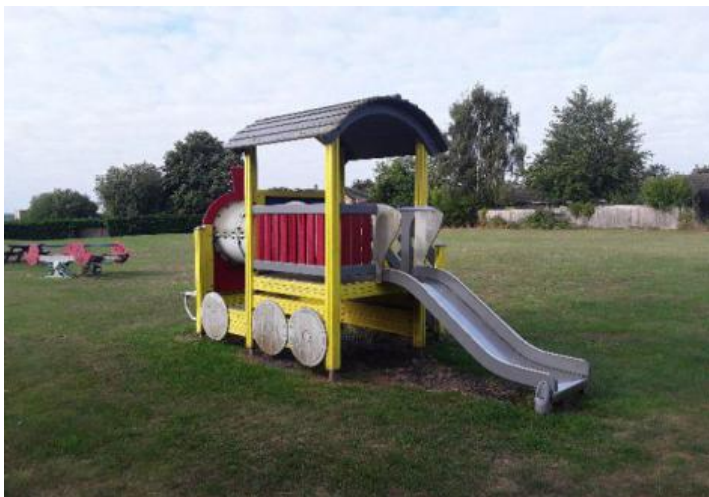
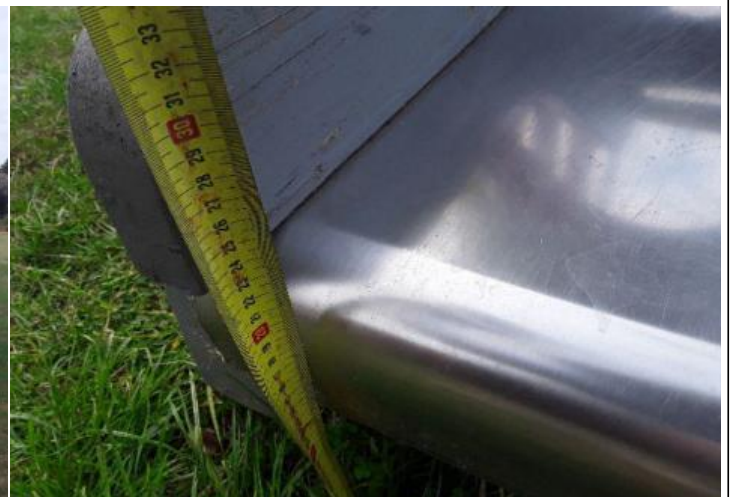
Finding: The height of the slide runout is in excess of 200mm and does not meet the requirements of BS EN 1176 Part 3

Action: Monitor - No action given the risk assessment

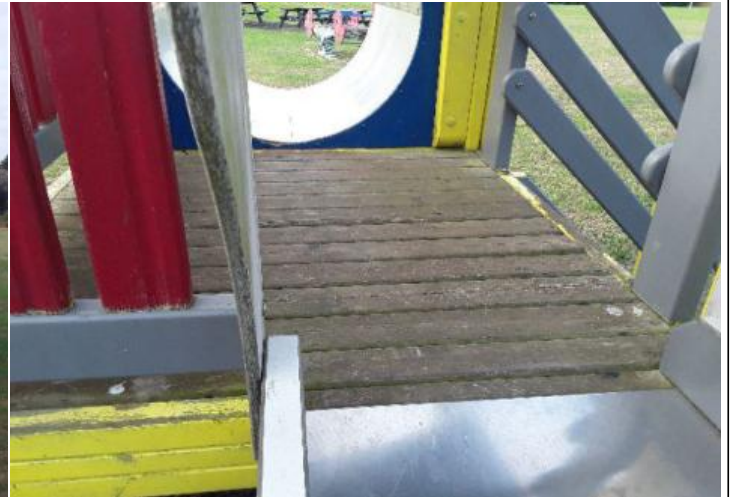
Finding: There is algae or moss on the surface of the equipment

Action: Clean and treat appropriately

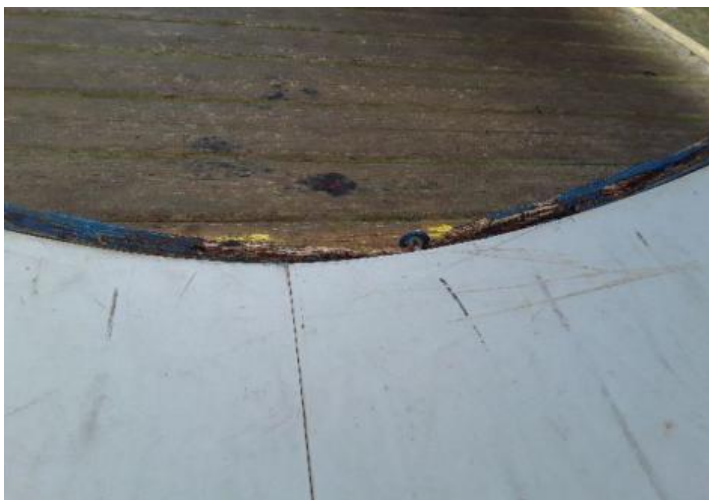
Finding: There are areas or parts of the timber panel that have rotted

Action: Replace all affected timbers

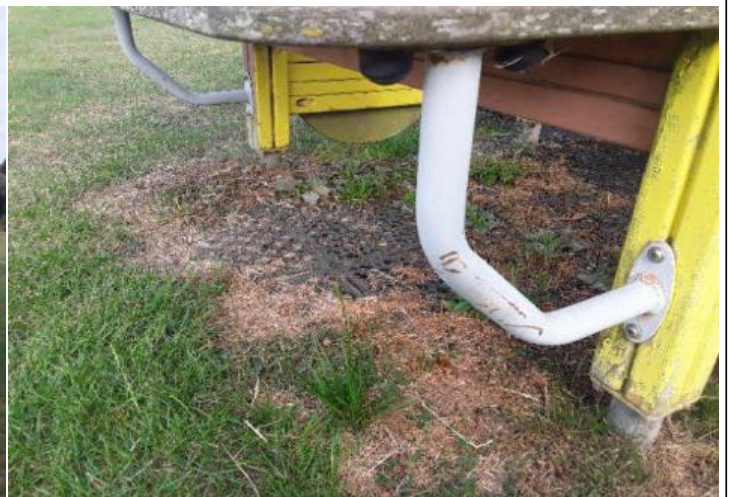
Finding: The paintwork on this item has been damaged or worn exposing the metal underneath which is rusting / corroding

Action: Treat affected areas and repaint

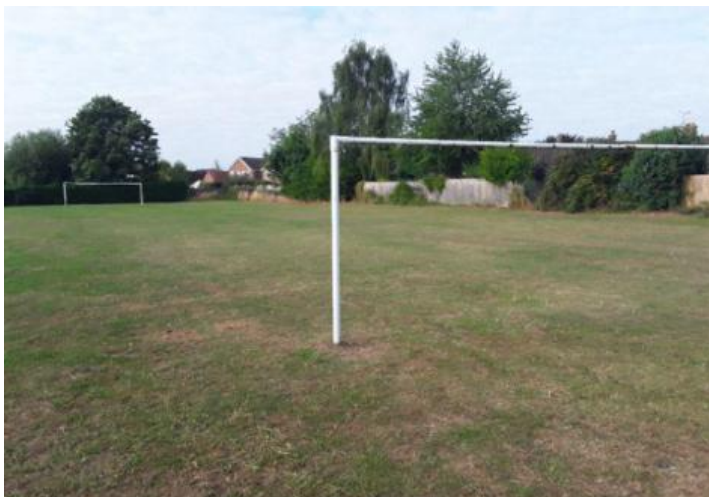
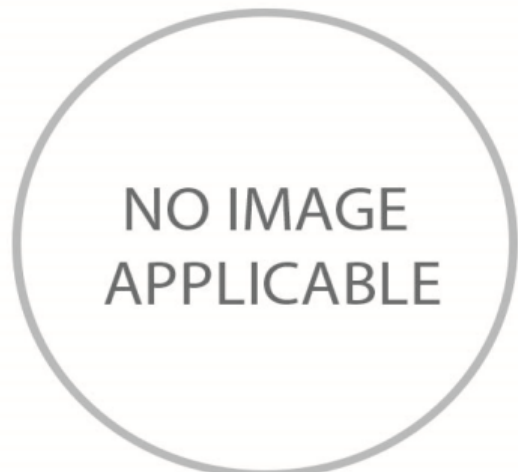
Finding: NB: We have undertaken a maintenance inspection only of the football goal(s); full load testing falls outside the scope of our inspection.

Action: Implement load testing as required

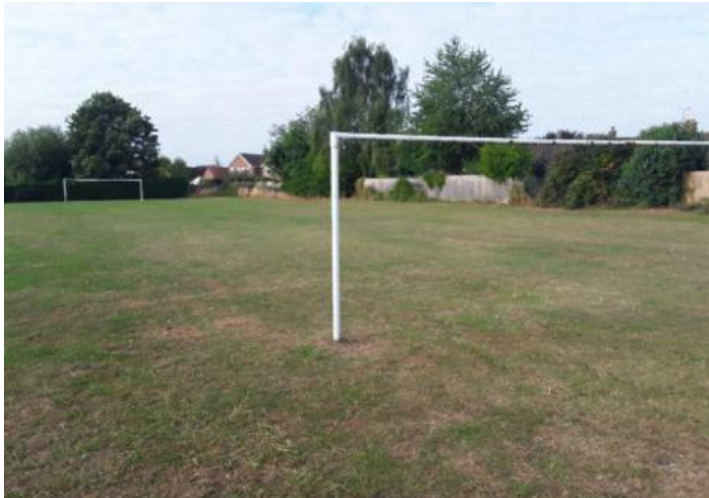
Finding: There is or are fixings missing on the item

Action: Replace all missing fixings

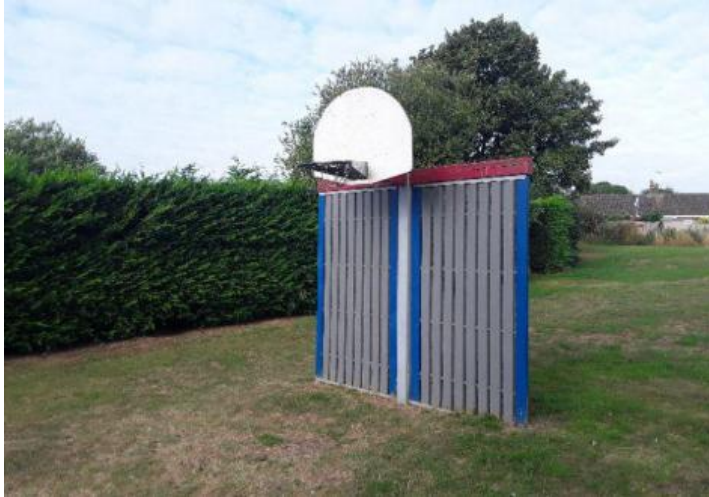
Finding: A clearly visible facility sign should be provided in a prominent position with the wording as detailed BS EN 15312- the equipment is not intended for children less than 3 years old- the warning - Do not climb on the framework or nets- the warning - Do not hang on the ring (if provided)- the warning - Do not wear rings or other jewellery- name and telephone number of the administrator- number to call in case of accident

Action: Provide signage to BS EN 15312
