the **play inspection** company

Annual Inspection

Welton Parish Council

Welton Recreation Ground

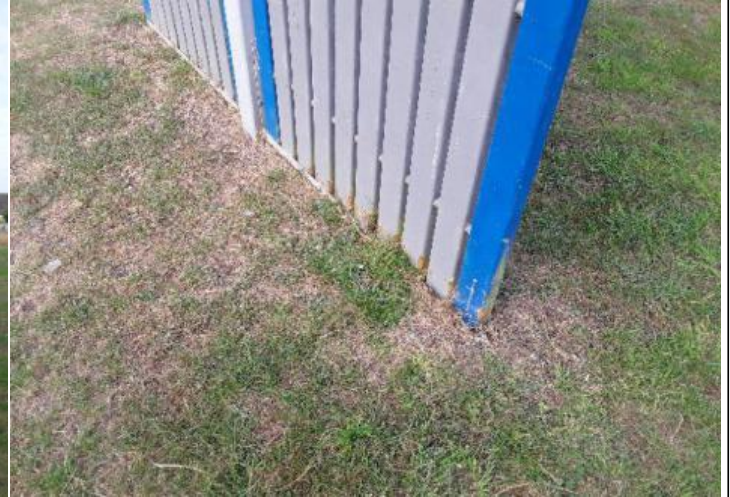
Finding: There is some strimmer / machinery damage apparent on the posts, this can penetrate the preservative applied to the timber and accelerate the rotting process

Action: Monitor for any deterioration (rot) and replace as required

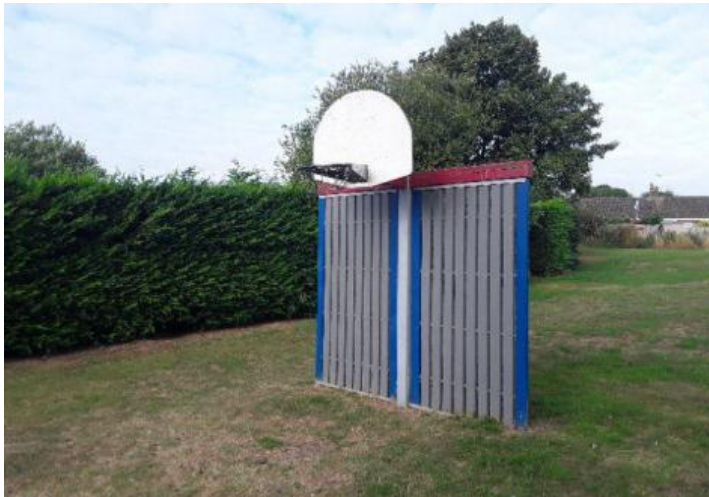
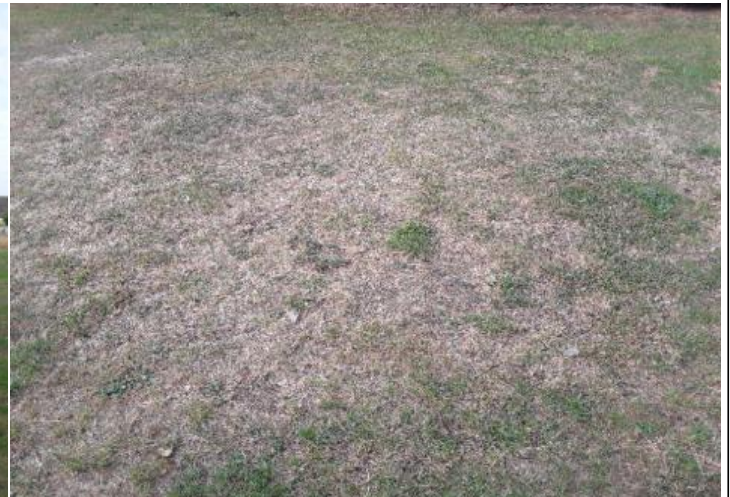
Finding: The grass mats are silted up, the soil is compacted and the area will become very slippery when the soil is wet.

Action: Reinststate as required

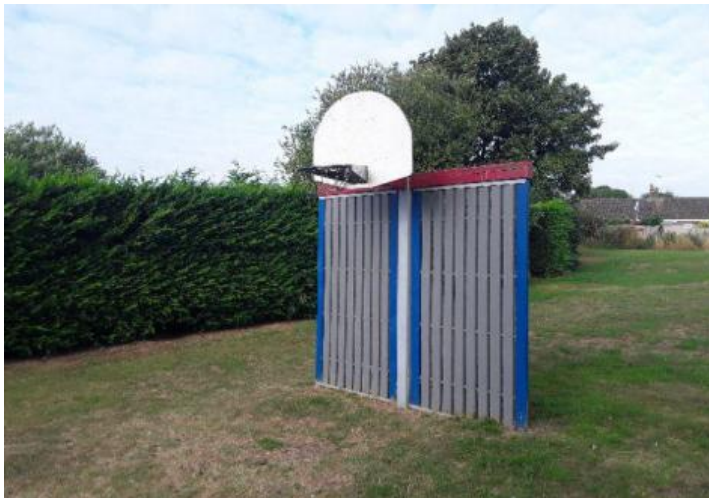
Finding: There is/are bolt cap covers missing or damaged on the item

Action: Replace missing or damaged bolt cap covers

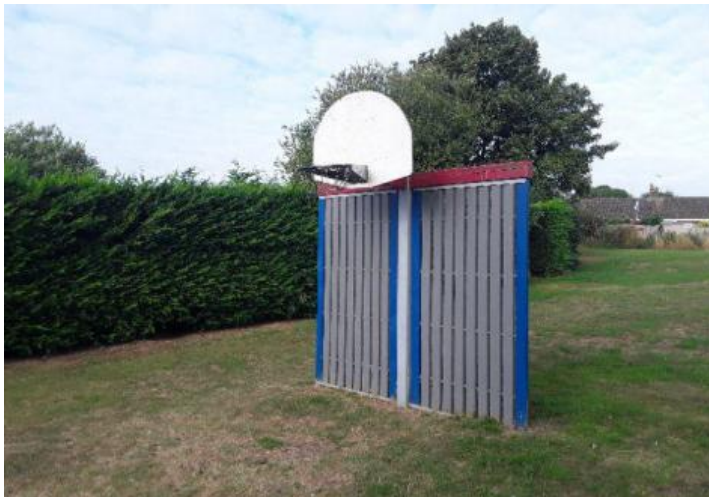
Finding: There is/are finger entrapments in the hoop chain and the item fails to meet the requirements of BS EN 15312 Clause 4.4.2.2 Entrapment of fingers

Action: Monitor - No action given the risk assessment

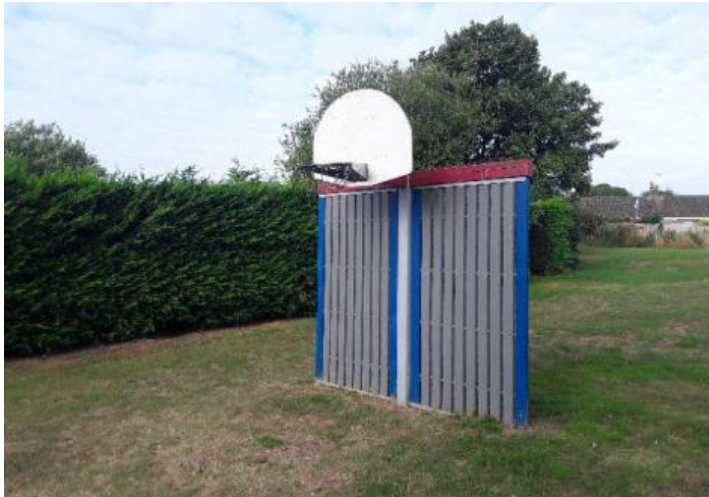
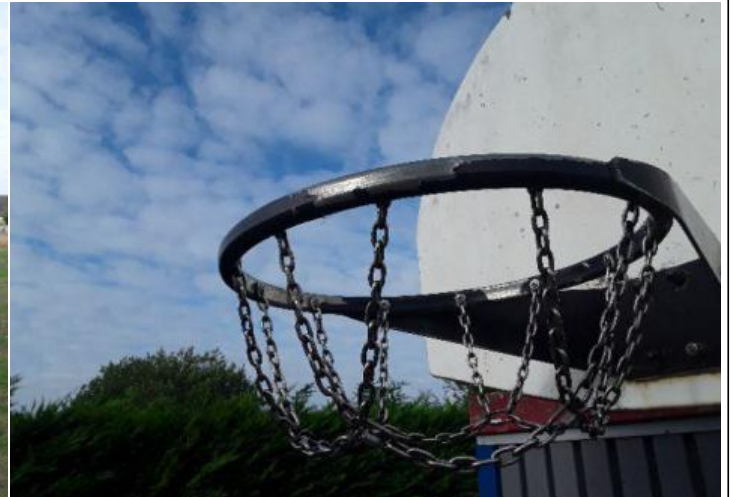
Finding: The paint is flaking off the metalwork

Action: Rub down and re-paint

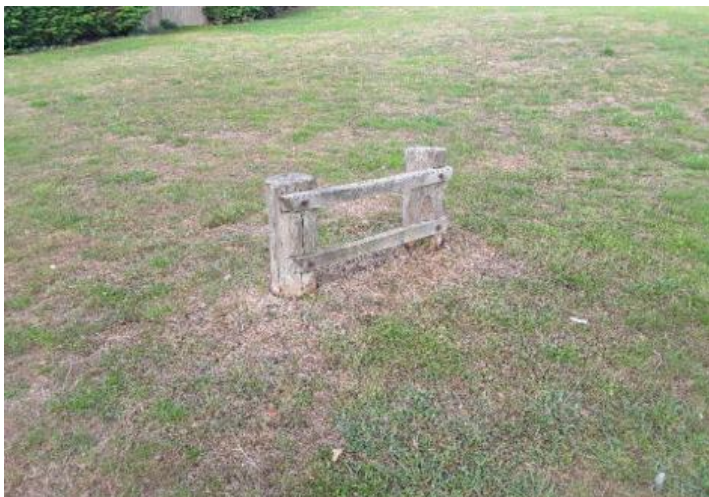
Finding: There is some strimmer / machinery damage apparent on the posts, this can penetrate the preservative applied to the timber and accelerate the rotting process

Action: Monitor for any deterioration (rot) and replace as required

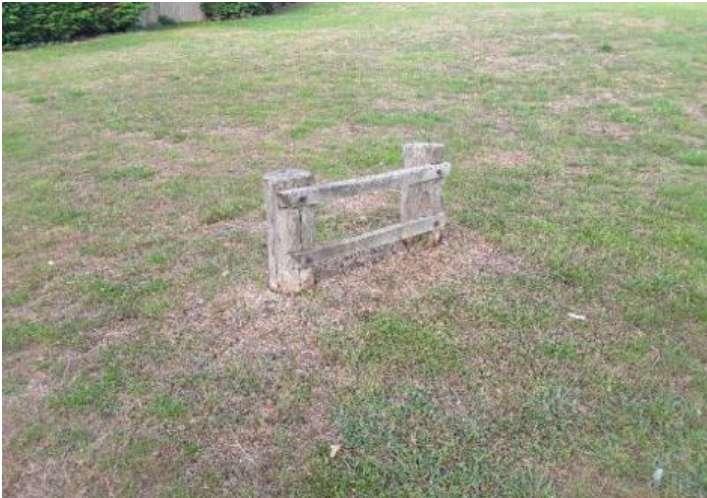
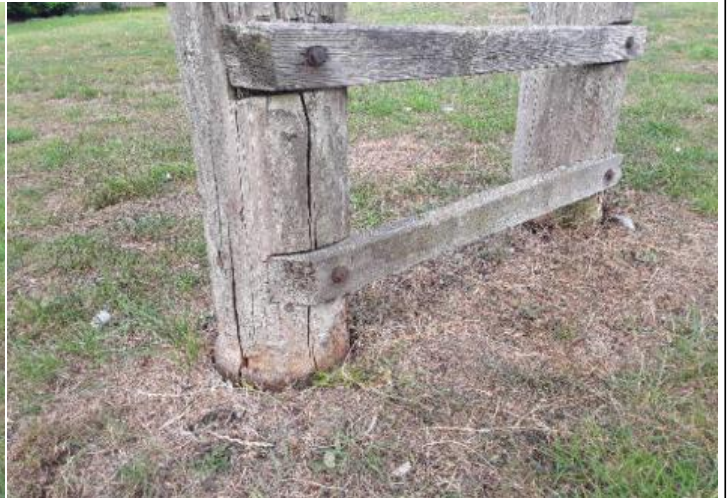
Finding: The timber has a number of splits/shakes or air cracks and this may affect the stability or allow water ingress which will accelerate the rotting process. Timber splits may also create rough / splintering edges.

Action: Monitor, sand down any rough edges and ensure the splits do not cross through fixing points of the structure and/or cause any instability

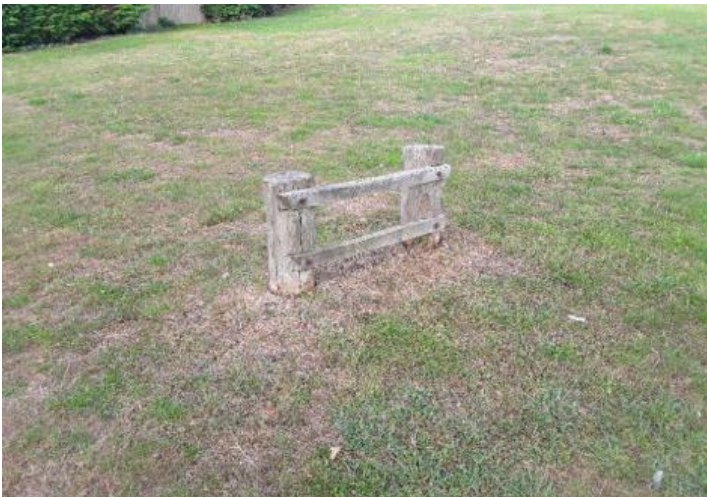
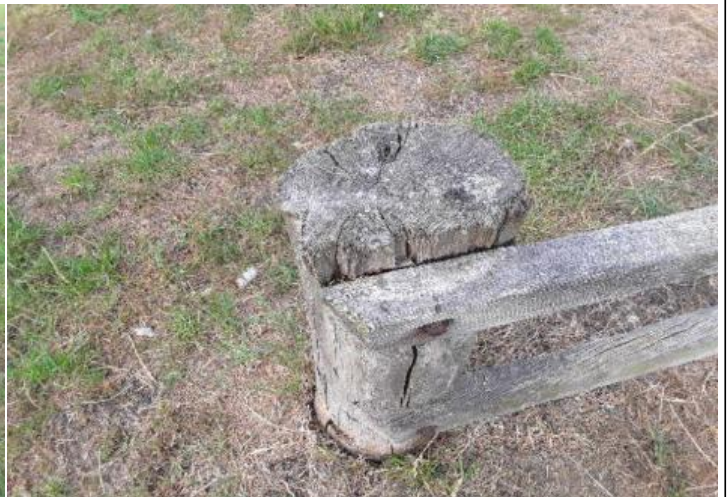
Finding: Parts of the timber are rough or splintered

Action: Remove all rough or sharp edges

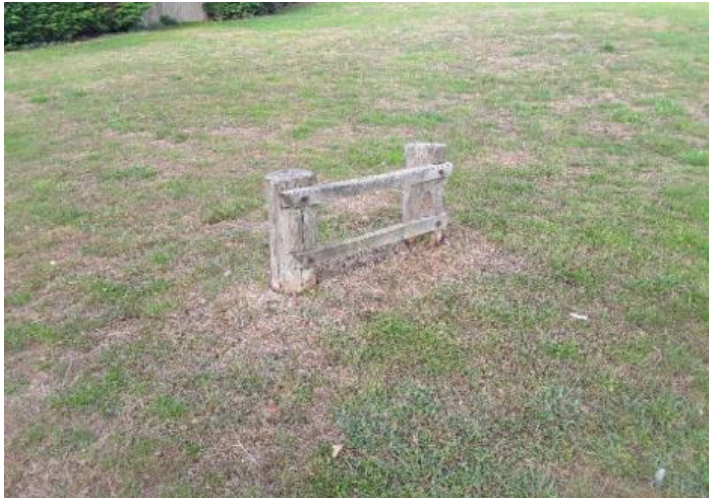
Finding: There is some evidence of rot in the timber

Action: Monitor for any further deterioration and replace as required

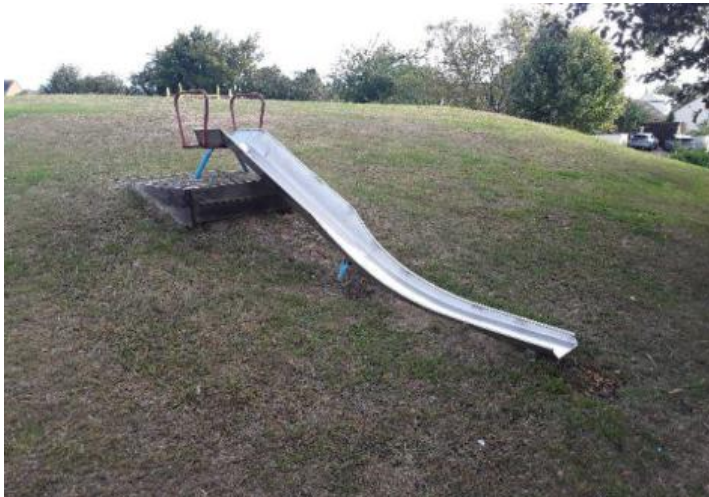
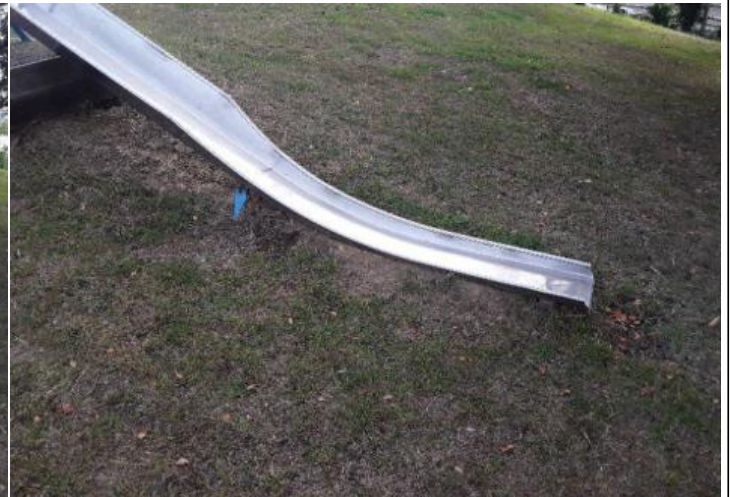
Finding: The grass has eroded within the impact area of the equipment and may not provide the necessary impact attenuating properties for the equipment fall height; the surface may also be slippery in wet weather

Action: Reinstate the grass or provide an all weather surface

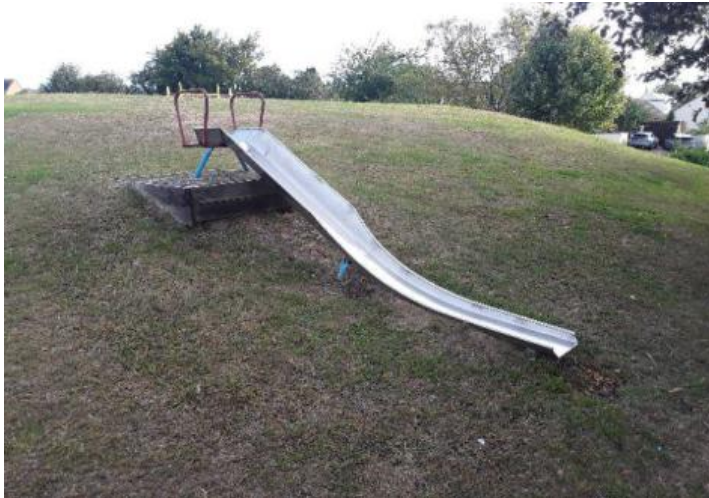
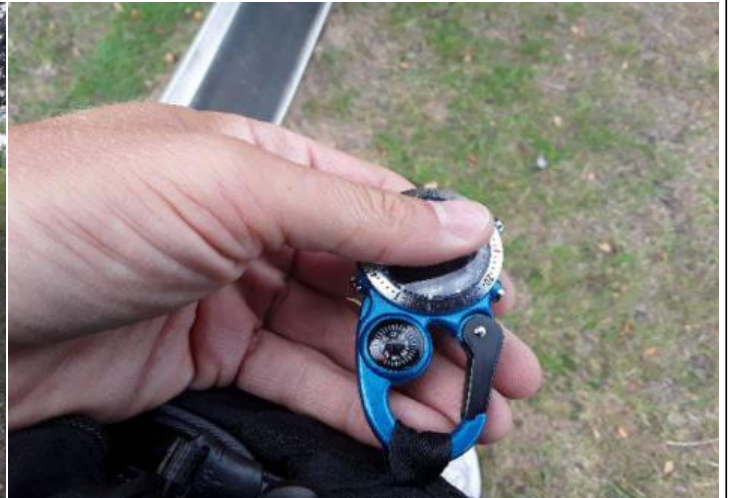
Finding: The slide is predominately south facing and will catch the majority of the sun's heat during the day. Slide surfaces can become very warm during periods of sustained sunny weather

Action: Monitor - No action given the risk assessment

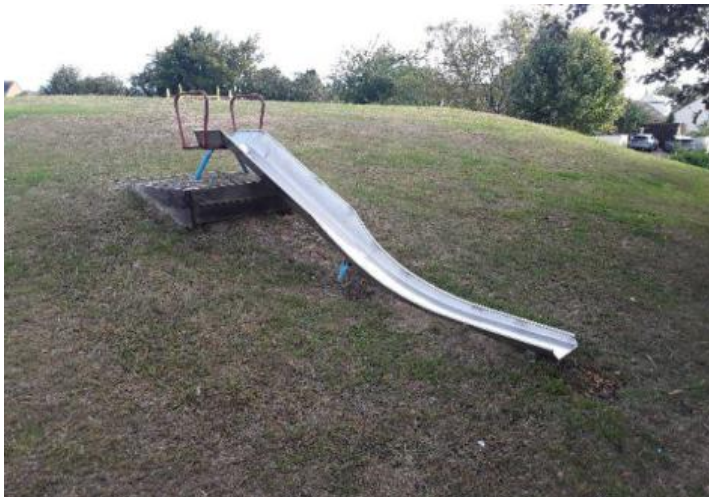
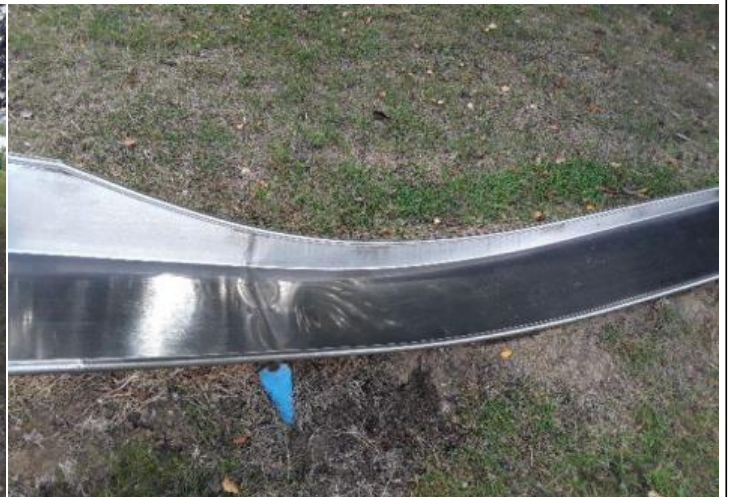
Finding: There are a number of dents in the slide surface

Action: Monitor for any further deterioration and repair as required

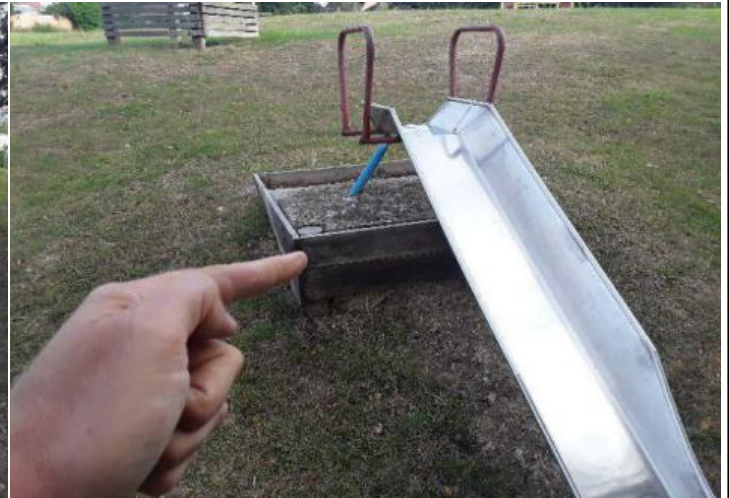
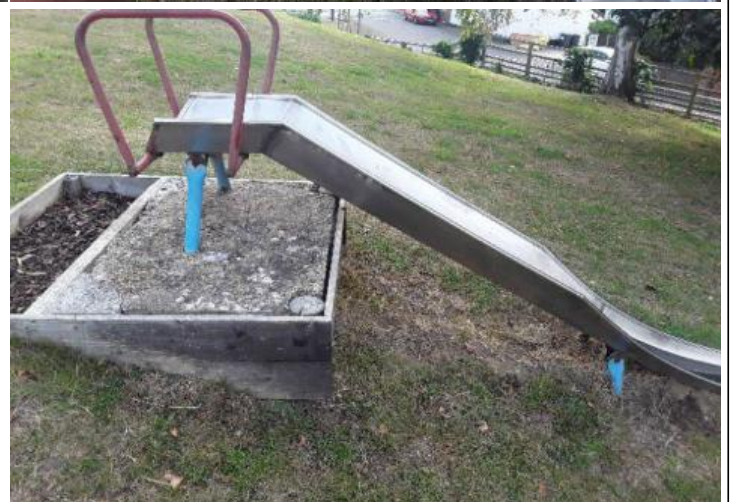
Finding: The platform structure forms a projecting obstacle / hard object within the falling space of the equipment, in contravention of the requirements of BS EN 1176 Part 1 / **Action:** Monitor - No action given the risk assessment

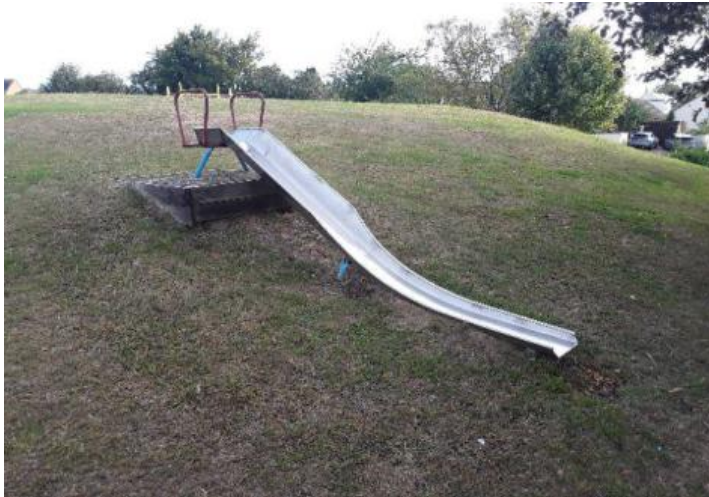
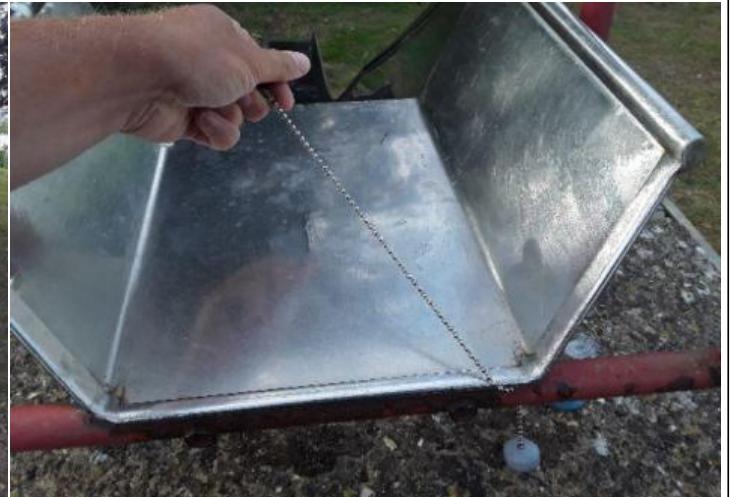
Finding: There is / are toggle entrapment/s present in contravention of the recommendations set out in BS EN 1176 Part 1

Action: Monitor - No action given the risk assessment

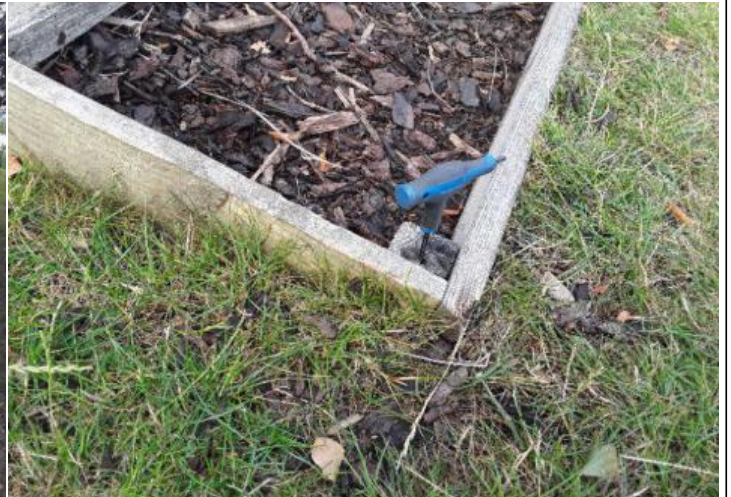
Finding: There are areas or parts of the timber on the structure that have rotted

Action: Replace all affected timbers

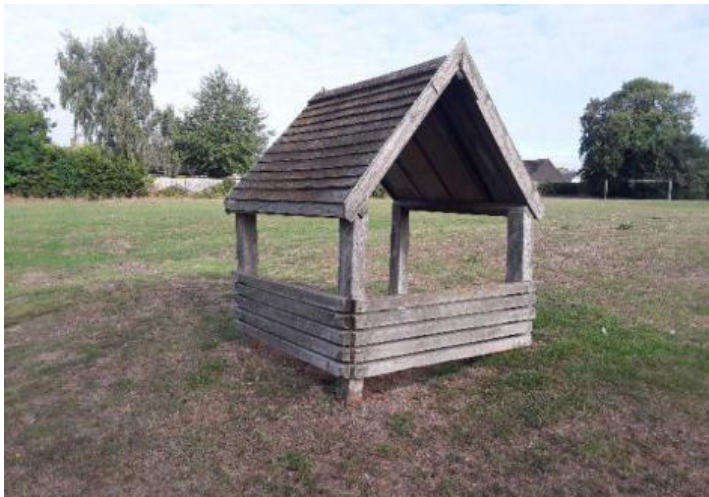
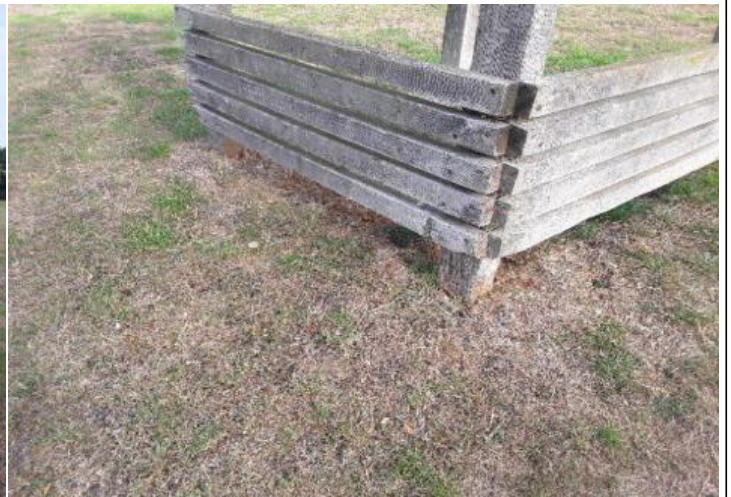
Finding: There is some strimmer / machinery damage apparent on the posts, this can penetrate the preservative applied to the timber and accelerate the rotting process

Action: Monitor for any deterioration (rot) and replace as required

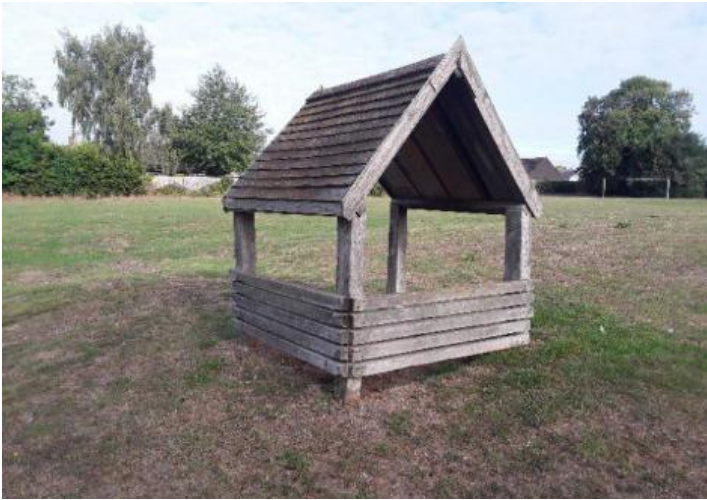
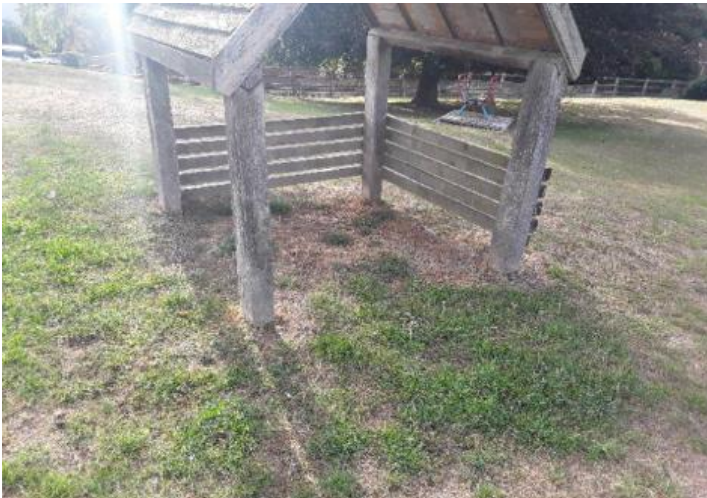
Item: Ancillary Items - Shelter
Manufacturer: Not Identified

Risk Level: L - Low Risk
Surface: Grass

Finding: All of the timber posts on the structure have rotted **Action:** Replace all affected timbers

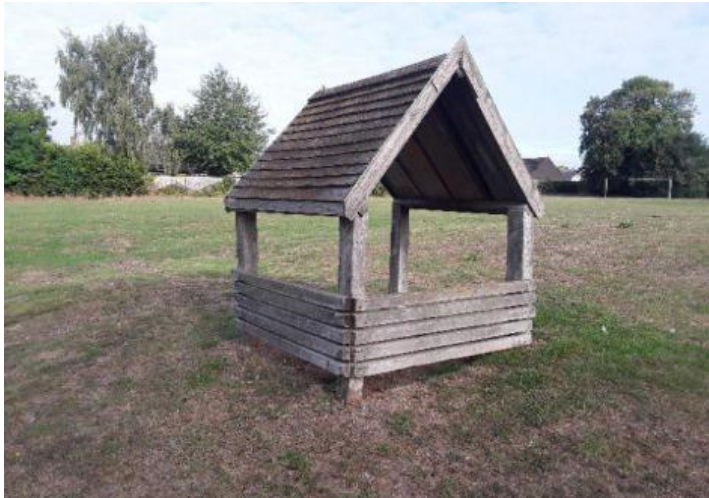
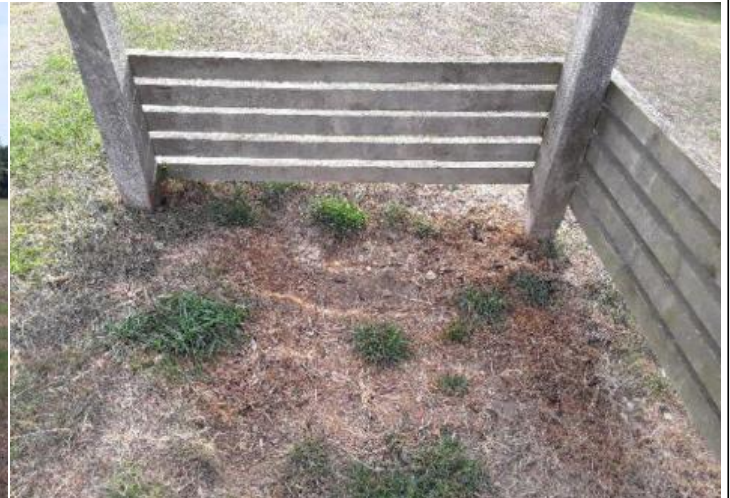
i 8 - Low Risk (Finding 3)

Item: Ancillary Items - Shelter
Manufacturer: Not Identified

Risk Level: L - Low Risk
Surface: Grass

Finding: The area around the item has eroded and may become slippery

Action: Reinstate eroded area

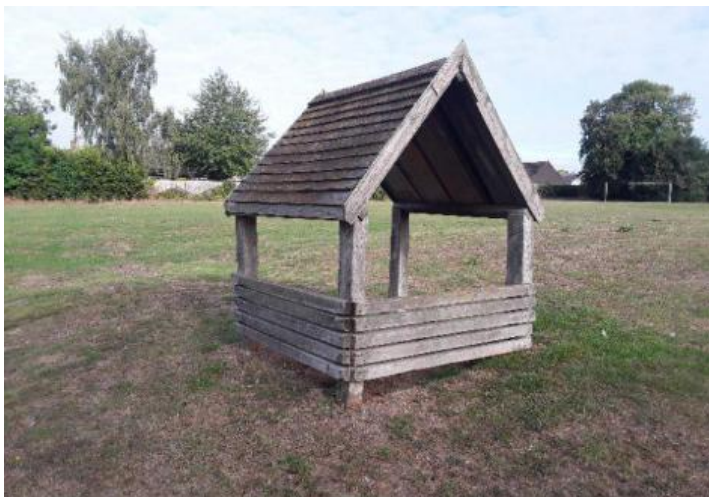
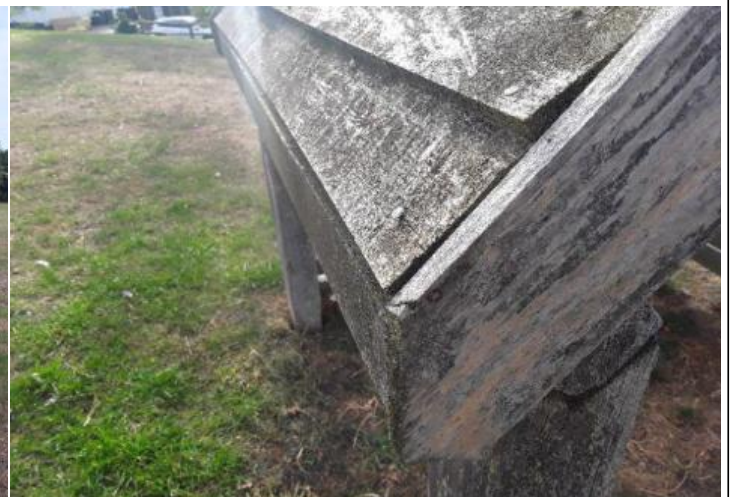
Item: Ancillary Items - Shelter
Manufacturer: Not Identified

Risk Level: L - Low Risk
Surface: Grass

Finding: A number of fixing(s) have worked loose

Action: Secure all loose fixings

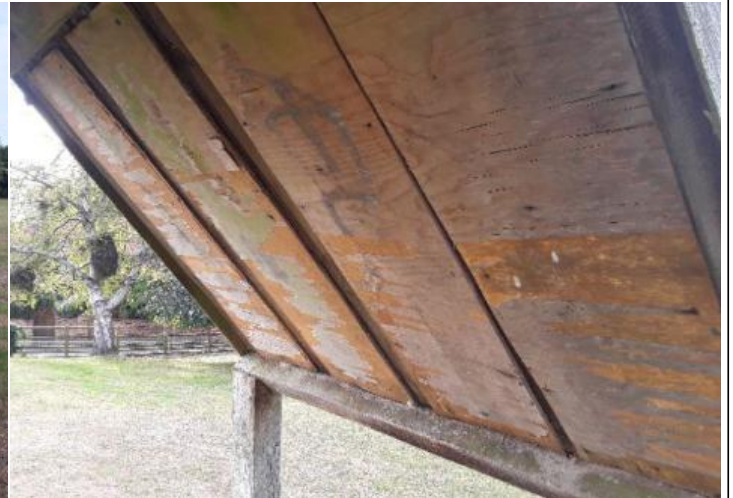
Item: Ancillary Items - Shelter
Manufacturer: Not Identified

Risk Level: L - Low Risk
Surface: Grass

Finding: The plywood has delaminated in some places

Action: Remove all rough or splintered edges.
